December 20, 2004
OG :04:1857
NRC:04:073

Steam Generator Drain Line Leakage

Alloy 600/182/82 Recirculating Steam Generator Drain Line Leakage Information Summary

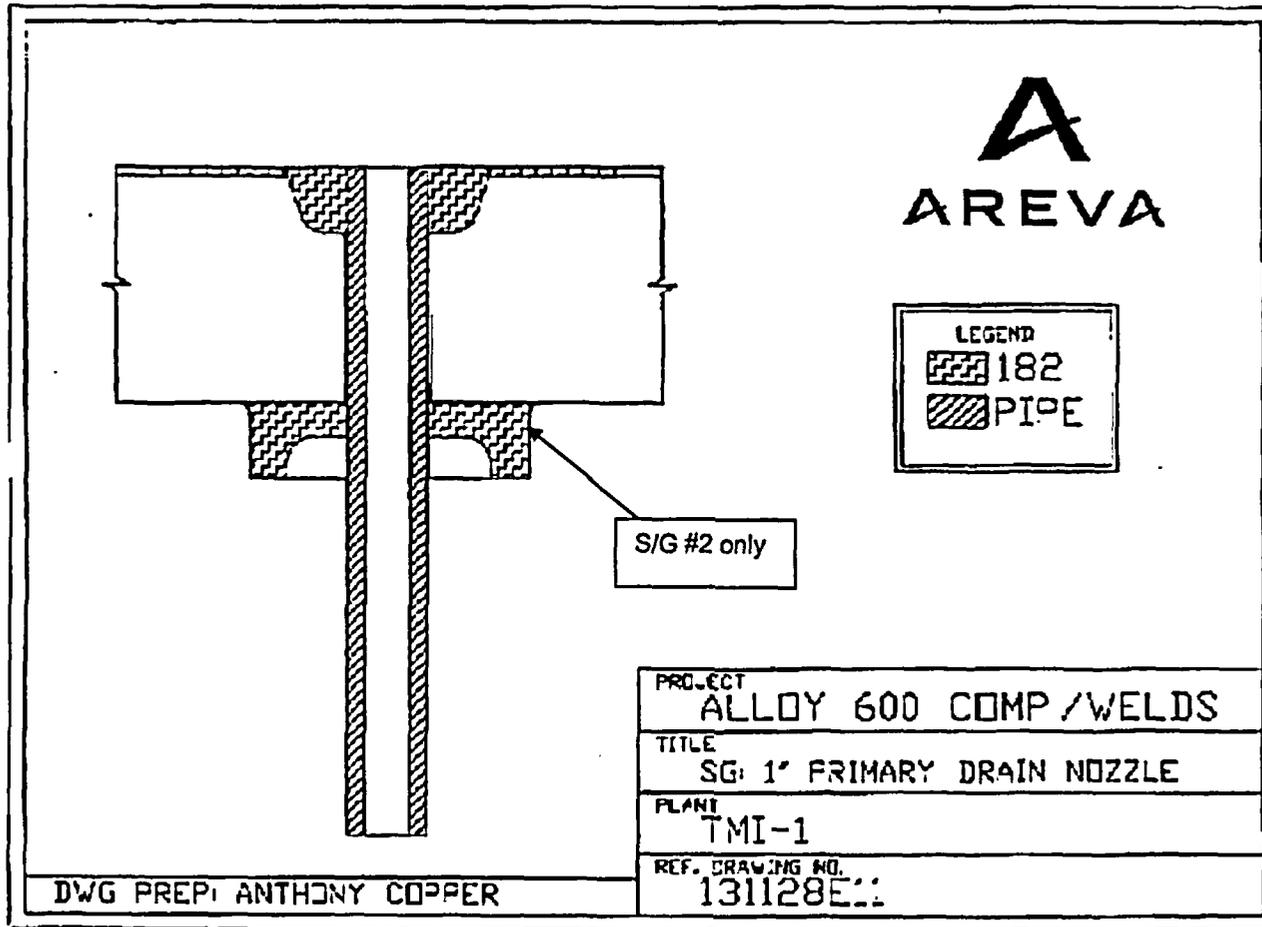
Figure 1. TMI-1 Steam Generator Primary Drain Nozzle Design

The primary drain nozzle design (for the originally installed OTSGs at all the operating units) consists of an Alloy 600 nozzle (SB-167 material), which is buttered and J-groove welded into the lower OTSG shell with Alloy 182 material. The nozzle was also hard-rolled into the shell following final stress relief of the OTSG. There is also a full penetration field weld (butt weld) using either Alloy 182 or 82 material between the nozzle and the piping or valve that exists at each unit.

3. Perform a bare metal visual examination of each steam generator primary drain nozzle and surrounding area at the next refueling outage. Consideration should also be given to developing an inspection plan for performing this inspection at future outages.

- Dye-penetrant examination of the weld(s) surfaces
6. The currently recommended repair procedure for this location is the "1/2-nozzle repair." This repair approach involves depositing an Alloy 52 circular weld pad around the perimeter of the existing nozzle bore on the steam generator. The existing Alloy 600 nozzle is then removed by machining to a depth of approximately halfway through the shell thickness and reinstalling an Alloy 690 nozzle with a new structural weld to the Alloy 52 pad. Alternative repair configurations may also be applicable.
