Subject: Brunswick Steam Electric Plant, Unit No. 2
Docket No. 50-324/License No. DPR-62
Licensee Event Report 2-2004-003

LICENSEE EVENT REPORT (LER)

4. TITLE
Unanalyzed Condition due to Missing One-Hour Rated Fire Barrier - 480 Volt Switchgear Room

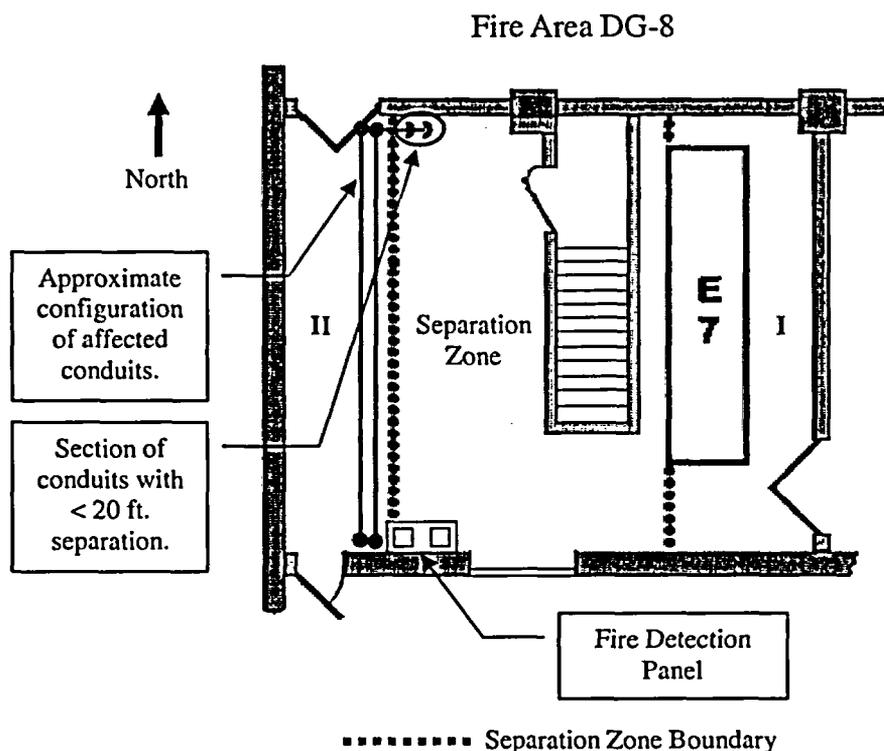
The affected conduits run south to north, paralleling the 20-foot wide separation zone but properly remaining outside (i.e., west) of the separation zone. When the conduits reach the north wall, they angle into the separation zone then proceed down through the floor, (i.e., a vertical run in the separation zone by approximately two feet). Approximately 22 feet of conduit within the separation zone was not protected by one-hour rated fire wrap. This conduit configuration resulted in 18 feet of separation from the redundant train.

The following diagram provides a simplified representation of fire area DG-08 with the approximate location of the unprotected conduits identified.

The cause of this event is attributed to the use of a plant drawing that did not accurately reflect the as-built conduit configuration within the fire area DG-08 separation zone. BSEP developed the original Alternative Shutdown Capability Assessment (ASCA) Report in 1983 to support creation of the safe shutdown separation analysis and ensure compliance with 10 CFR 50 Appendix R separation requirements. As prescribed by the ASCA Report, plant computer based conduit and cable raceway schedules were used to identify the physical routings of individual safe shutdown related cables. Plant electrical raceway drawings were then overlaid with fire zone information to identify the safe shutdown cable routes and equipment locations. This information was then combined to produce fire area designations to support the subsequent separation analysis. The fire area DG-08 raceway drawing used during this effort did not correctly reflect the as-built conduit configuration, (i.e., the affected conduits were not identified as traversing into the 20-foot separation zone). Consequently, the actions required to ensure compliance with separation criteria (i.e., the application of cable protection) were not identified for the affected conduits.

1. Upon detection of the cable protection deficiency, a one-hour roving fire watch was established and transient combustibles restricted in fire area DG-08 until a one-hour rated fire barrier material could be applied to the affected conduits.
2. On December 7, 2004, a one-hour rated fire barrier material was installed on the affected conduits.
3. A review of the other 480 switchgear room cable separation configurations was performed. This review determined that the identified separation concern is not applicable to those areas.
4. As part of the ongoing Safe Shutdown Revalidation Project a verification of the fire area designation for conduits credited for safe shutdown will be completed by June 15, 2005.
