December 28, 2004  
LIC-04-0132

**SUBJECT: Response to Request For Additional Information Concerning the 2003 Steam Generator Inservice Inspection Reports**

### Response to Request For Additional Information Concerning the 2003 Steam Generator Inservice Inspection Reports

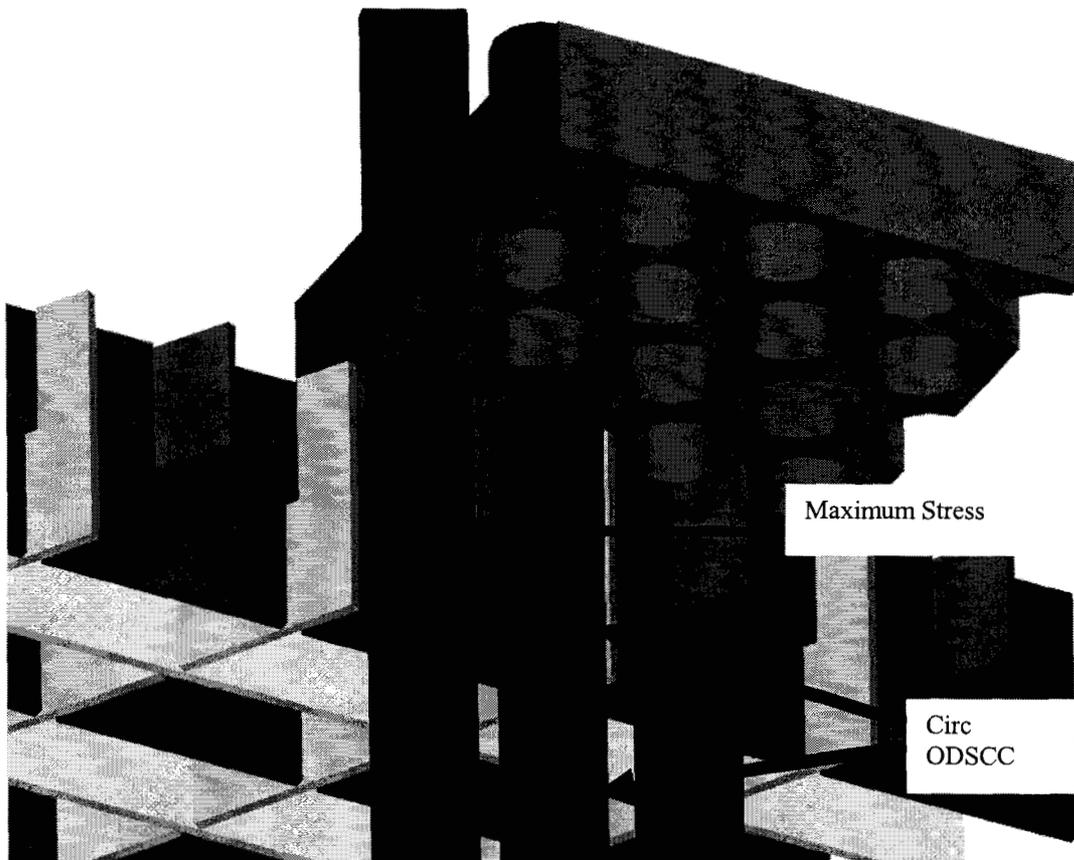
A root cause analysis was conducted after the inspection. The indication identified at the eggcrate support is at the chord region (edge) of the partial drilled support plate (see UT results for SG B Row 84 Line 73 listed above in question #1). A second tube (also in the chord region) with a circumferential indication at an eggcrate location was detected in SG B (R87/L52) at support H4 – 1.10". This support structure is also a combination eggcrate / drilled plate assembly. The indication is 0.27 volts with an estimated depth of 33% and an arc length of 21 degrees. The three coil delta probe confirms the presence and orientation of the flaw. The low frequency pancake coil data shows that the flaw is located below the tube support plate and the azimuthal orientation of the flaw is about 120 degrees relative to the eggcrate lattice. Only one lattice bar is evident in the ECT data. This intersection was not included in those tested by UT.

At the top of these eggcrates along the chord the edge of the drilled plate is scalloped and has the shape of a series of semi circles when viewed from the top. Growth of the drilled plate from denting results in a bending strain at and below the eggcrate where the tube is restrained from movement in the lateral plane. This configuration is unique to the chord region and these locations have been identified as a critical area in accordance with EPRI guidelines. The February 2005 examination will include plus point coil testing of 100% of this critical area.

Eggcrate and Tube Support Plate Intersection –  
Bottom View with Maximum Stress and Crack Locations
