**Subject: Beaver Valley Power Station, Unit No. 1
BV-1 Docket No. 50-334, License No. DPR-66
Reactor Head Inspection 60-Day Report for 1R16**

**Evaluation Report for
1R16
Beaver Valley Unit 1
Reactor Vessel Head Penetration
Inspections
(Ref: Order EA-03-009)**

December 2004

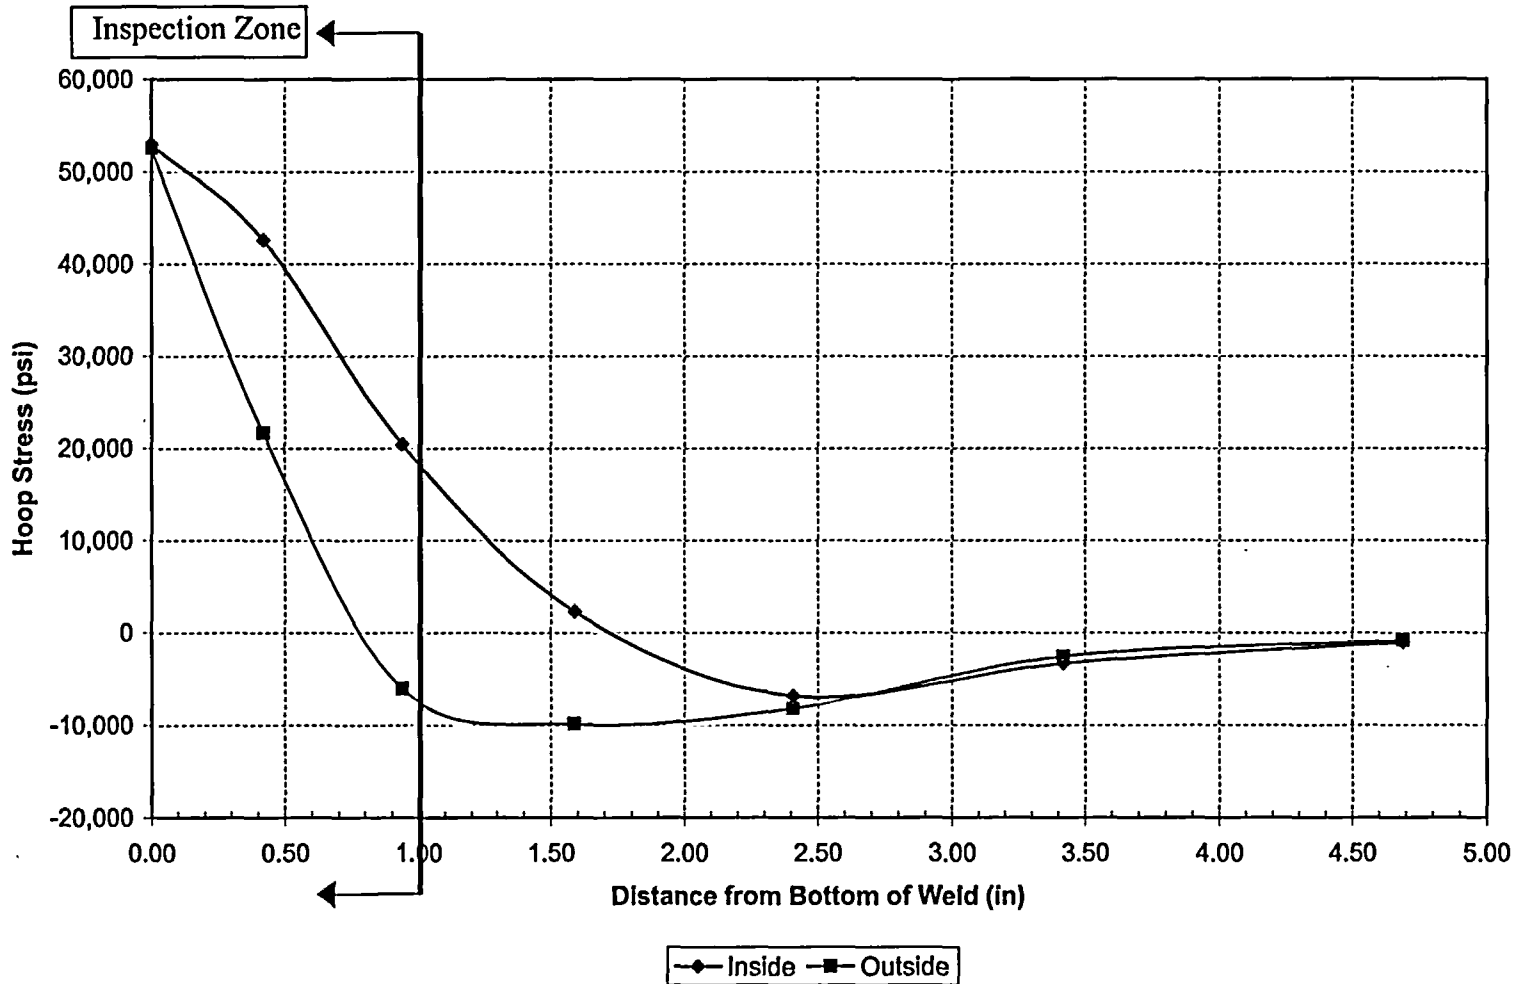
Figure 1
Hoop Stress Vs Distance from Bottom of Weld
0° CRDM Center Penetration Nozzle – Uphill and Downhill

Underhead NDE examinations were performed using a combination of ultrasonic and eddy current examination techniques, in accordance with the requirements of Paragraph IV.C.(5)(b)(iii). Multiple techniques had to be used in order to account for difficult penetration geometries and access limitations. (Note: Each RPV head penetration was inspected using ultrasonic OR eddy current testing. Examination techniques were not combined on any one penetration, therefore, the requirements of Paragraphs IV.C.(5)(b)(iii)(1) and (2) do not apply.) In all cases (ultrasonic or eddy current), the minimum examination coverage extended from 2 inches above the highest point of the root of the J-groove weld to 1 inch below the lowest point at the toe of the J-groove weld. For BVPS Unit 1, the minimum required coverage below the toe of the J-groove weld is 1 inch, as a plant-specific stress analysis has been performed (WCAP-16071), and tensile stresses beyond 1 inch below the J-groove weld are shown to be < 20 ksi in all cases, as shown in Attachment A.
