**Subject: Beaver Valley Power Station, Unit No. 1  
BV-1 Docket No. 50-334, License No. DPR-66  
Reactor Head Inspection 60-Day Report for 1R16**

**Evaluation Report for  
1R16  
Beaver Valley Unit 1  
Reactor Vessel Head Penetration  
Inspections  
(Ref: Order EA-03-009)**

**December 2004**

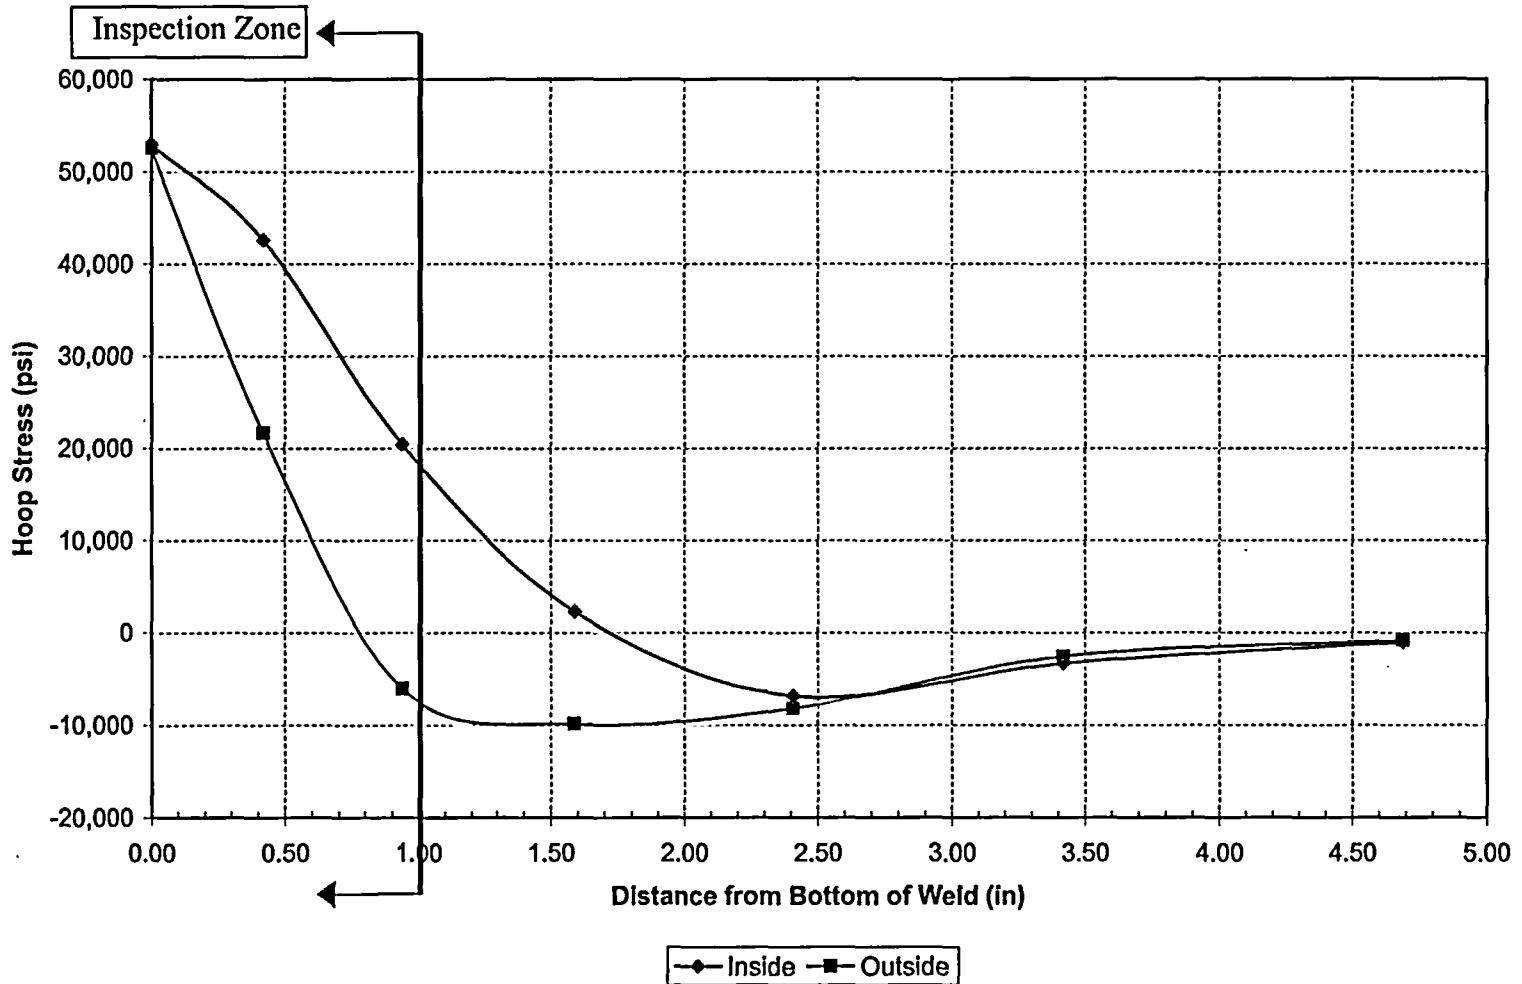
Figure 1  
Hoop Stress Vs Distance from Bottom of Weld  
0° CRDM Center Penetration Nozzle – Uphill and Downhill

Underhead NDE examinations were performed using a combination of ultrasonic and eddy current examination techniques, in accordance with the requirements of Paragraph IV.C.(5)(b)(iii). Multiple techniques had to be used in order to account for difficult penetration geometries and access limitations. (Note: Each RPV head penetration was inspected using ultrasonic OR eddy current testing. Examination techniques were not combined on any one penetration, therefore, the requirements of Paragraphs IV.C.(5)(b)(iii)(1) and (2) do not apply.) In all cases (ultrasonic or eddy current), the minimum examination coverage extended from 2 inches above the highest point of the root of the J-groove weld to 1 inch below the lowest point at the toe of the J-groove weld. For BVPS Unit 1, the minimum required coverage below the toe of the J-groove weld is 1 inch, as a plant-specific stress analysis has been performed (WCAP-16071), and tensile stresses beyond 1 inch below the J-groove weld are shown to be < 20 ksi in all cases, as shown in Attachment A.
