**Root Cause Analysis of:**

**HC 'B' Recirculation Pump  
Excessive Seal Leakage**

**Condition Report No: 70029861**

**Event Date: March, 2003**

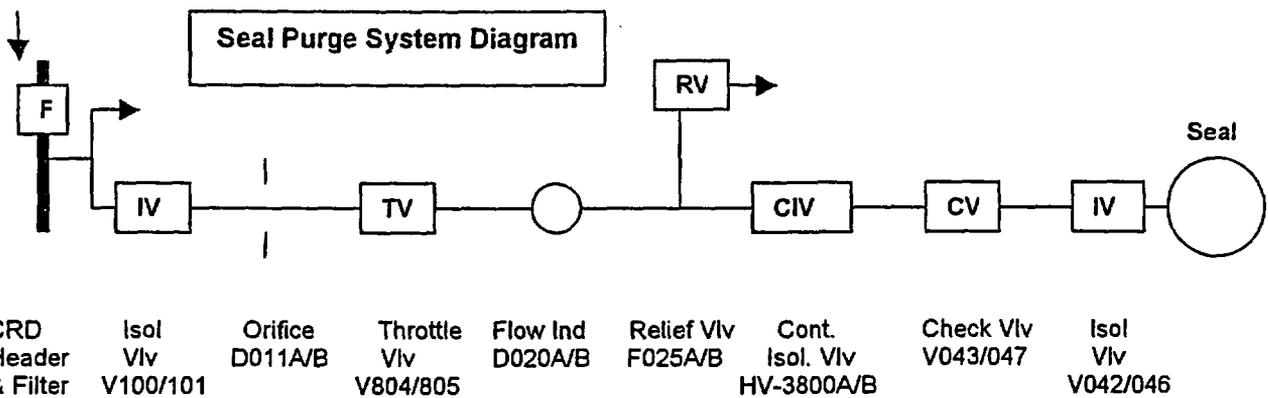
Basis: Purge system is designed to prevent the reactor coolant from entering the seal. Without adequate purge seal water flow, the Reactor Recirculation System enters through the shaft throttle bushing carrying impurities into the seal cavity. The impurities in the water are deposited on the seal faces and result in damage to the seal faces during operation. Observations that indicate inadequate purge seal flow include: particulate residue in the seal cavity and on the seal faces, the high radioactive contamination of the residue and the cuts on the seal surface, seal cavity temperature spike after pump is taken out of service.

Seal purge flow is diverted out of the damaged relief valve. As-found leak tests confirmed that relief valves were sufficiently damaged to divert the 2.5 gpm purge flow from the seal. On 03/26/2003, a Relief Valve Technician, performed as-found leak test and inspection on the F025A/B relief valves that were removed during the outage. The result of the leak test at 200 psig for one minute was:

- F025B = 12,890 ml/min or 3.4 gal/min
- F025A = 9430 ml/min or 2.5 gal/min.

Valve internals were severely eroded indicating long-term leakage and the disc had gouges in the seating surface. See Attachment 7 for As found test details.

Corrective Action:	Repaired and replaced the damaged F025A(B)valves
Type/Status:	Remedial/Complete
Effectiveness:	Monitoring of the discharge piping for F025A(B) during routine operator rounds
	VERF 0170                      Due Date: 09/01/2003                      R-REP05
Corrective Action:	Revise HC.OP-S0.BB-0002 procedure prior to RF11 to protect against over pressurization of the purge supply header and inadvertent lifting of the F025A(B) relief valves during shutdown and isolation of the reactor recirculation pump and during fill and vent evolution.
	CRCA 0080                      Due Date: 4/15/2003                      O-HTP05
Type/Status:	Remedial/Complete
Effectiveness:	Monitoring of the discharge piping for F025A(B) during routine operator rounds See VERF 0170
Corrective Action:	A rigorous documented review of the entire shutdown and venting evolutions should be performed by an Operations and Engineering team. Appropriate changes should be made to ensure that an adequate seal venting is accomplished without challenging the relief valve setpoint. The review should include:
