H-1-BB-CEE-1862

Hope Creek Recirc/RHR Pipe Vibration Common Cause Analysis

07/27/2004

Revision: 0

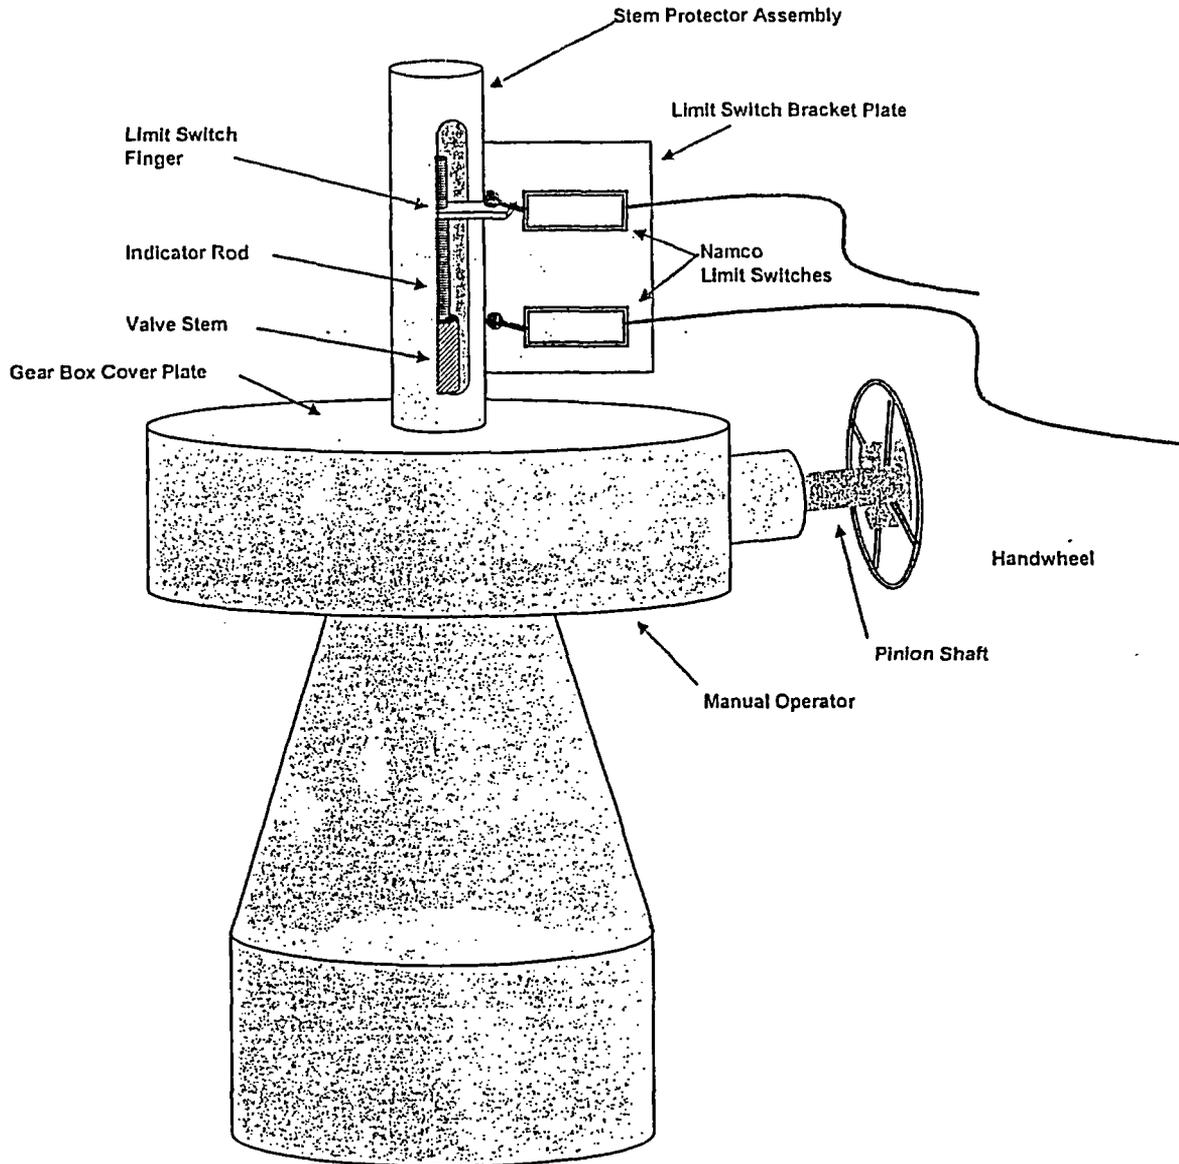
Figure 6-4
F060 Valve Topworks with Limit Switch/Stem Protector Geometry

The geometry of the fingers installed in the F060A and F060B valves differ, as shown in Attachment A photographs. A search of early plant records shows that the F060B limit switch finger was modified during plant construction (Reference: Startup Deviation Report BC-0951). The configuration of these switches found broken in March 2004 does not match the vendor design for the limit switch finger (Anchor/Darling Valve Company drawing number 152860404).

- The stem protector subassembly. This subassembly is mounted on the gear box cover which in turn is bolted to the top of the F060 valve gear box assembly. The gear box cover supports a half coupling which threads onto the bottom of the stem protector subassembly. The valve stem passes through this half coupling when the valve is opened. The stem protector subassembly consists of a nominal 3.5" diameter pipe (which has an actual OD of 4") which is 19.5" long and is threaded on each end. The pipe is slotted to allow the limit switch finger to extend out to contact the limit switch levers. The limit switch bracket is a plate welded to the stem protector pipe section adjacent to the slot. This bracket plate supports the two Namco limit switches that indicate the position of the valve.

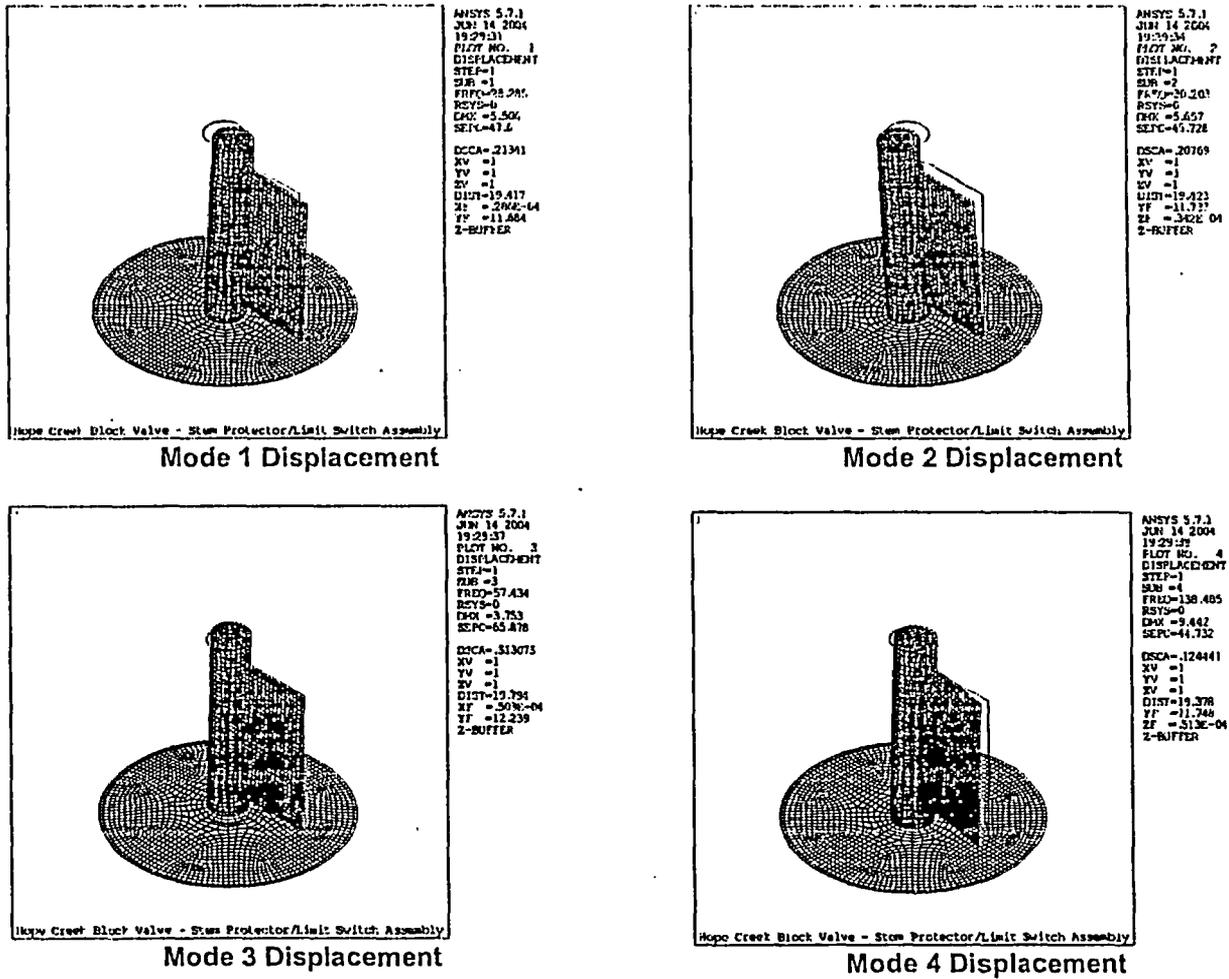
Figure 6-6
Modal Displacement Shapes for Gear Box Cover Plate and Stem Protector Assembly

The gear box cover plate and stem protector pipe have several natural frequencies and mode shapes in the frequency range of the expected pressure pulsations, as shown in the Figure 6-6 and described below:

- Mode 1 occurs at 28 Hz. In this mode, the top of the stem protector pipe moves relative to the stem, in the plane of the limit switch bracket plate.
- Mode 2 occurs at 30 Hz. In this mode, the top of the stem protector pipe moves relative to the stem, in the plane perpendicular to the limit switch bracket plate.
- Mode 3 occurs at 57 Hz. In this mode, the cover plate itself deflects up and down, causing the stem protector pipe section to rise and fall. The pipe also tilts relative to the stem in this mode.
- Mode 4 occurs at 138 Hz. In this mode, the plate attached to the stem protector wags from side to side, causing the stem protector pipe to tilt relative to the stem.

All four of these motions cause relative motion between the stem and the stem protector slotted pipe. If this motion is large enough to close the gap between the indicating finger and the side of the slot, the resulting contact force could cause fretting of the side of the indicating finger, and bending loads on the finger and on the linkage connecting the finger to the top of the stem.

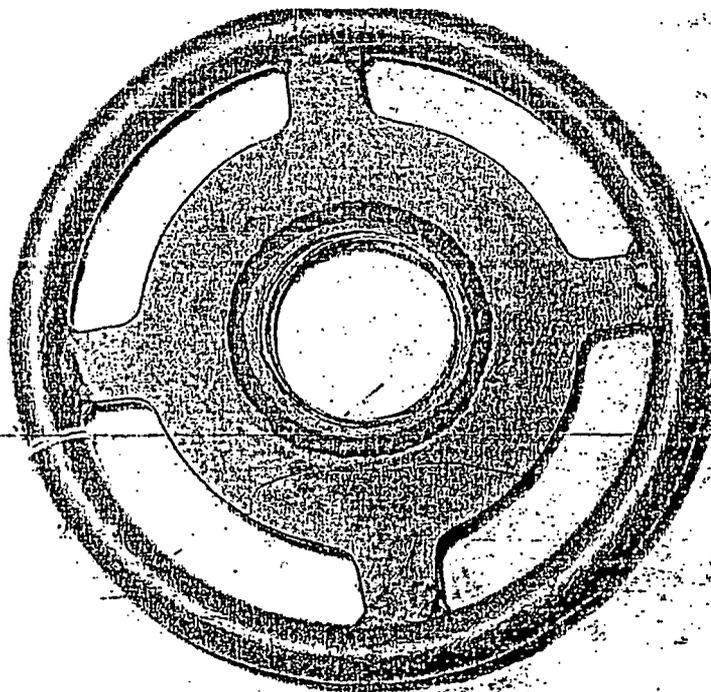
- The hand wheel had fallen off of valve 1BC-HV-F060B. This is a manual block valve located inboard of the testable check valve 1BC-HV-F050B in the “B” loop RHR return line. (Note, this line does not communicate with the north pipe chase.) The handwheel was found suspended from its lockwire near the manual valve operator where it had previously been attached. The hub on the operator shaft was found to be worn and the retaining ring meant to hold the handwheel on the hub was missing.

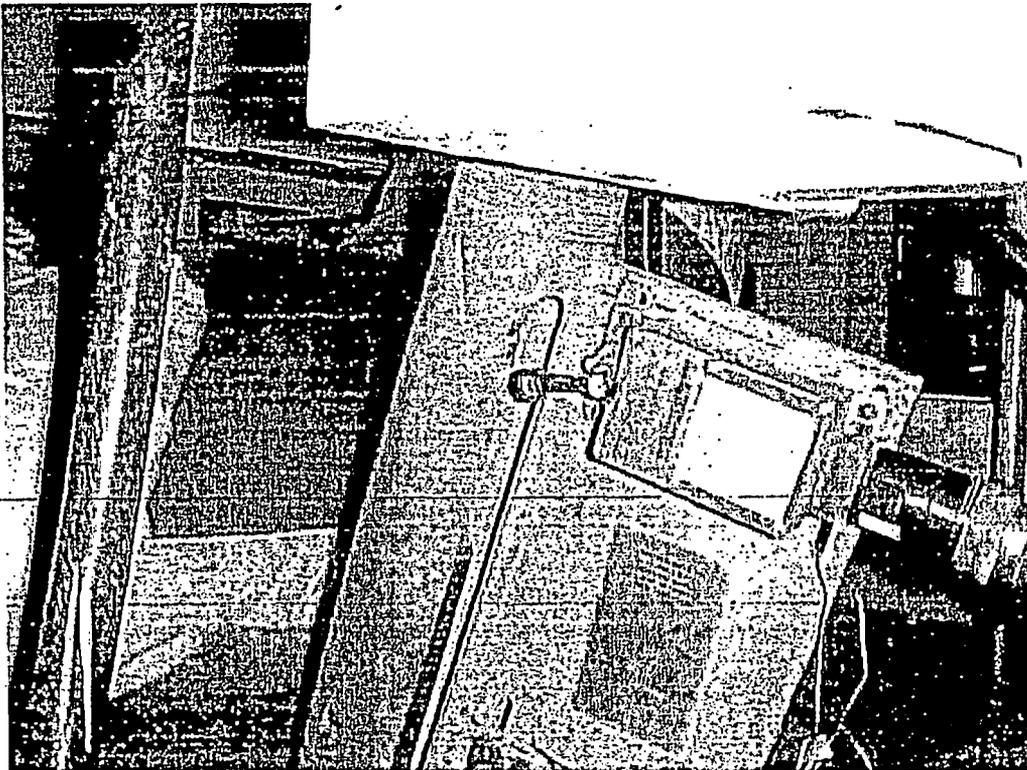
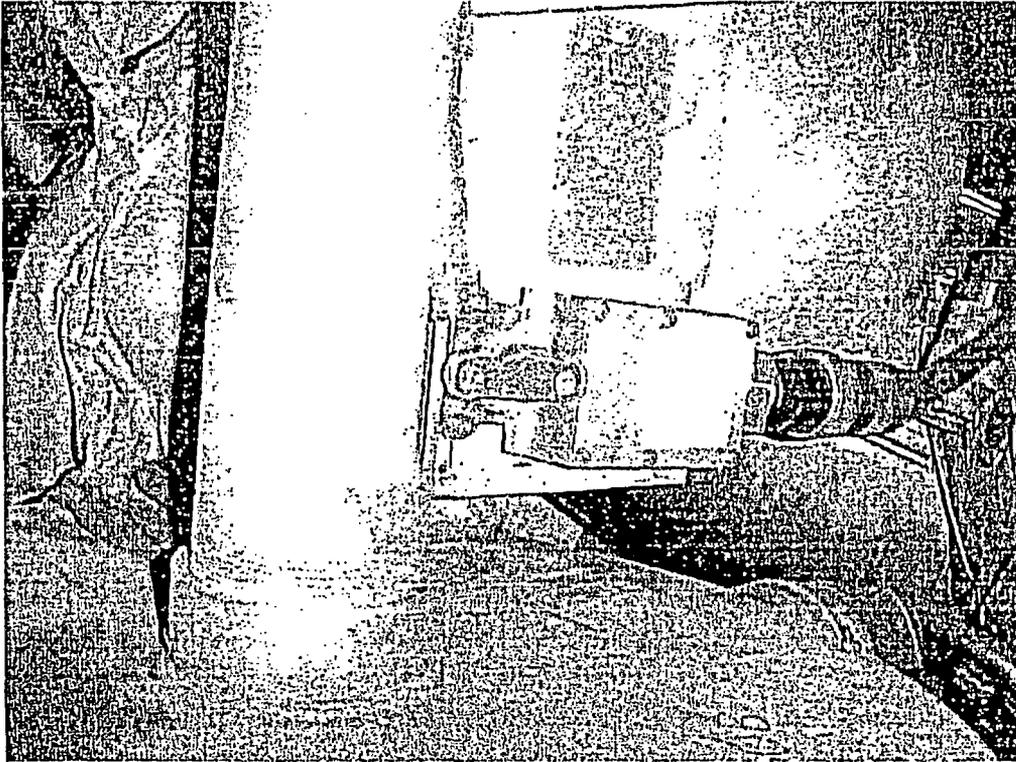
- Limit switches were found to have failed on the 1BC-HV-F060A and 1BC-HV-F060B valves in containment. These valves are located on the RHR return piping lines near where they connect to the recirculation discharge piping. In addition, the limit switch on valve 1BC-HV-F065D was also found to be close to the edge of its indicating finger.

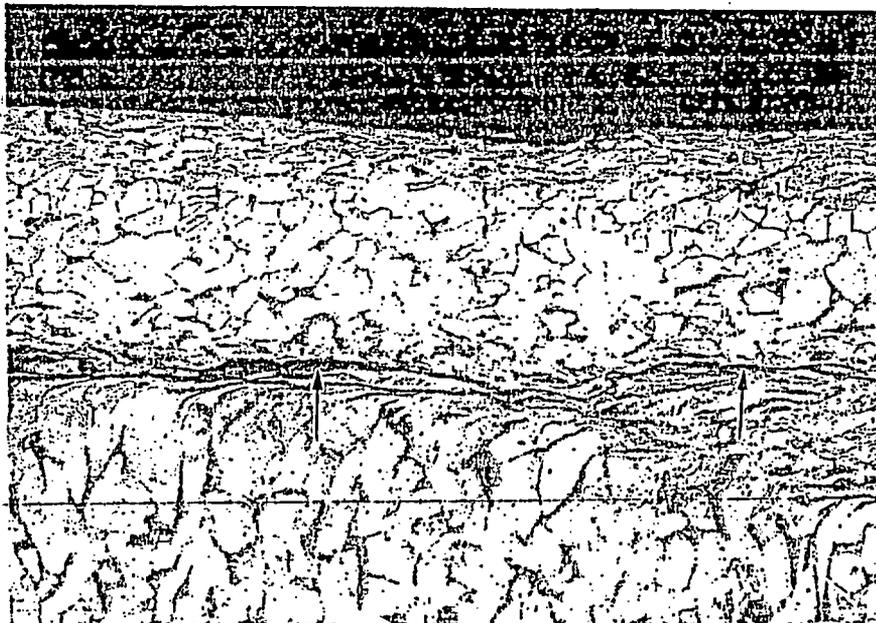
Photo No. 7203

Microphotograph shows subsurface discontinuity in the form of a lap (arrows) below the mounting hole surface.
