H-1-BB-CEE-1862

Hope Creek Recirc/RHR Pipe Vibration Common Cause Analysis

07/27/2004

# ***Hope Creek Recirc/RHR Pipe Vibration Common Cause Analysis***

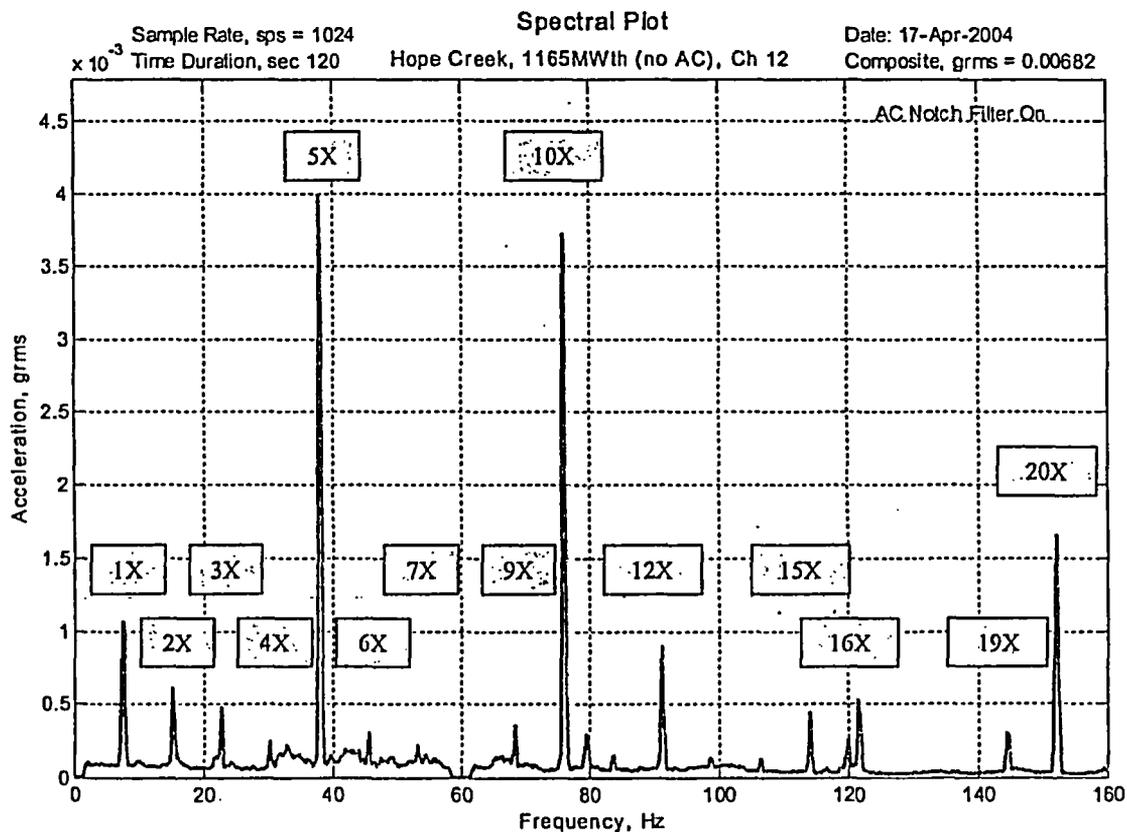
Figure 4-3  
 Typical Vibration Accelerations with Pump Speed of 460 rpm

In addition, pressure fluctuations can occur at higher multiples of these speeds. For example, Figure 4-3 below shows the measured vibration accelerations at a point on the Loop B recirculation piping when the Loop B pump was operating at 460 rpm. At this pump speed, the 1X frequency is 7.7 Hz and the 5X frequency is 38.3 Hz. The piping response at these frequencies is clearly evident. The figure shows there are also smaller but noticeable responses (peaks) at the following frequencies:

- Multiples of the pump running speed: 2X (15.3 Hz), 3X (23 Hz), 4X (30.7 Hz), 6X (46.0 Hz), and so on.
- Multiples of the vane passing frequency: 5X (38.3 Hz), 10X (76.7 Hz), 15X (115.0 Hz), and 20X (153.3 Hz).

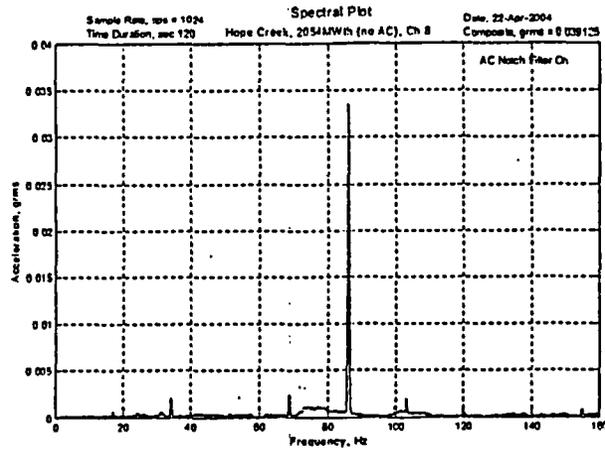
Figure 6-1. Noise in Acceleration Data and its Effect on Calculated Displacements

Data taken at 2054 MWth on April 22, 2004  
Little or No Noise Present; Calculated Displacement = 3.4 mils peak-to-peak

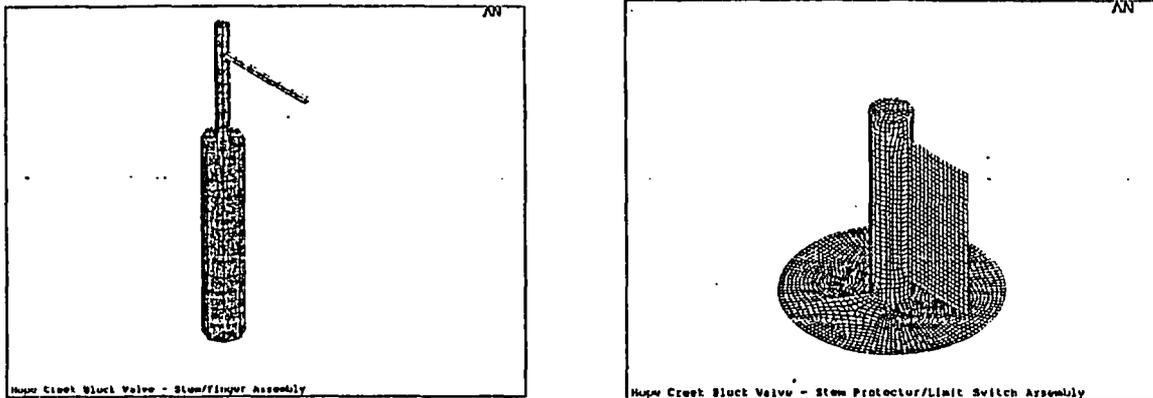
**Figure 6-5**  
**ANSYS Models Used to Determine Mode Shapes of F060 Valve**  
**Limit Switch/Stem Protector Geometry**

The models created in this effort are shown in Figure 6-5 below. Note that the model of the limit switch indicator rod and finger modeled the stem in the position that it would be in when the valve is full open. The computer program ANSYS used these models to determine the natural frequencies of each of these components.

The analysis results showed that the limit switch rod and indicating finger have natural frequencies well above the highest expected 5X vane passing frequency. Accordingly, the indicating finger and stem rod will move as the stem itself moves, with little or no amplified relative motion.

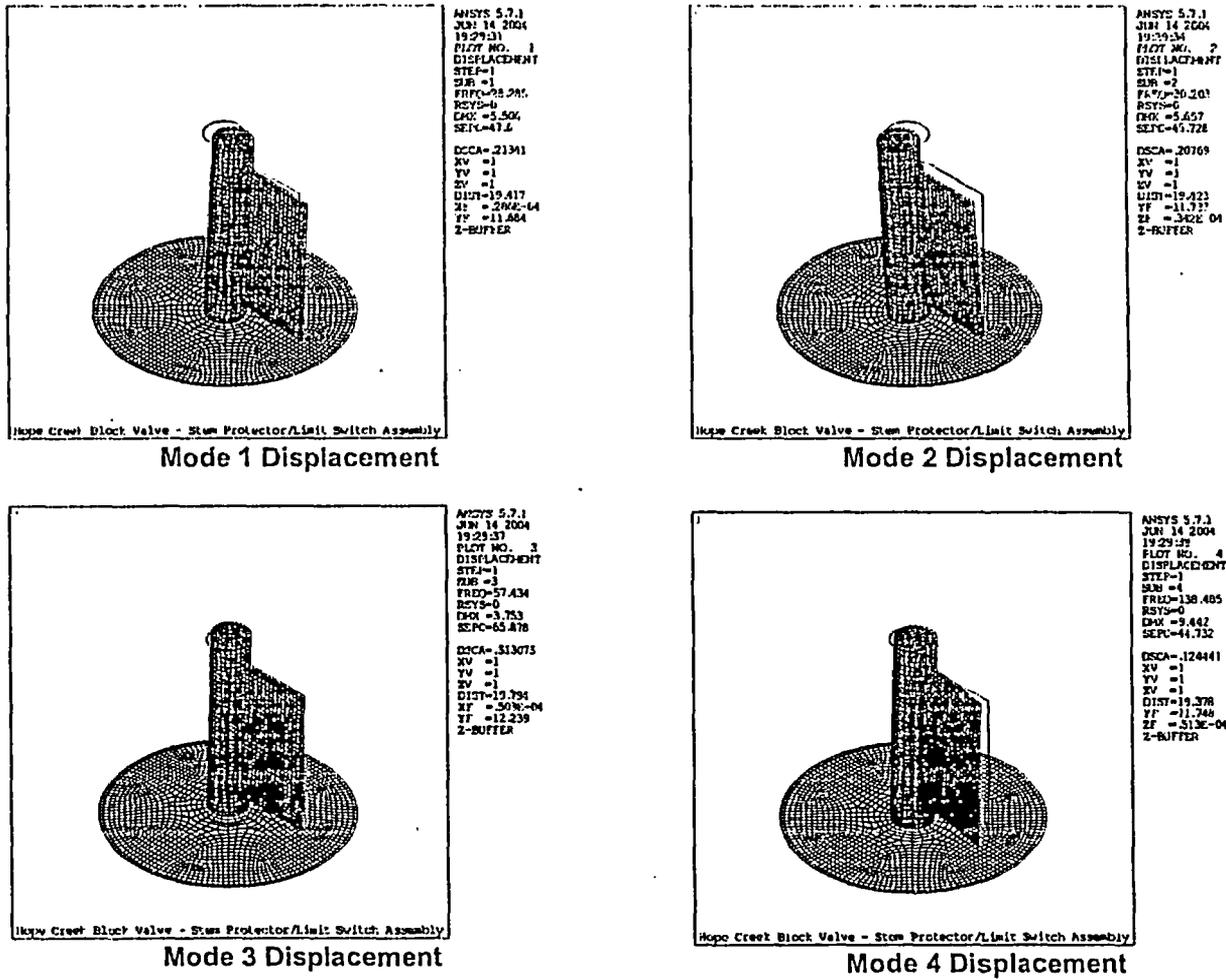
**Figure 6-6**  
**Modal Displacement Shapes for Gear Box Cover Plate and Stem Protector Assembly**

The gear box cover plate and stem protector pipe have several natural frequencies and mode shapes in the frequency range of the expected pressure pulsations, as shown in the Figure 6-6 and described below:

- Mode 1 occurs at 28 Hz. In this mode, the top of the stem protector pipe moves relative to the stem, in the plane of the limit switch bracket plate.
- Mode 2 occurs at 30 Hz. In this mode, the top of the stem protector pipe moves relative to the stem, in the plane perpendicular to the limit switch bracket plate.
- Mode 3 occurs at 57 Hz. In this mode, the cover plate itself deflects up and down, causing the stem protector pipe section to rise and fall. The pipe also tilts relative to the stem in this mode.
- Mode 4 occurs at 138 Hz. In this mode, the plate attached to the stem protector wags from side to side, causing the stem protector pipe to tilt relative to the stem.

All four of these motions cause relative motion between the stem and the stem protector slotted pipe. If this motion is large enough to close the gap between the indicating finger and the side of the slot, the resulting contact force could cause fretting of the side of the indicating finger, and bending loads on the finger and on the linkage connecting the finger to the top of the stem.

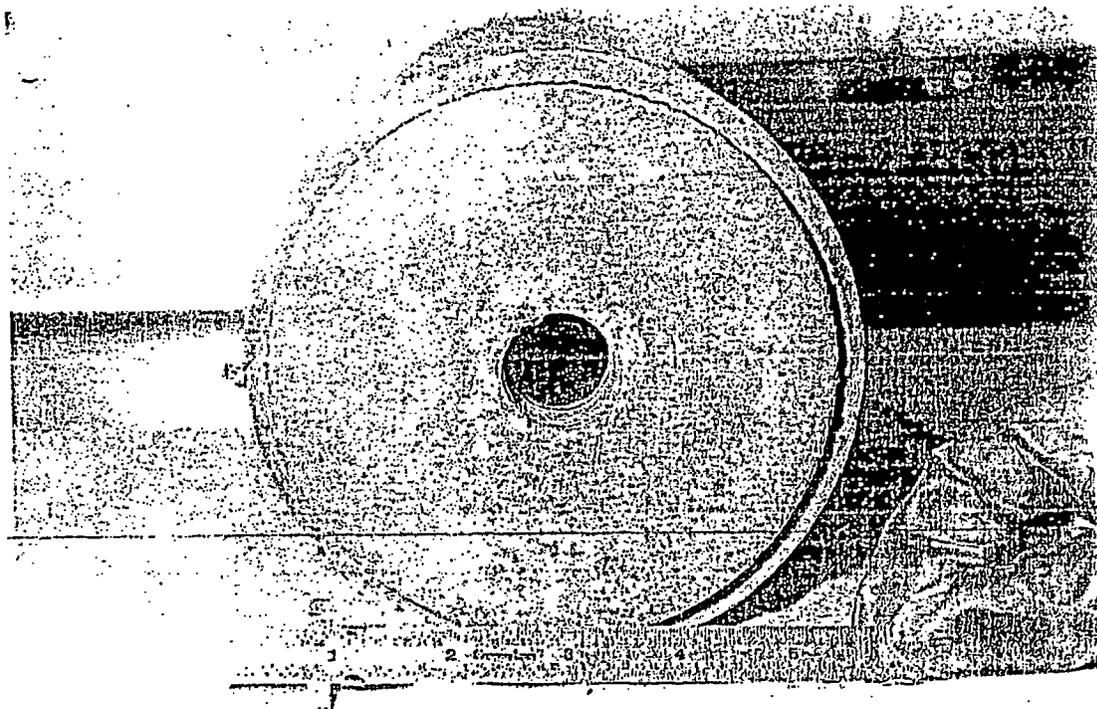
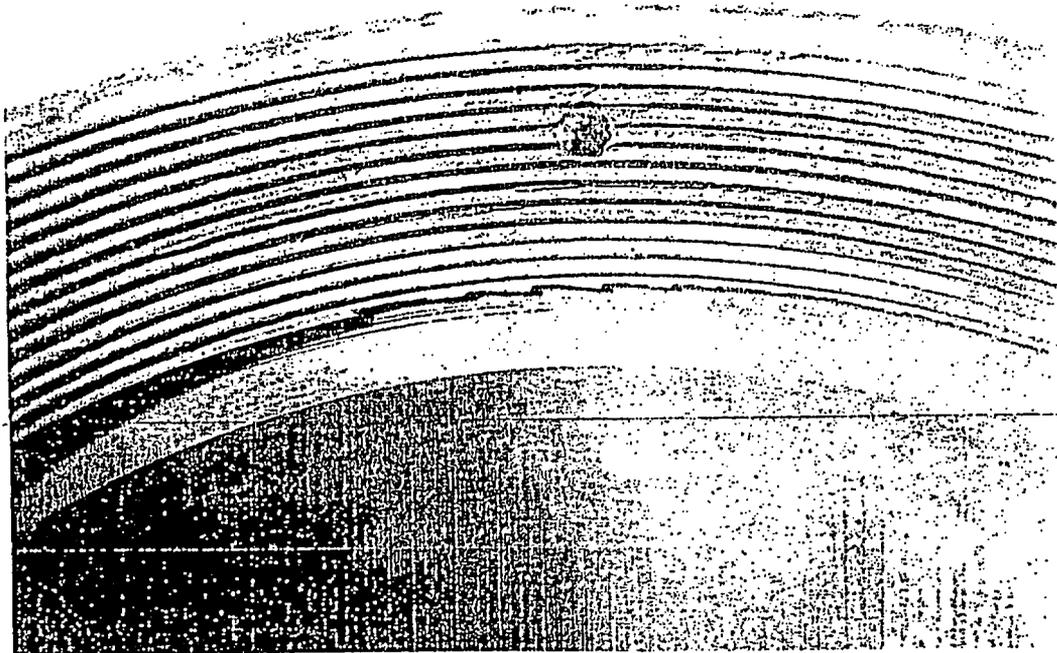
- The air piston cylinder for the actuator on testable check valve 1BC-HV-F050A was found to be disconnected from the actuator assembly. The cylinder is normally fastened to the actuator assembly with a threaded connection and held in place with a set screw.

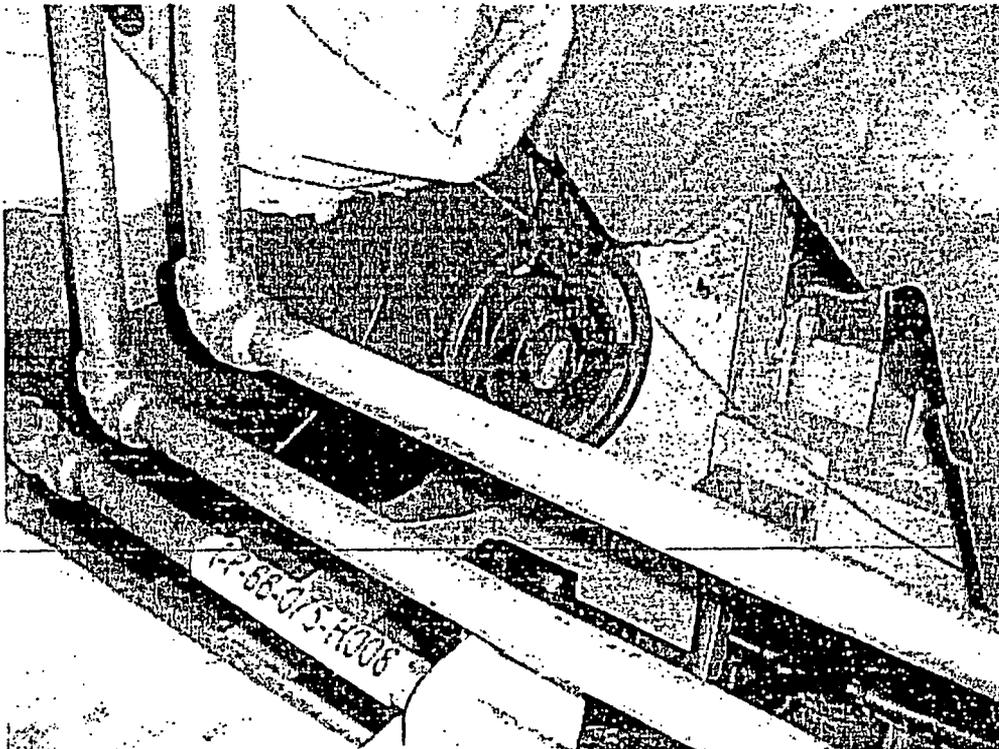
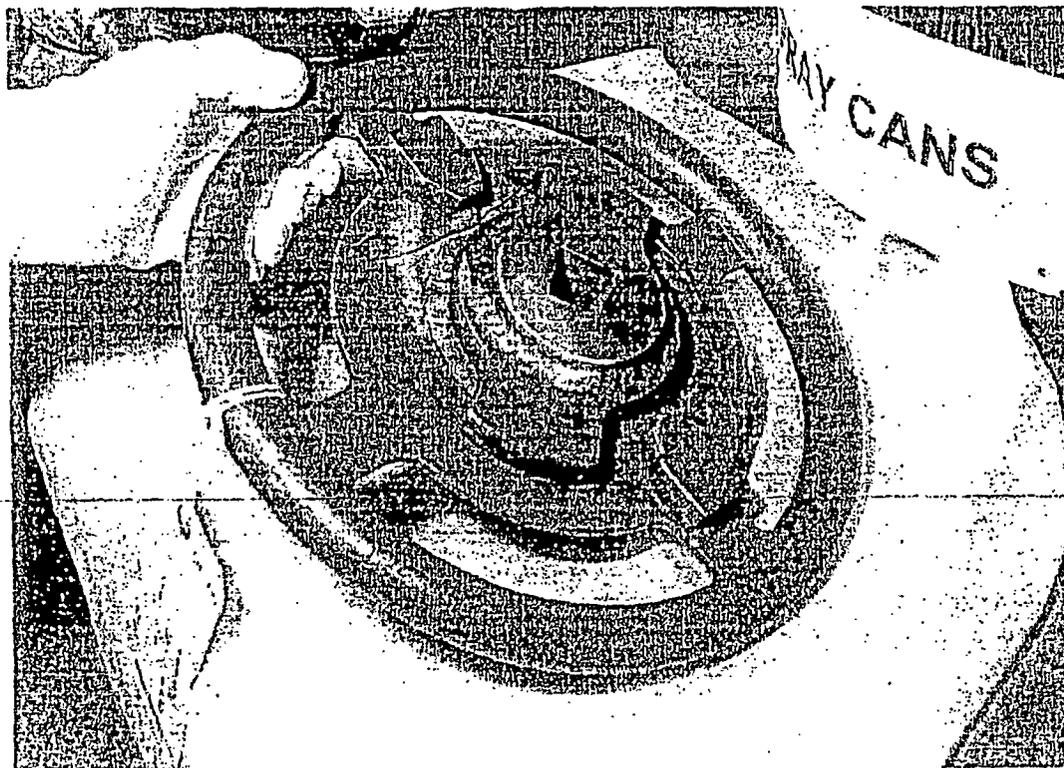
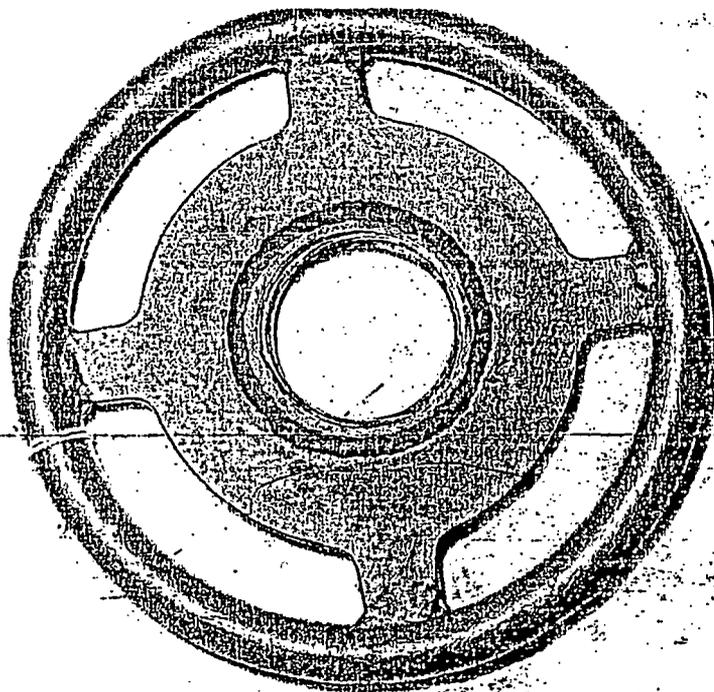
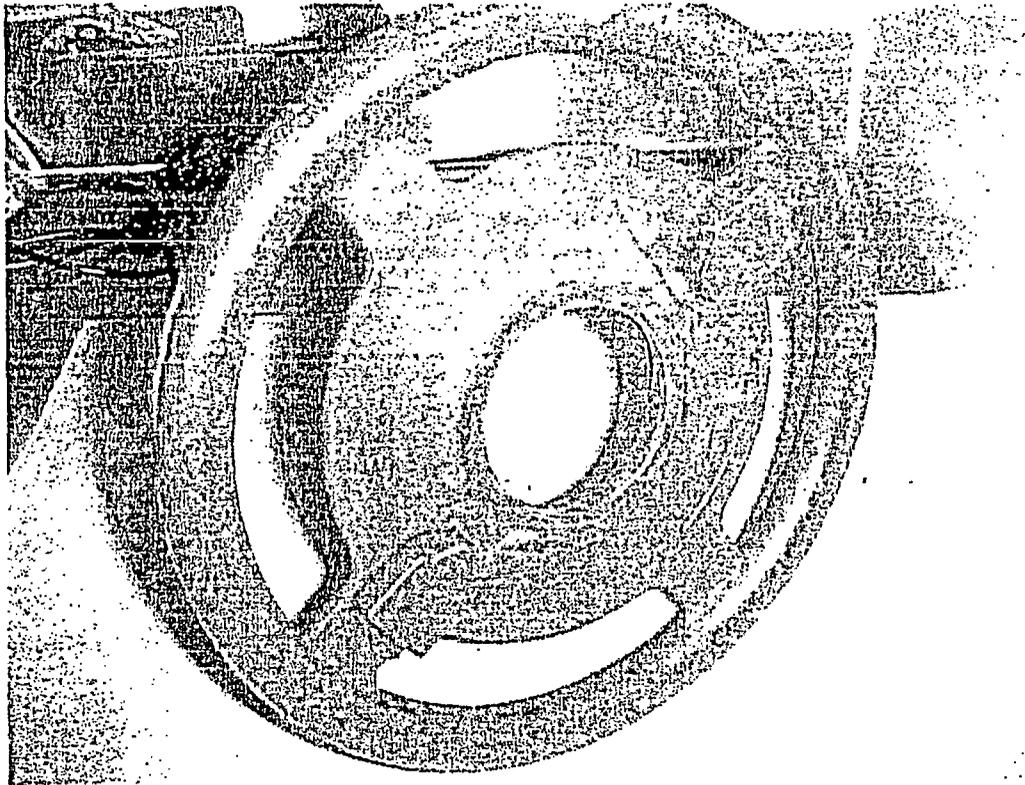
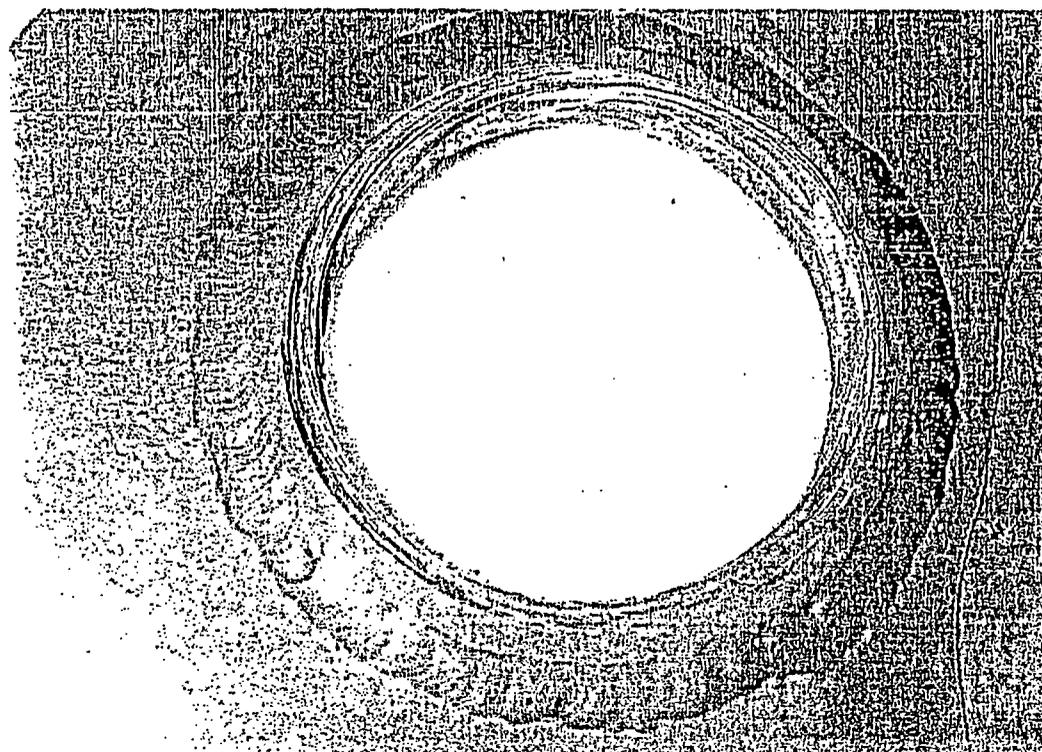
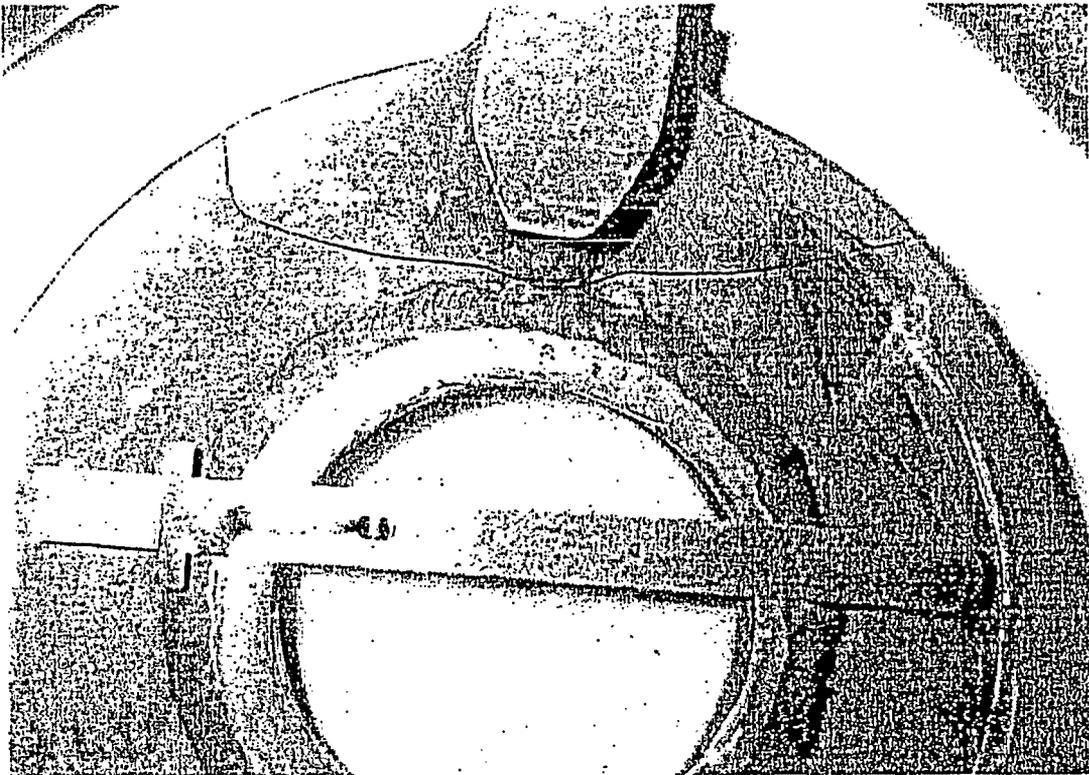
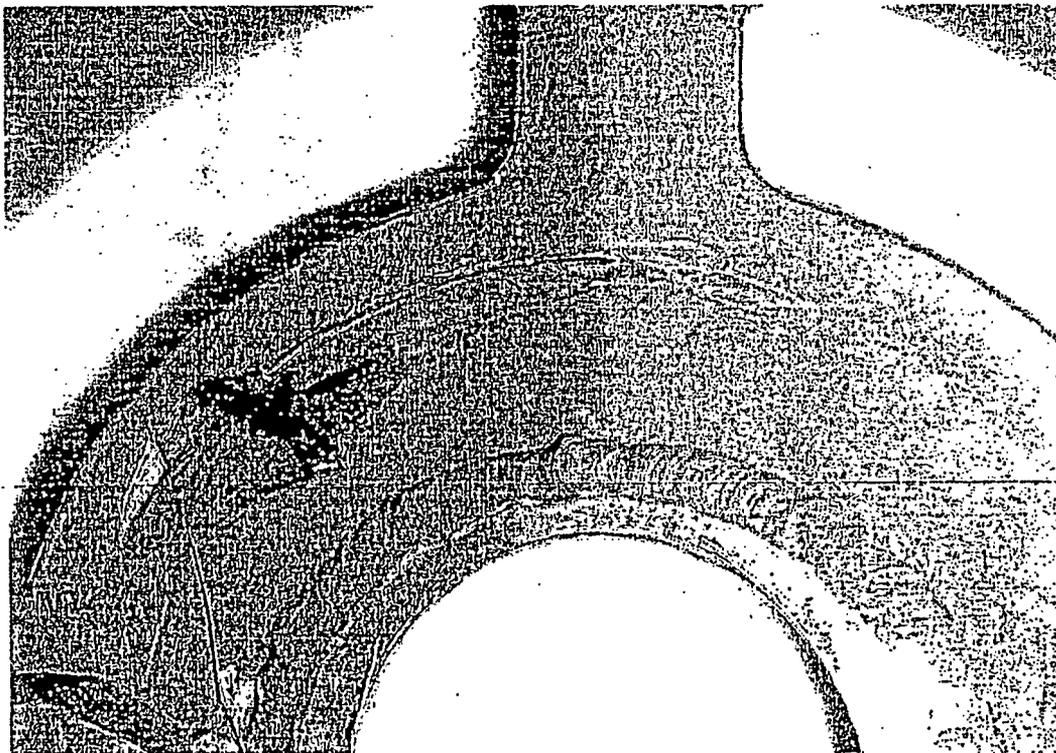
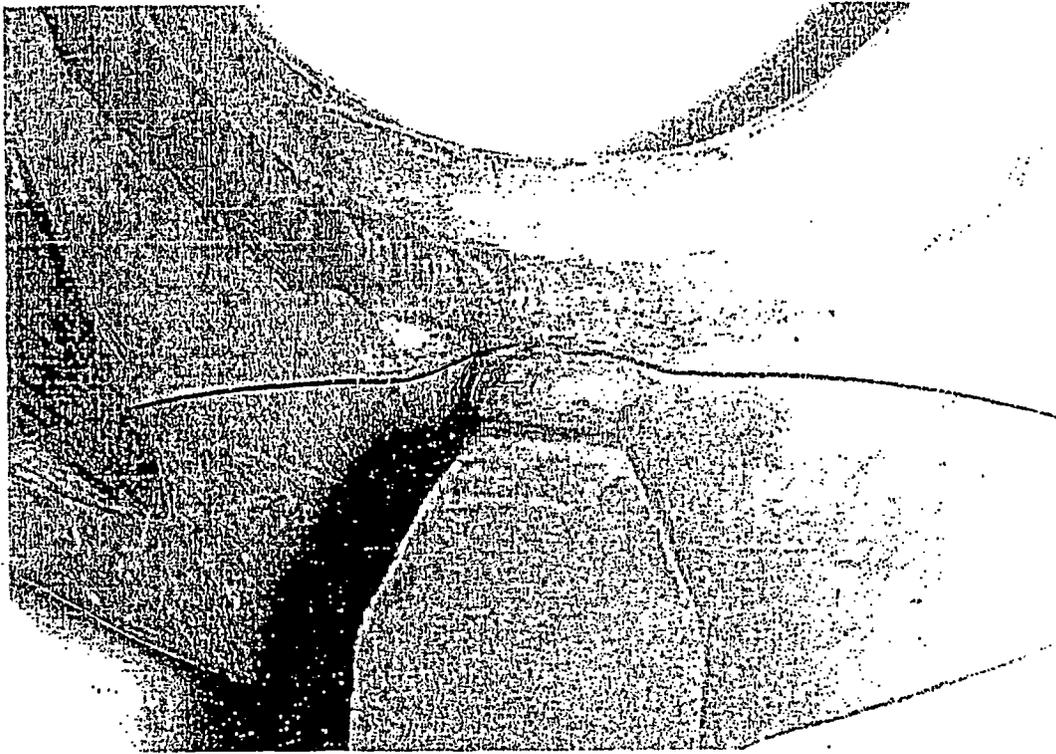
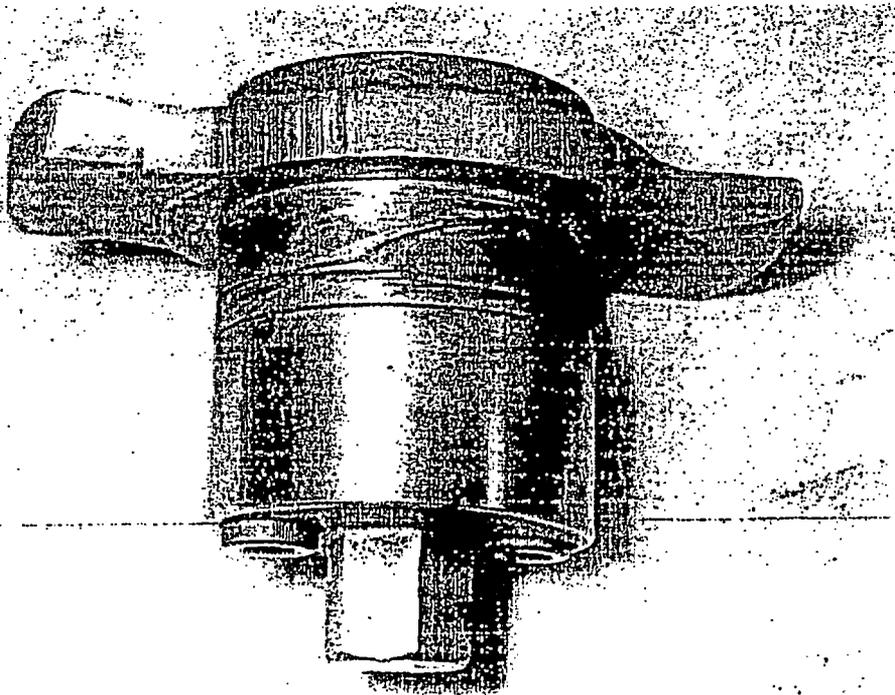
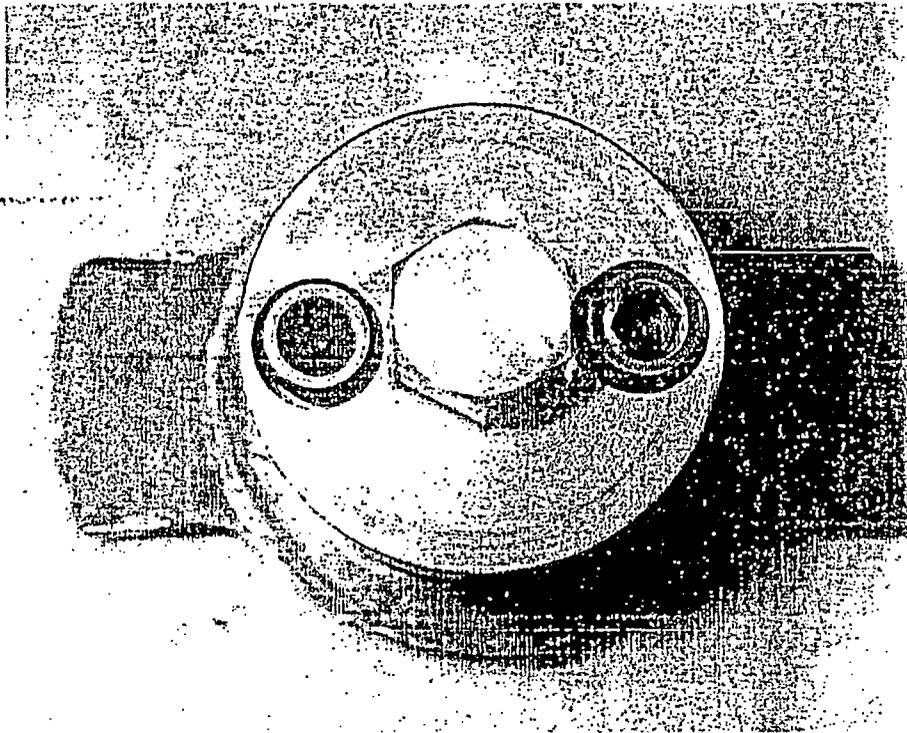
- The hand wheel had fallen off of valve 1BC-HV-F060B. This is a manual block valve located inboard of the testable check valve 1BC-HV-F050B in the “B” loop RHR return line. (Note, this line does not communicate with the north pipe chase.) The handwheel was found suspended from its lockwire near the manual valve operator where it had previously been attached. The hub on the operator shaft was found to be worn and the retaining ring meant to hold the handwheel on the hub was missing.

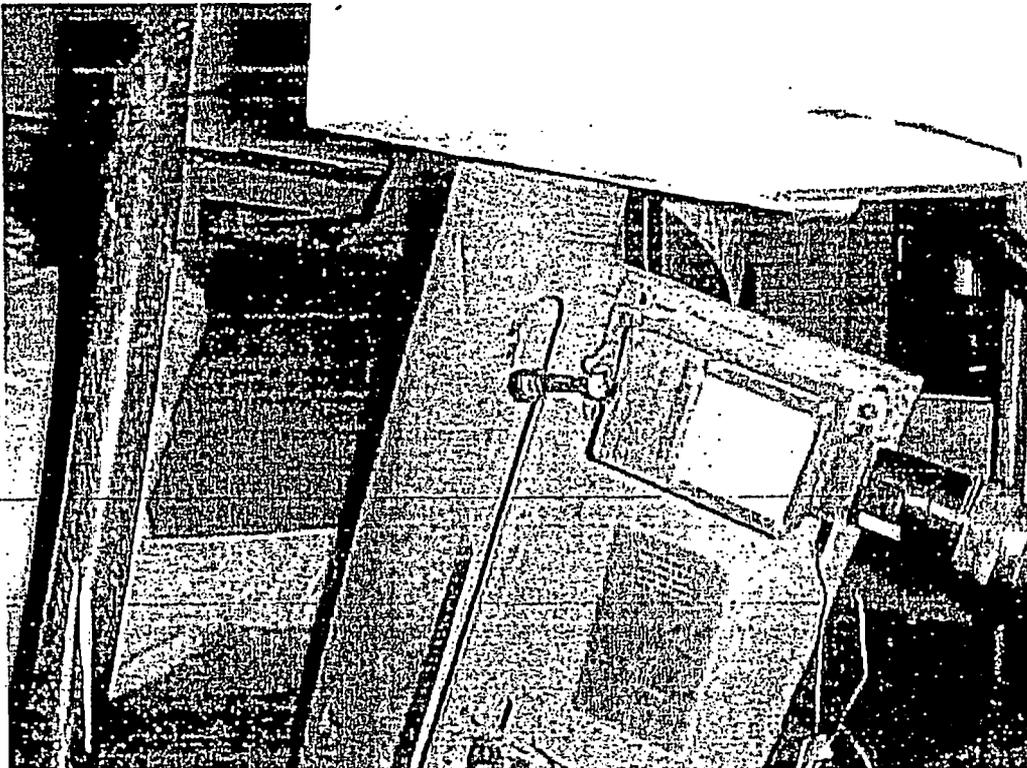
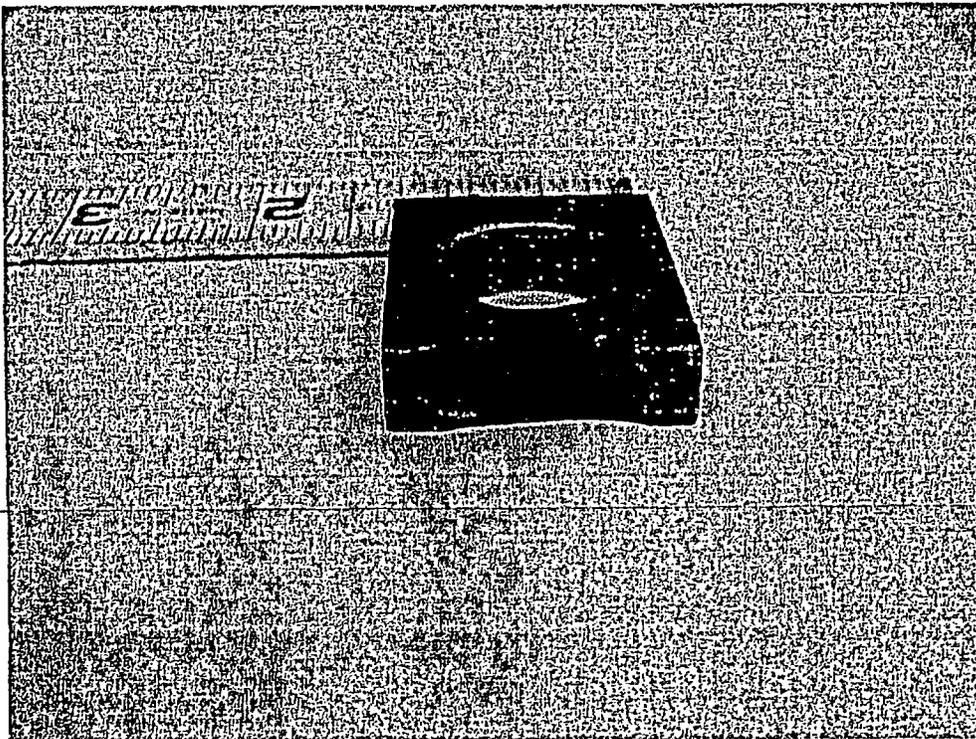
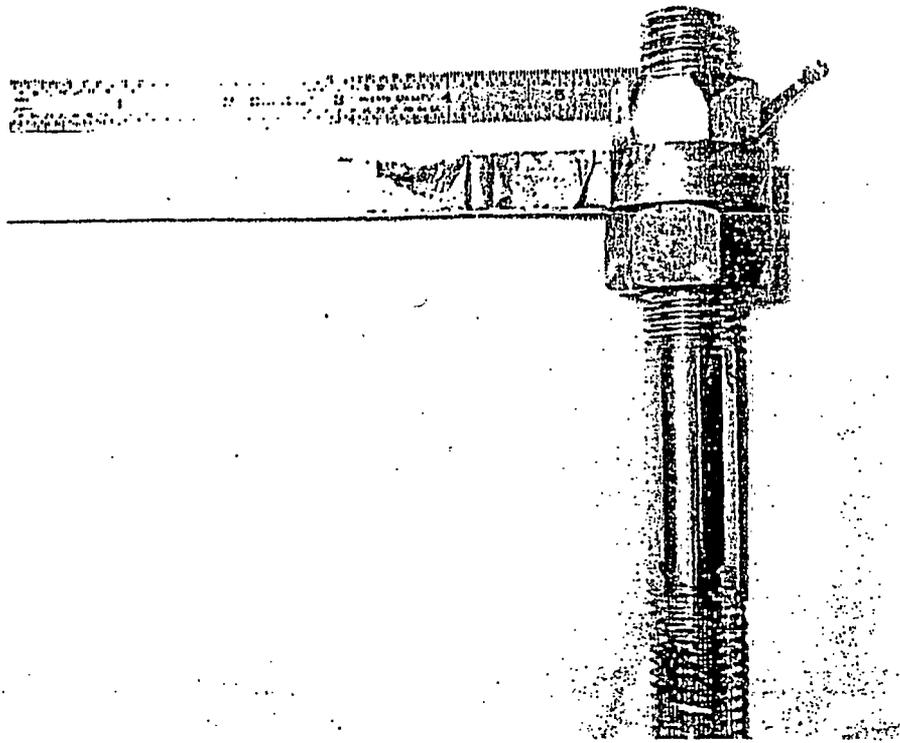
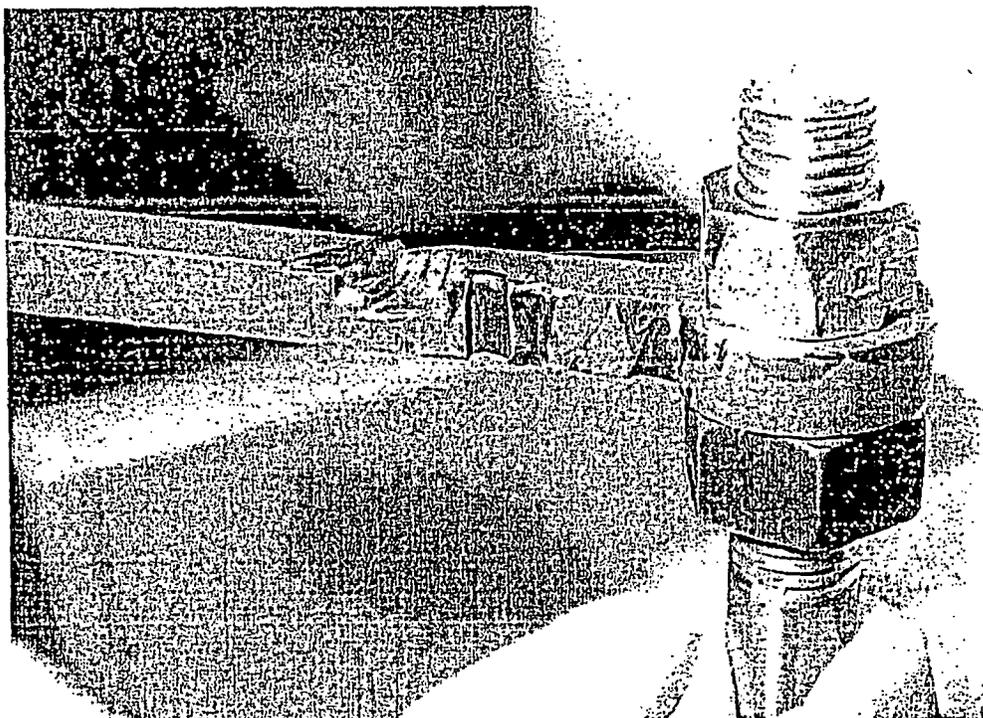
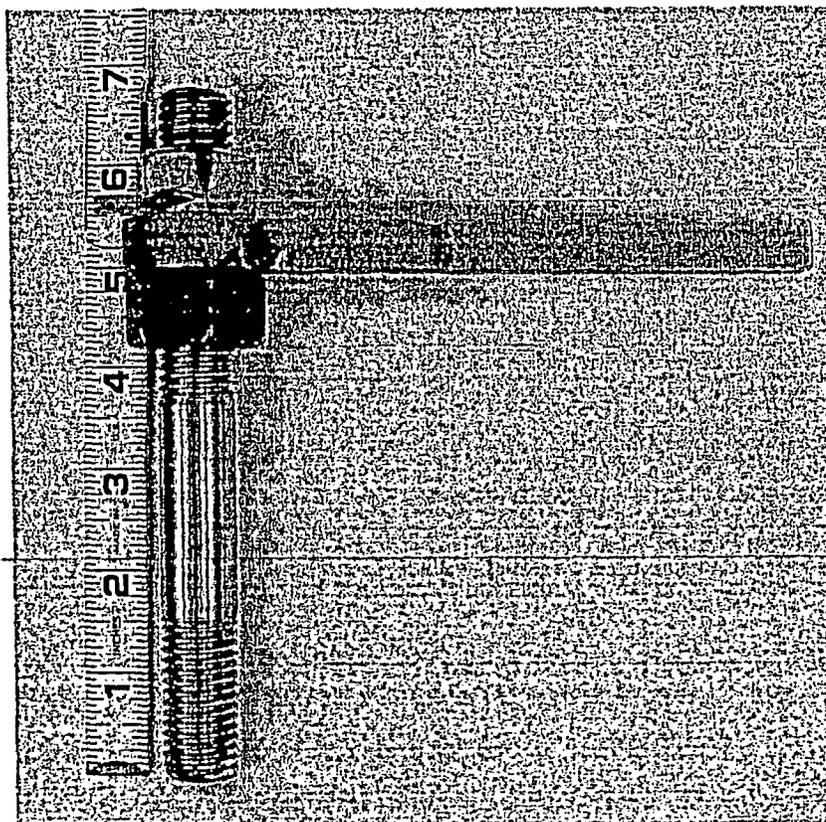
- Limit switches were found to have failed on the 1BC-HV-F060A and 1BC-HV-F060B valves in containment. These valves are located on the RHR return piping lines near where they connect to the recirculation discharge piping. In addition, the limit switch on valve 1BC-HV-F065D was also found to be close to the edge of its indicating finger.

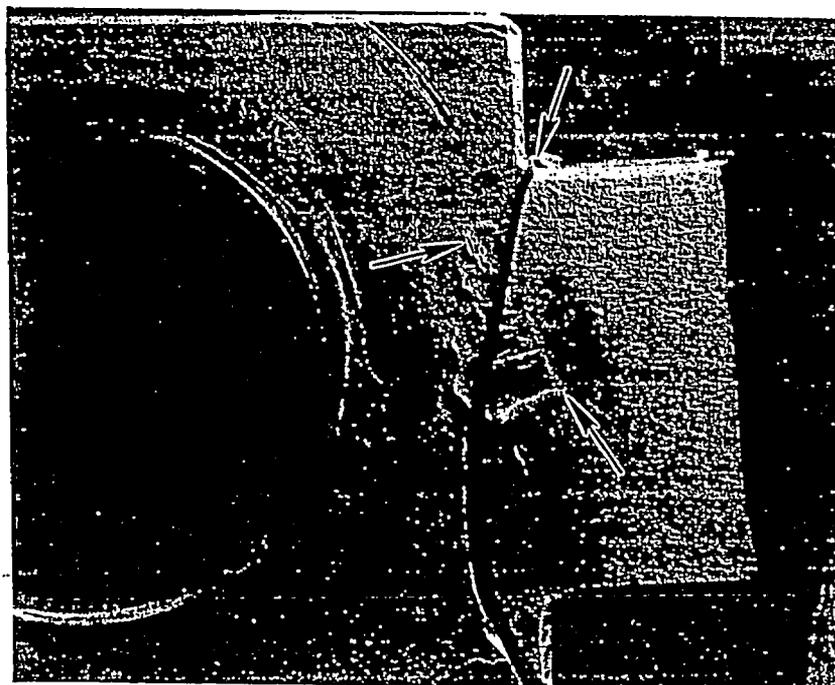
Photo No. 7200

Macro photograph shows mechanical damage (arrows) on the side of the fracture. Note the sharp angle at the apparent fracture origin (upper arrow).

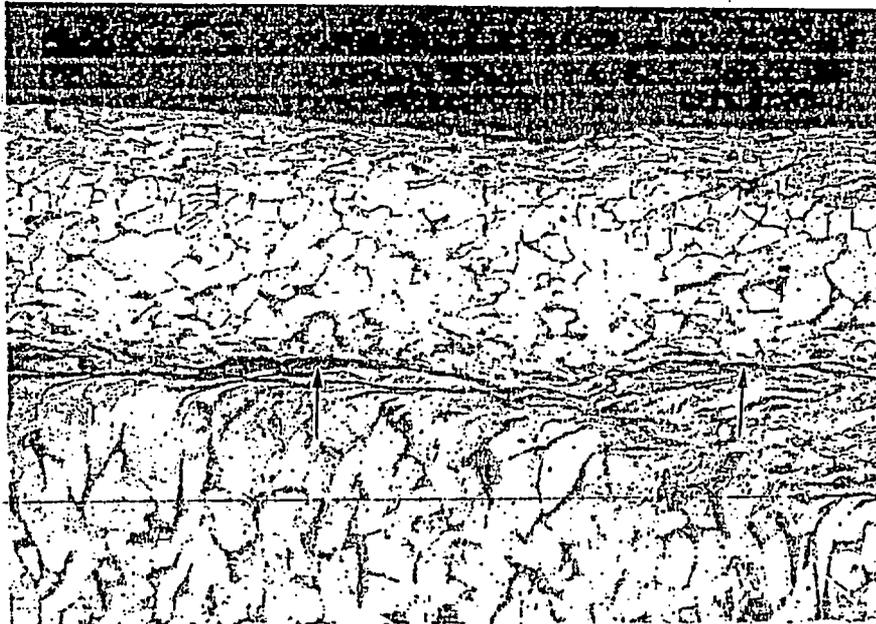
Photo No. 7203

Microphotograph shows subsurface discontinuity in the form of a lap (arrows) below the mounting hole surface.

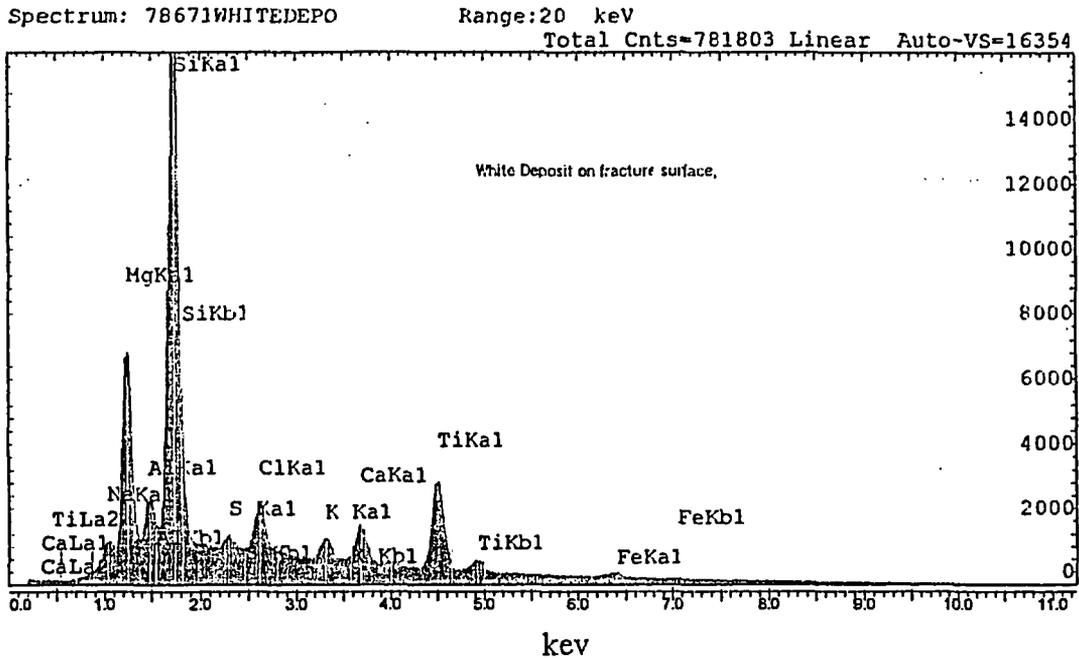
### SPECTRUM 1

EDS spectrum of the white, paint like deposit on the fracture surface shows the major elements silicon, titanium and magnesium.

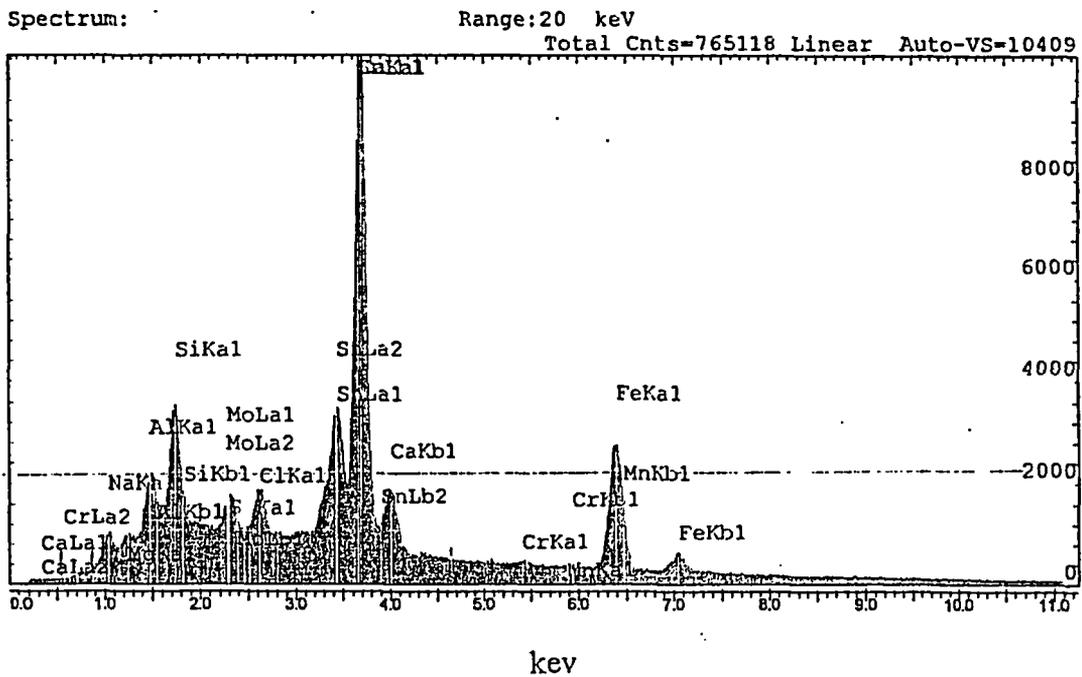
### SPECTRUM 2

EDS spectrum of the fluorescing deposit at the corner of the fracture shows the major elements calcium, tin, and iron suggesting the deposit possibly from solder and flux.
