PSEG NUCLEAR LLC VTD NUMBER: 326560

System / Title: REACTOR RECIRCULATION SAP Sys Code: BB

**Evaluation and  
Vibration Testing of  
Recirc. and RHR Piping Instrumentation  
12-14 May, 2004**

VibrAlign Job Number:  
040555BP

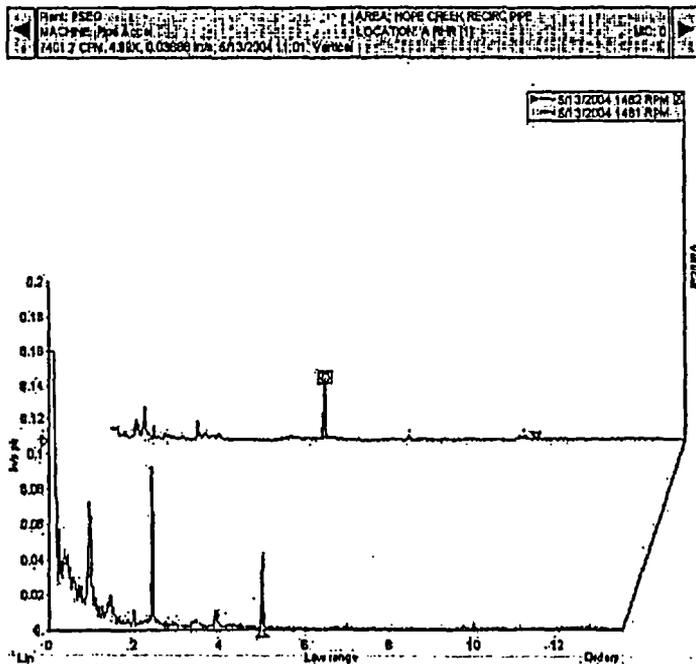
- B. Trouble shooting of the installed transducer and data acquisition system showed the signal noise to be electrically induced due to a system ground loop. This resulted in the presence of a 60 Hz. component and low level signal noise being induced onto the acceleration signal. Evaluation showed that the most effective method of reducing the signal noise was to isolate the electrical input of the power supply from plant ground. Figure 1 shows before and after spectrums of the A RHR Vertical transducer location. Evaluation showed that noise was reduced on all monitored channels.

Reduction of the 60 cycle component and noise floor by floating the ground on the accelerometer power supply. The apparent ground loop was believed to be caused by the potential difference in ground between the installed accelerometer system in the Drywell and the plant ground available at the power outlet that the power supply was connected to. Isolation of the ground at the power supply reduced both the 60 Hz. component and the low level induced noise caused by the potential difference.

Figure 1- Before and After Noise Reduction

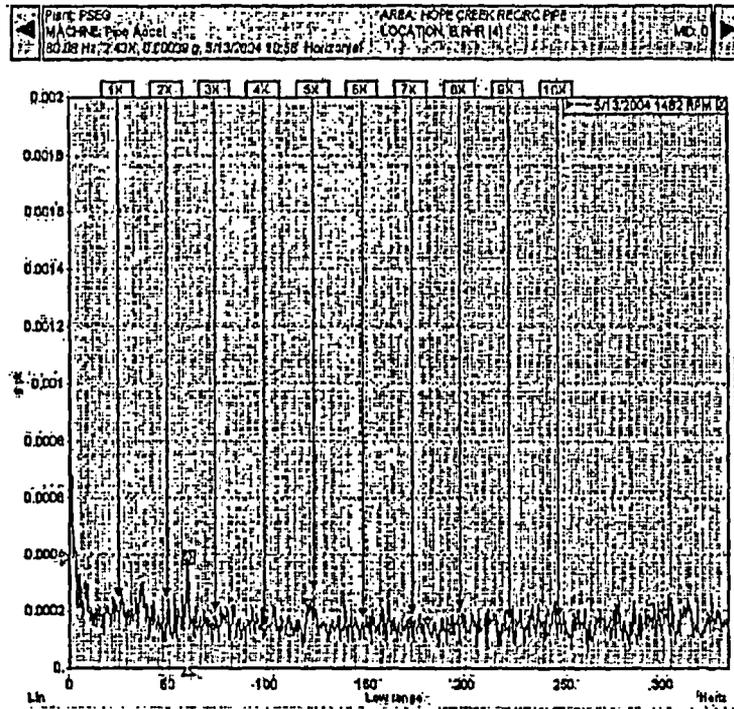
- C. Accelerometer Bias Voltage was checked on all installed transducers. The Bias voltage was measured to be between 13.1 and 13.5 Vdc on all transducers with the exception of channel 10 which was measured to be 9.1 Vdc.

Review of the installed transducers showed that Channel #10, B RHR Perpendicular, was not functional during our evaluation of the system. This was indicated by a low measured Bias Voltage and through review of the acquired signal. Figure 2 shows a spectrum of channel 10 following reduction of the electrical signal noise.

Figure 2 – Channel 10 Non Functional

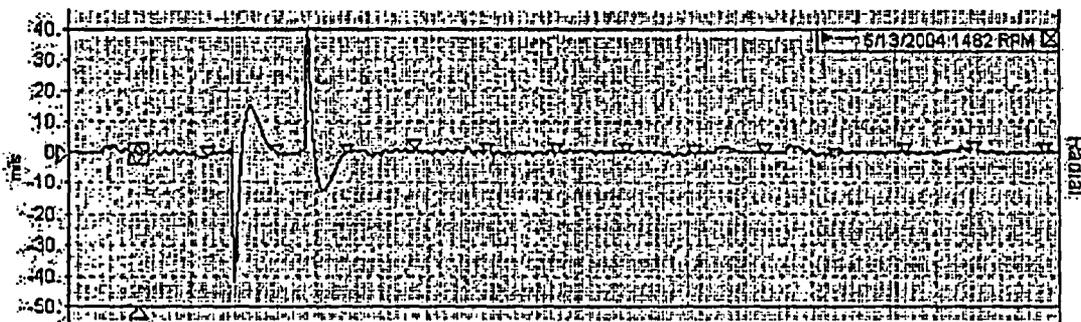
During evaluation of the accelerometer outputs it was noted that channel 6, A Recirc Vertical, showed indications of intermittent failure. This condition was not always present. This was most easily seen on in the time waveform of the acceleration signal.

Figure 3 – Time waveform showing intermittent failure of Channel 6

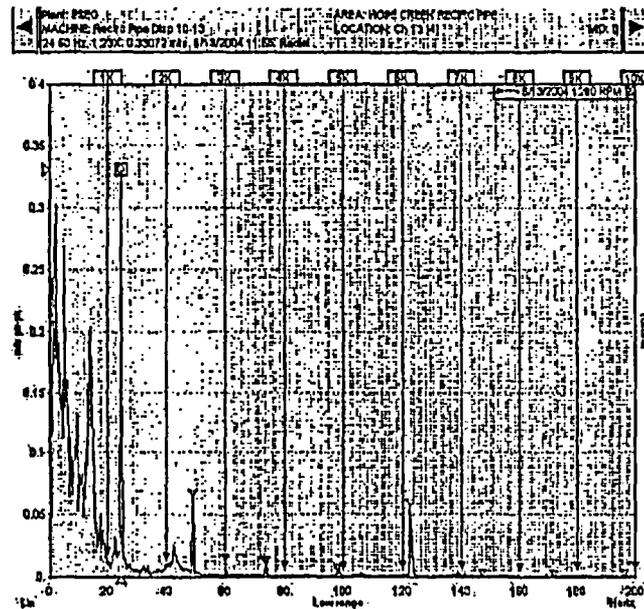
- G. Review of the acquired spectrum still showed that the overall level was still dominated by low frequency components not believed associated with actual piping motion. This response characteristic is typical for acceleration signals which have been double integrated to displacement. See Figure 4.

Overall displacement amplitudes were acquired following reduction of the signal noise. This was accomplished by double integrating the acceleration signals and then passing the output through a 5 Hz. high pass filter before acquiring the time waveforms and spectrums. The 5 Hz. high pass filter was used to suppress low frequency integration noise present. The presence of low frequency components in an acceleration signal which has been double integrated is not unusual. However, as can be seen in Figure 4 the low frequency components resulting from this manipulation of the data can dominate the reported vibration levels.

Figure 4 – Double Integration of Acceleration Signal

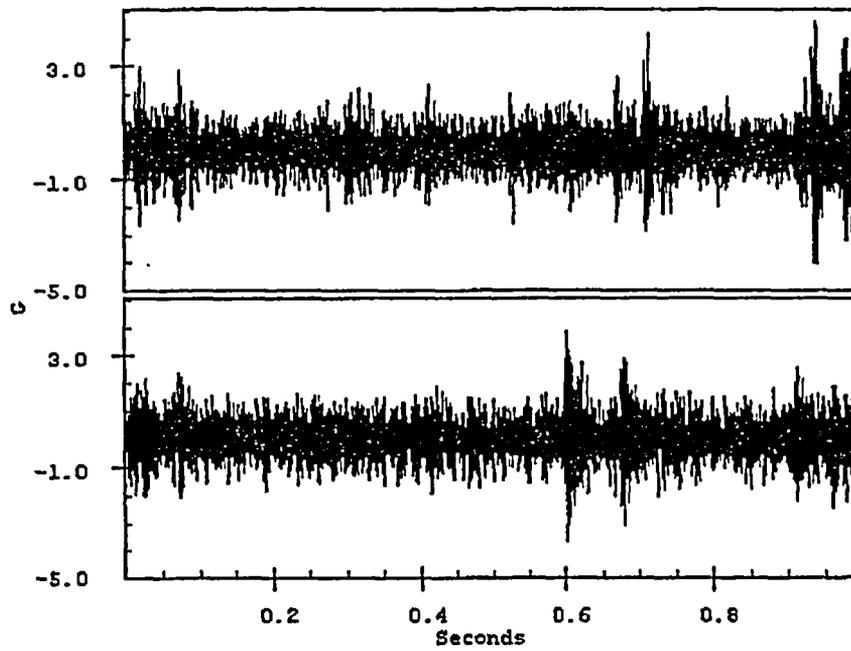
- I. Review of data collected on the A RHR line indicates that the audible noise noted in the North Pipe Chase is most likely the result of a problem with either the Check or Bypass Valve located in the Drywell. Collected data shows evidence of high frequency impacts due to component movement. Impact response was measured on the piping both within and external to the Drywell. This indicates that the source of the impacts is between the measurement points making the valves the most likely source. Inspection of the valves during a unit outage is warranted. See figure 5.

Review of data collected on the A RHR line indicates that the audible noise noted in the North Pipe Chase is most likely the result of a problem with either the Check or Bypass Valve located in the Drywell. Collected data shows evidence of high frequency impacts due to component movement. Impact response was measured on the piping both within and external to the Drywell. This indicates that the source of the impacts is between the measurement points making the valves the most likely source. Figure 5 is representative of the impact response measured on the A RHR line.

**Figure 5 – Impacting on A RHR Line**
