SHEARON HARRIS NUCLEAR POWER PLANT, UNIT NO. 1  
DOCKET NO. 50-400/LICENSE NO. NPF-63  
60-DAY REPORT

NRC BULLETIN 2004-01, INSPECTION OF ALLOY 82/182/600 MATERIALS USED IN  
THE FABRICATION OF PRESSURIZER PENETRATIONS AND STEAM SPACE  
PIPING CONNECTIONS AT PRESSURIZED-WATER REACTORS, REQUEST (2)

**Attachment 1 to SERIAL: HNP-04-166  
60-Day Report, NRC Bulletin 2004-01, Request (2)**

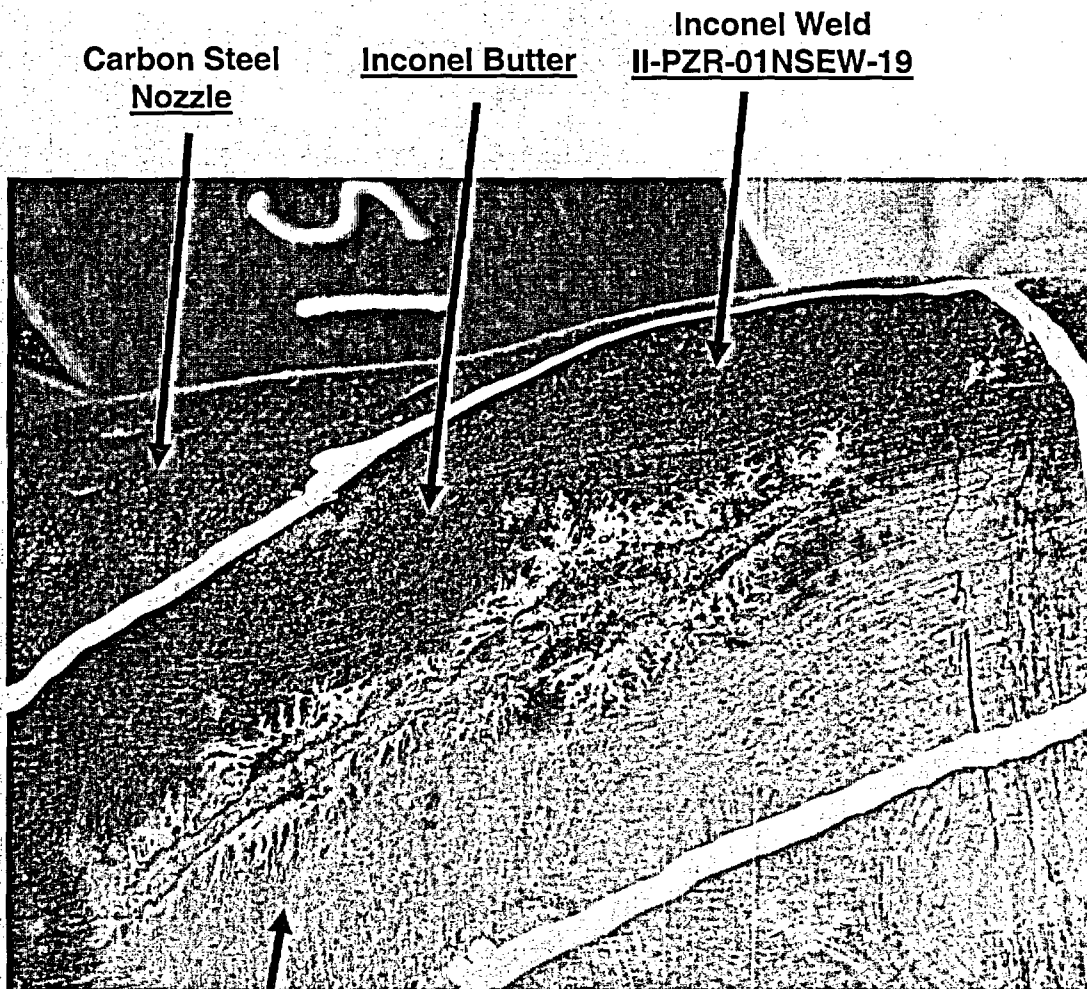
Photo of White Residue

No indications of boric acid leakage were found on any of the components during the inspections. However, on one of the PZR safety nozzle to safe end welds (Weld ID #II-PZR-01NSEW-19), inspection personnel found a thin, dry and mostly transparent white residue. The residue was approximately 1.0 inch wide by 4.5 inches in length and was oriented axially across the weld area and the carbon steel nozzle. Photos are included in this report.

The source of the residue was not identified. The amount of residue was too small to provide an adequate sample. No residue was identified on either the inside or outside of the removed insulation. The component is located under platform grating, and several valves are located above the grating. In addition, personnel had been working in this area between the time that the insulation was removed and the examination performed. The most likely source, therefore, is either a component above the grating or from work being performed in that area.

Carbon Steel to Inconel  
Butter Interface

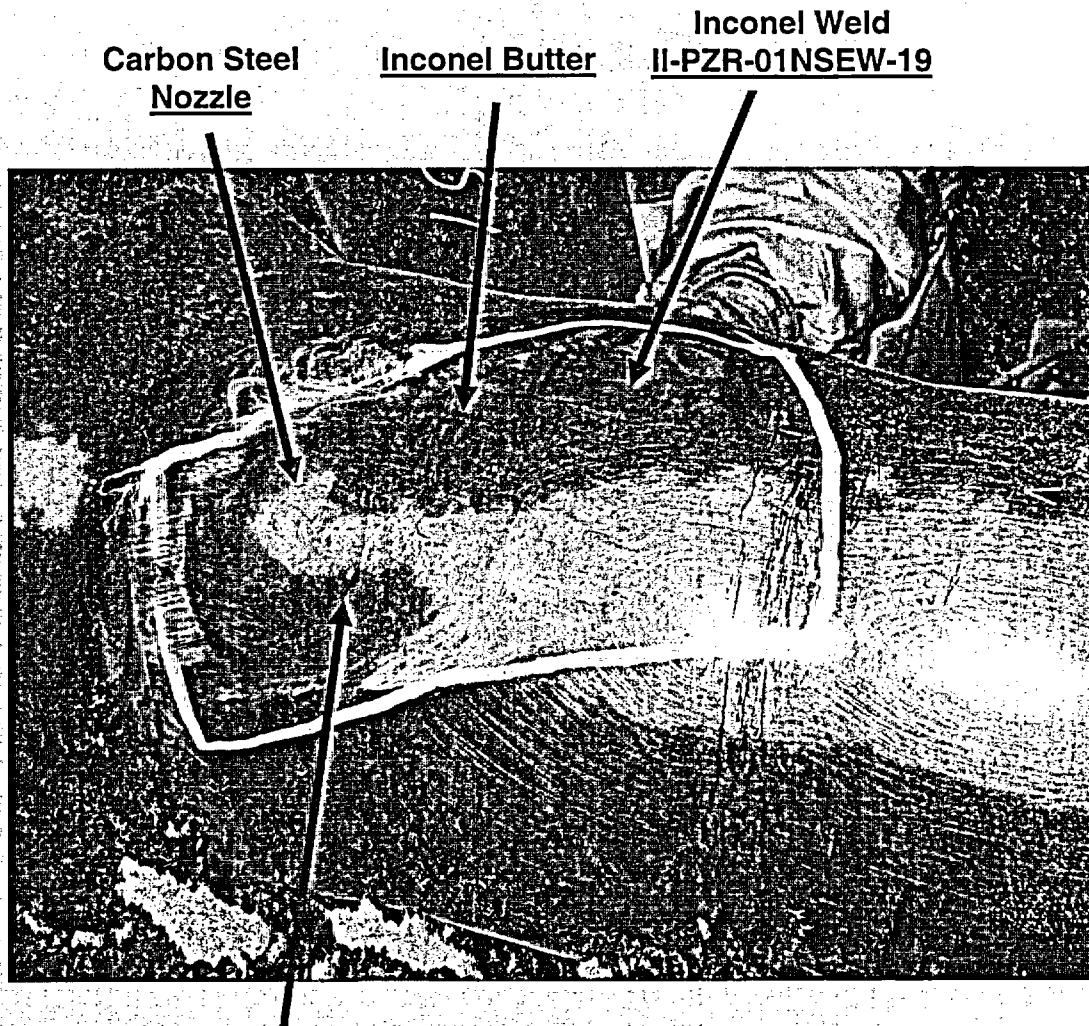
Photo of Area After Cleaning

After cleaning, the area was visually examined and no evidence of cracking or leakage was noted. In addition, a liquid penetrant examination was performed on the area and no indications were found. Consequently, since no indications of leakage were identified, no corrective action was required or taken.

As stated in the 60-day response (HNP-04-097) to NRC Bulletin 2004-01, BMV exams will be performed on these welds during every refueling outage until mitigation is performed, additional guidance is provided by the Materials Reliability Program (MRP), or new Code or regulatory requirements are imposed. Consequently, follow-up examinations of this area will be performed every outage for additional confirmation of the conclusions reached during this examination.
