UNITED STATES
NUCLEAR REGULATORY COMMISSION
OFFICE OF NUCLEAR REACTOR REGULATION
WASHINGTON, D.C. 20555-0001

February 4, 2005

NRC INFORMATION NOTICE 2005-01: HALON FIRE-EXTINGUISHING SYSTEM PIPING
INCORRECTLY CONNECTED

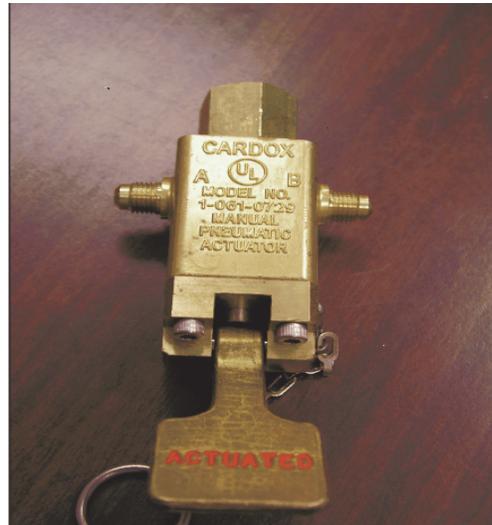
Figure 1 - Manual-Pneumatic Actuator

Typically, each of the manual-pneumatic actuators have ports marked A and B, (see Figure 1). The ports have specific requirements for connection to the pilot manifold (from port A) and to the solenoid pilot valve assembly (from port B). In the improper configurations recently identified, the actuation piping to ports A and B was reversed. Figure 2 is a diagram of a correctly configured actuator.

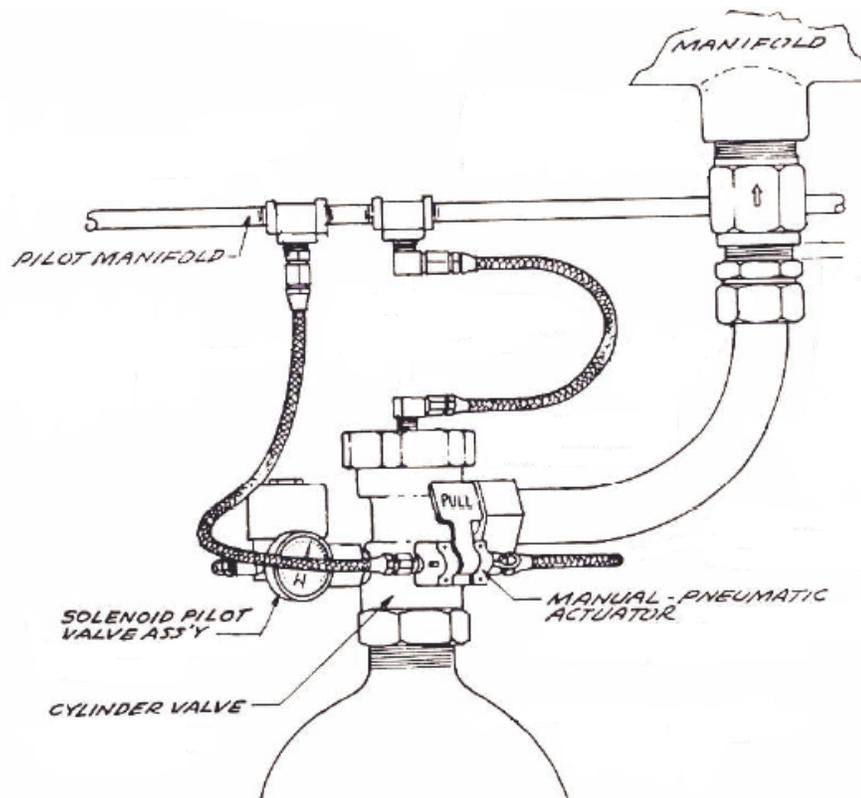
Figure 2 - Diagram of Actuator Setup

Improper configurations of the halon fire-extinguishing system could have adverse effects on the system. The Callaway and Wolf Creek licensees contacted the vendor (Chemetron) to assist in the assessment of the halon system with the piping to the actuator reversed. On January 26, 2005, an NRC fire protection specialist observed the vendor perform a series of tests with the actuator piped in both the correct and reversed configuration. With the piping to the actuator reversed and based on the internal non-symmetric construction of the actuator, there was an approximate 2-second delay in the opening of the cylinder valve. This would result in a 2-second delay in the delivery of halon gas to the affected equipment.

Based on the above discussion, both carbon dioxide and halon fire-extinguishing systems that are not properly configured have the potential to impact the extinguishing capability of the system. Thorough inspection of the systems and adequate postmaintenance testing procedures can help to ensure that the systems are properly configured.
