A. TOBLIN STAFF EXHIBIT 5

Detection and Location of Leaks in Geomembrane Liners Using an Electrical Method: Case Histories

Daren L. Laine
Michael P. Miklas, Jr.
Southwest Research Institute
San Antonio, Texas

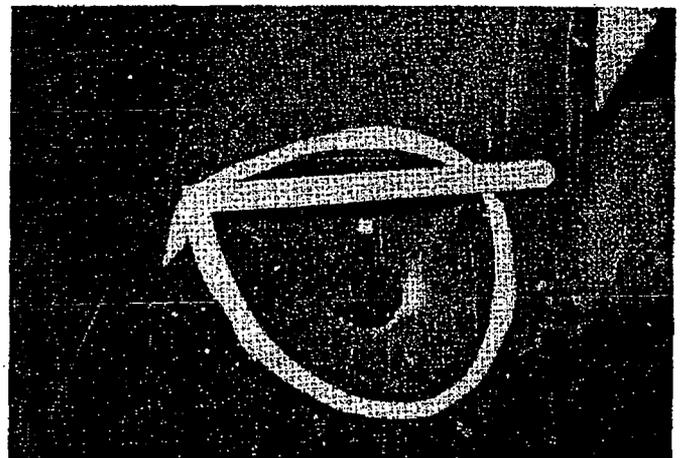
The leaks in the parent material generally can be attributed to accidental damage from equipment or tools, crescent-shaped cracks due to equipment being dropped, slits due to razor-edged tools cutting the liner, burns from cigarettes, gashes and gouges. Figures 10 and 11 show typical leaks in the parent material. Some of the leaks in the parent material probably were caused by improper material handling or wind buffeting. Many leaks in the parent material of installations with a protective soil cover appeared to have been created during the application of soil cover over the liner.

Figure 10
Large Leak in HDPE Parent Material

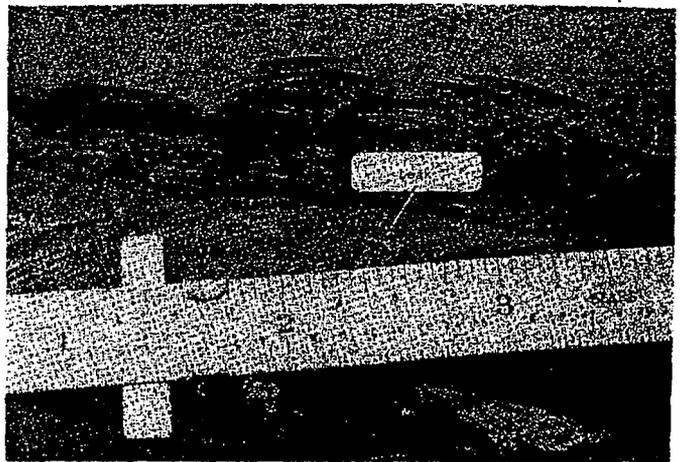
Figure 13
Leak in Seam After Grinding, Just Prior to Repair
