**A. TOBLIN STAFF EXHIBIT 5**

**NIRS/PC EC-1**

# Detection and Location of Leaks in Geomembrane Liners Using an Electrical Method: Case Histories

Daren L. Laine  
Michael P. Miklas, Jr.  
Southwest Research Institute  
San Antonio, Texas

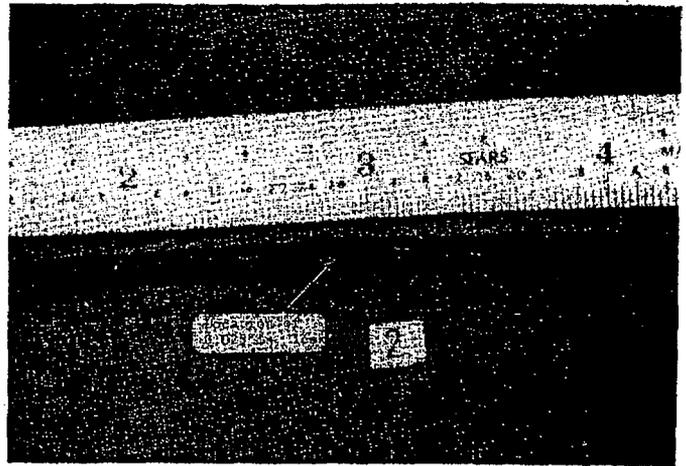
percent of the leaks were in seams, and the remaining 13% were in the parent material. Figures 8 and 9 show examples of seam leaks detected with the Southwest Research Institute electrical leak location system. Leak sizes and shapes ranged from relatively circular holes from less than 0.025 to 1 in. in diameter, to slits from 0.25 to 12 in. long, to gashes and gouges up to 6 by 8 in., to evidently tortuous paths through seam welds.

Figure 8  
Leak in HDPE Seam. Approximate Leak Size 0.025 In. (Note: Leak not apparent in reproduced photograph.)

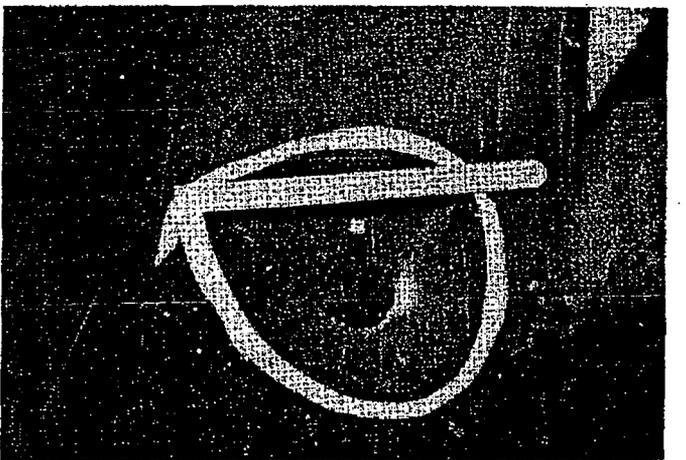
The leaks in the parent material generally can be attributed to accidental damage from equipment or tools, crescent-shaped cracks due to equipment being dropped, slits due to razor-edged tools cutting the liner, burns from cigarettes, gashes and gouges. Figures 10 and 11 show typical leaks in the parent material. Some of the leaks in the parent material probably were caused by improper material handling or wind buffeting. Many leaks in the parent material of installations with a protective soil cover appeared to have been created during the application of soil cover over the liner.

Figure 10  
Large Leak in HDPE Parent Material

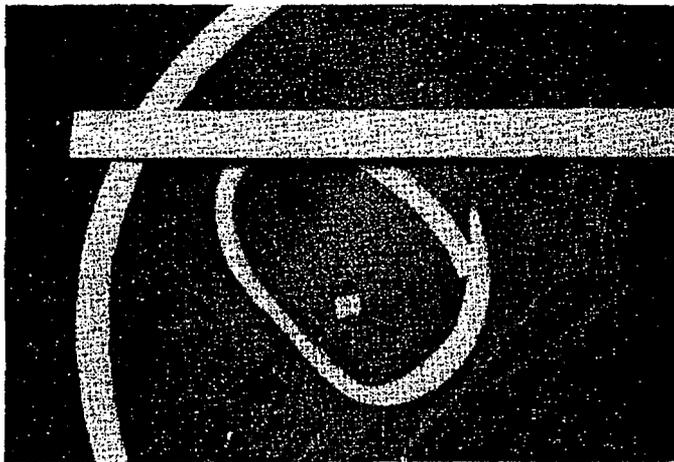
Figure 11  
Cut in HDPE Parent Material

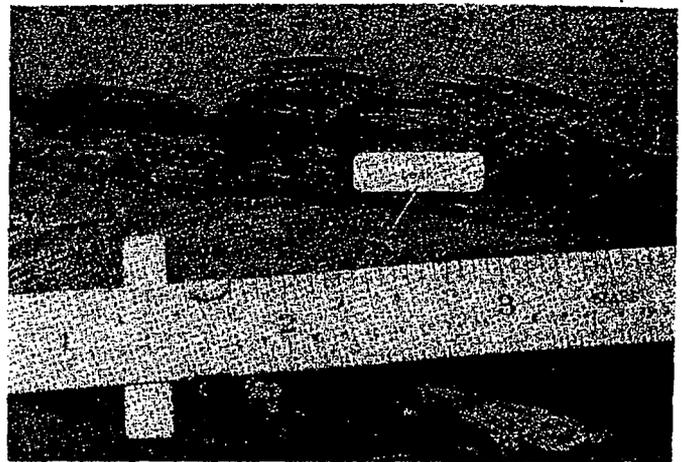
Figure 13  
Leak in Seam After Grinding, Just Prior to Repair
