Non-Proprietary Version
Materials Reliability Program:
Evaluation of the Effect of Weld
Repairs on Dissimilar Metal Butt
Welds (MRP-114NP)

1009559

Final Report, July 2004

Structural Integrity Associates.

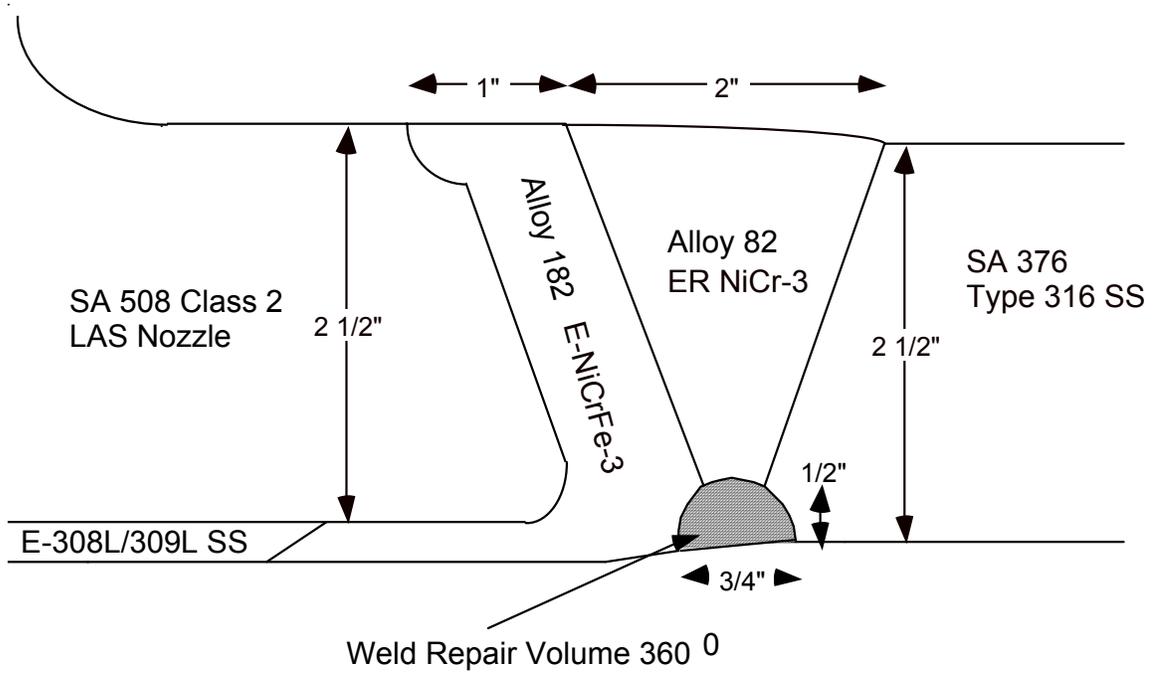
This repair is particularly damaging because it enlarges the weld volume and finishes the weld on the surface exposed to the reactor coolant. In addition most of the deposited weld volume remains in-place to provide surfaces that are pulled in tension as the weld deposit solidifies and cools. Repair welding always alters the original residual stress distribution, but repairs applied directly to the ID are especially significant. This is because high residual tensile stresses are applied directly to the ID surface by contraction forces resulting from solidification and cooling on the ID surface. Thus, an ID root weld repair can be a particularly influential SCC damage mechanism. The completed weld repair will be ground to contour and smooth the weld root and newly welded interface. Figure 2-3 provides a schematic cross-section of the ID repair.

For the purposes of Scenario 1, it is assumed that significant defect indications have been identified on the buttered sidewall just above the hot passes and are located intermittently completely around the ID circumference.

Figure 2-3
Schematic Cross-section of 360° ID Root Repair

The first step in the repair is to remove the ID root to a depth of 1/2" and blended to either side to a width of 3/4". The root cavity is then welded out from the ID using machine GTAW (ID track mount), using 0.045 inch diameter ERNiCr-3 (Alloy 82) filler material. Welding parameters are assumed to create a heat input of 30 KJ/inch producing weld beads that are 0.25" wide and 0.125" thick. A 60% welding efficiency is assumed. Finally manual grinding contours and smoothes the finished ID weld surface.

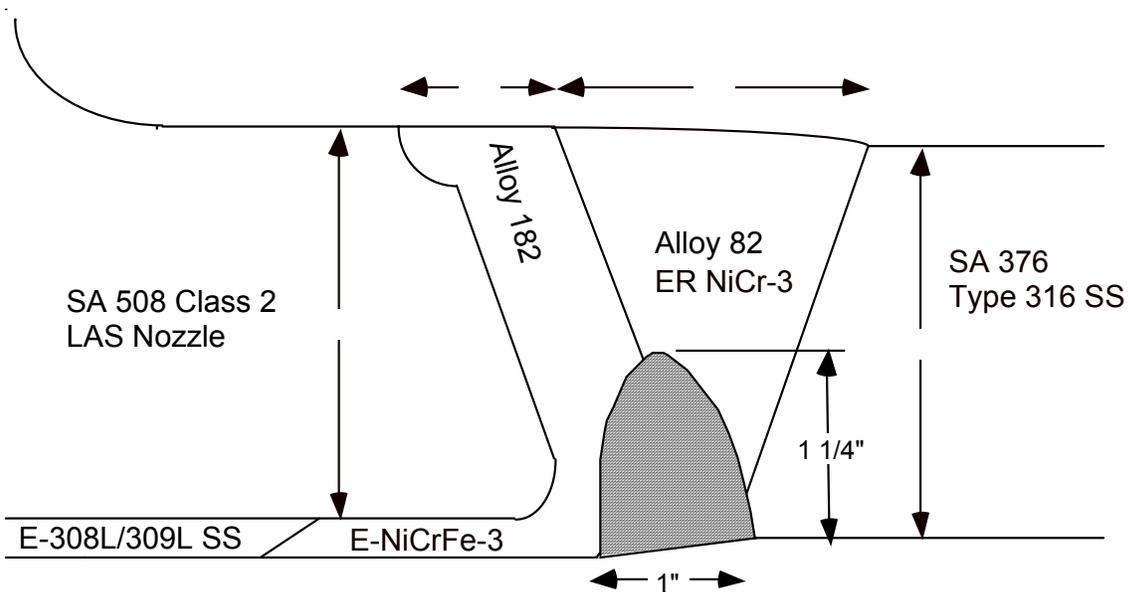
This ID repair involves the repair of a defective area just below mid-wall along a 45⁰ arc of the circumference (11.4” length). The flaws are assumed to lie along the buttered sidewall and are manually excavated by grinding from the ID to a depth of 1.25 inches and a width at the ID of 0.75”. The repair cavity has a total length of 21.4” that (includes a 5.0” long taper (4:1) on both ends of the cavity. The bottom of the cavity is rounded to blend. The weld repairs are accomplished from the ID using a manual SMAW repair procedure. Figure 2-4 shows a schematic cross-section of the limited circumference ID repair geometry.

Repair length is 21.4 inches long, 1 1/4 inches deep and 1 inch across.

Figure 2-4
Schematic Cross-section of Limited Length Mid-wall Weld Repair from ID

The SMAW repair weld will be accomplished using 1/8” diameter ENiCrFe-3 (Alloy 182) electrodes. Welding parameters and techniques are selected to produce weld beads 0.5” wide and 0.15” inches thick. The weld is deposited at a heat input of 18 KJ/inch at a 75% thermal efficiency.

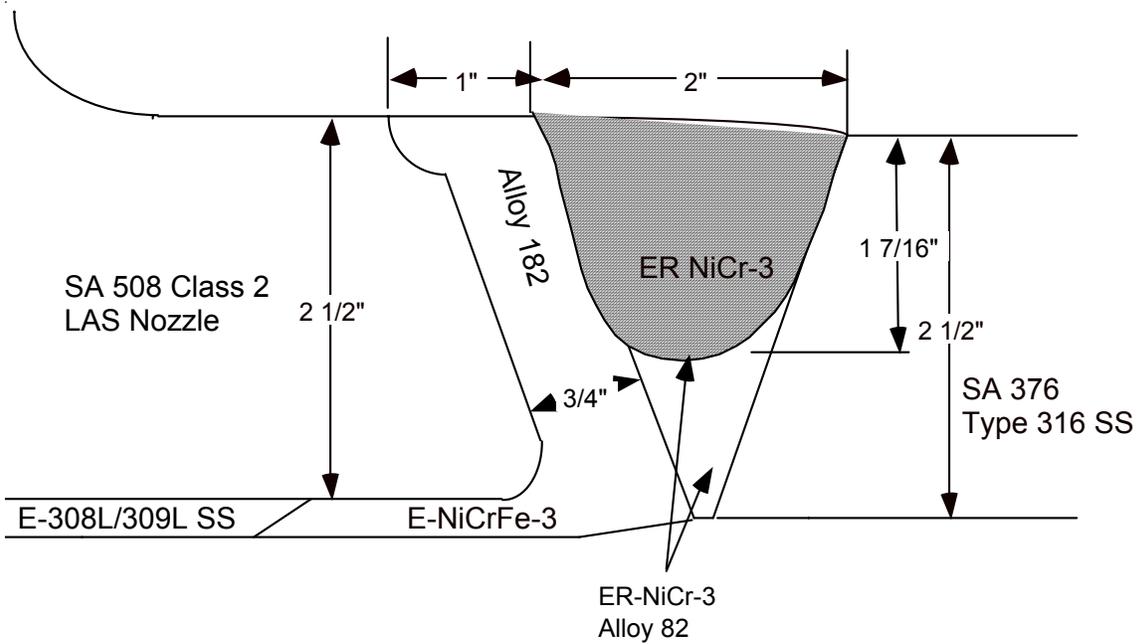
An OD repair to the entire circumference is often the best approach to repair extensive defects. This method normally would be performed using machine GTAW welding since the original weld made use of this process. The cavity would be excavated to a depth consistent with the deepest defect using a clamshell OD mounted portable lathe. See Figure 2-5. The advantage of this method over severing the weld and starting over is that no root purge is required for welding and the most likely source for weld defects is eliminated. The weld is contour ground flush after welding to facilitate ultrasonic inspection. Weld evaluations performed on stainless steel pipe welding for BWR applications suggested that excavating the weld below the centroid of the weld mass, then rewelding, produced weld residual stresses similar to an unrepaired weld. The centroid of the weld mass is about 2/3 of the wall thickness above the ID surface.

Figure 2-5
Schematic Cross-section of Deep 360° OD Repair

The depth of the machined cavity for Repair Scenario 3 is 1.44” (slightly deeper than mid-wall) and spans the entire weld cavity. Machine GTAW parameters are set for a travel speed of 2.8 inches/min using 0.045” diameter filler wire. A heat input of 30 KJ/in is assumed with a 60% weld thermal efficiency. The weld bead sizes are 0.25” wide and 0.125” thick. The weld crown is finished by hand grinding and flapping to eliminate any undercut and remove the weld crown to facilitate inservice ultrasonic inspection.

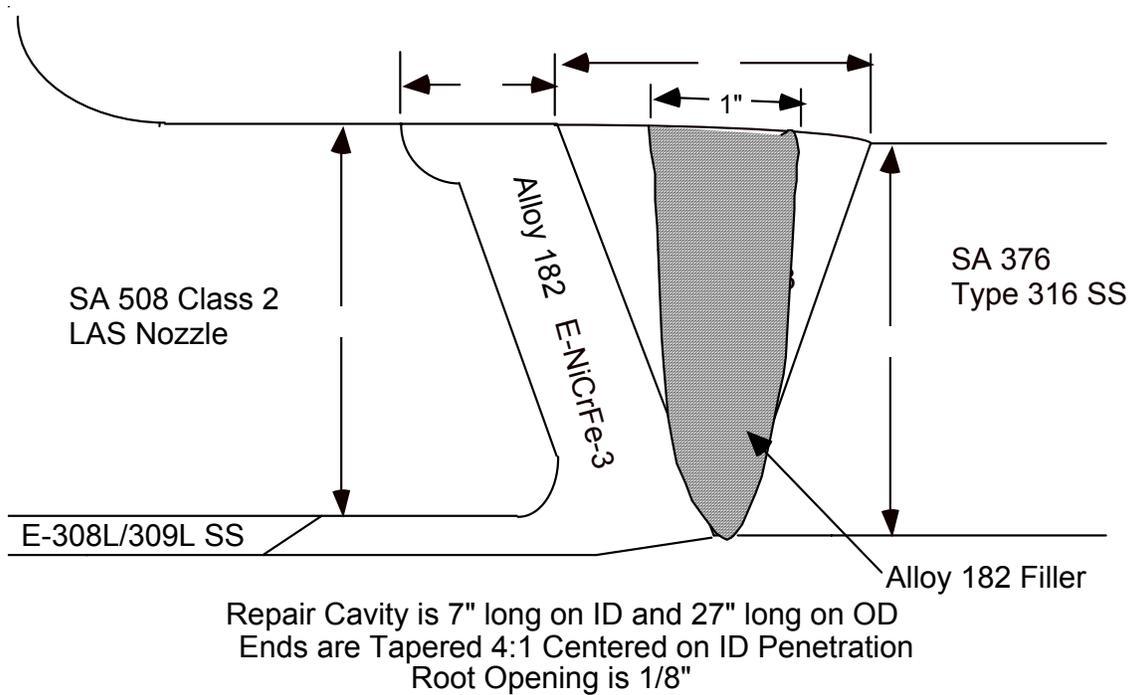
Localized through-wall weld repair from the OD surface is a difficult repair scenario because the weld root on the ID must be re-established from the OD. Access is limited. For this repair assume a repair cavity that is 7” at the ID and 27” at the OD and 1 1/2”

width and rounded at the bottom. Cavity is manually ground. The ends are tapered at 4 to 1 ratio (i.e. a 2.5 inch wall is tapered over a 10” length on each end of the cavity. See Figure 2-6. Manual GTAW open root technique (1/8” opening) will be used to simplify modeling. An inert argon purge is established on the inside of the pipe prior to welding the root and hot passes. Manual GTAW techniques are also used to complete the weld according to the following welding conditions.

Figure 2-6
Schematic Cross-section for OD Repair of 7" Long Root Defect

The depth of the manually ground cavity for Repair Scenario 4 is 2.5” inches deep, 7.0” long on the ID and 27 inches long on the OD. Manual GTAW parameters are established to produce a heat input of 30 KJ/inch using E-NiCrFe-3 (Alloy 182) 0.045” diameter filler wire. A 40% weld thermal efficiency is assumed. The weld bead size is 0.30” wide and 0.1” thick. The weld crown is hand ground and flapped to eliminate any undercut and eliminate any weld crown that would limit in-service ultrasonic inspection.

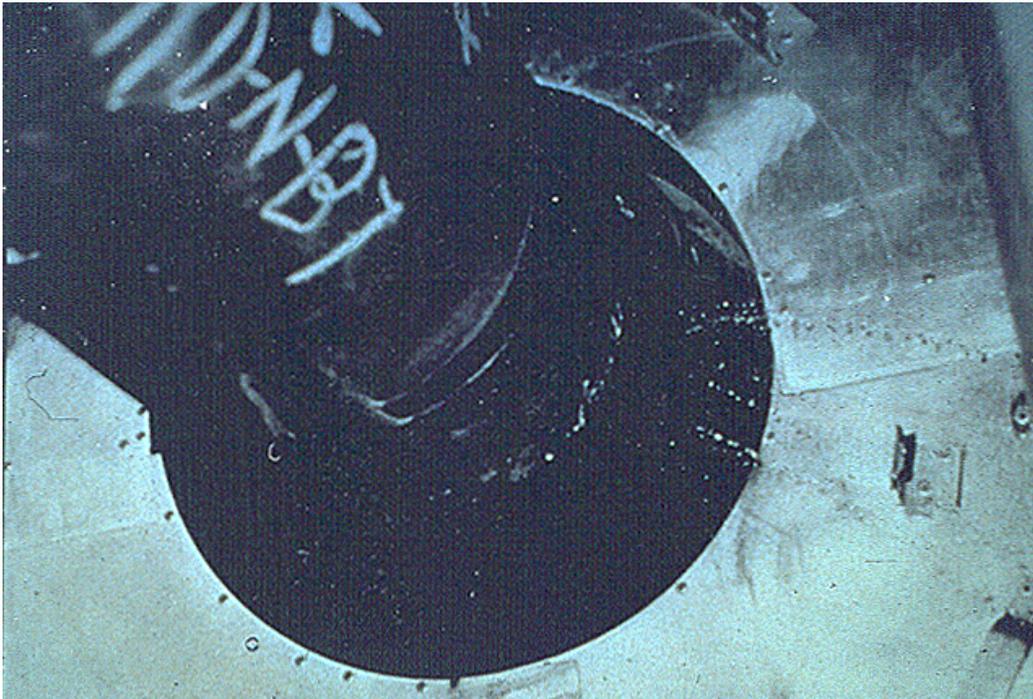
Figure 4-1
Leaking Alloy 600 Safe End at DAEC

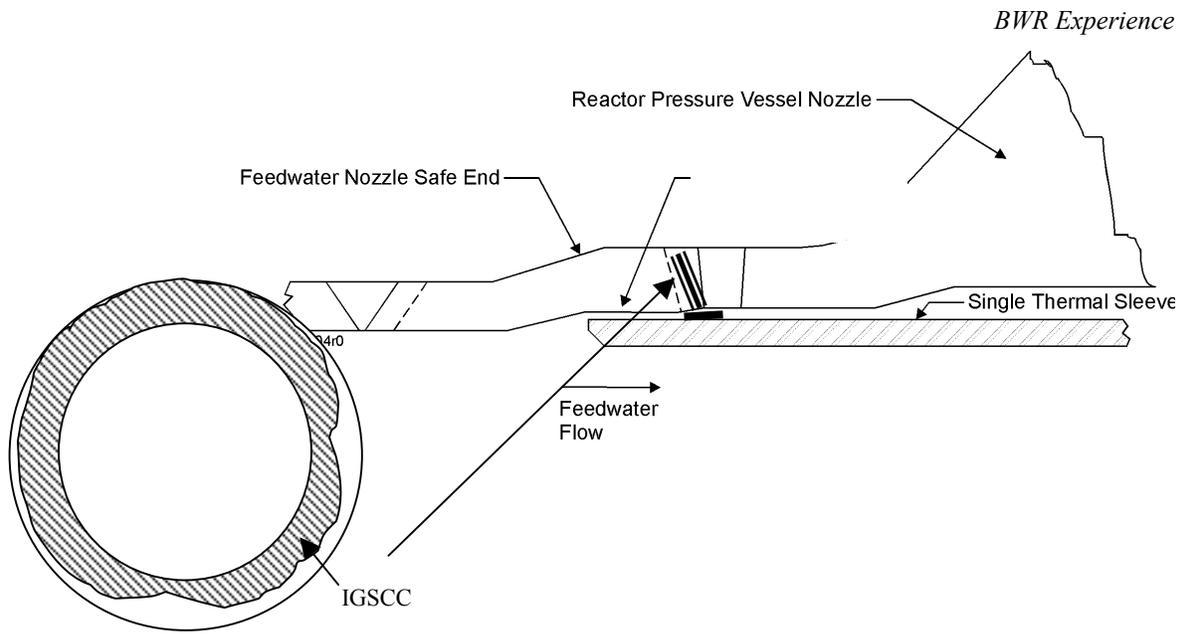
Figure 4-2
Schematic of the Circumferential IGSCC at Duane Arnold

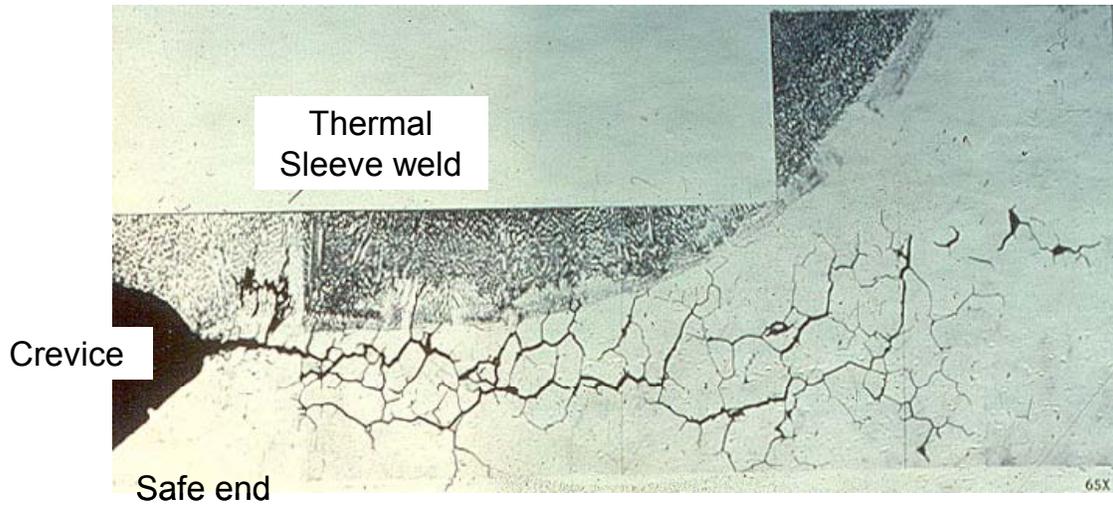
Figure 4-3
Duane Arnold Alloy 600 Recirculation Inlet Safe End Crevice with IGSCC
