Regulatory Performance Meeting

Failure of Atmospheric Dump Valve  
Quick-Open Override Relay

Bruce Montgomery, Engineering Manager

January 28, 2005

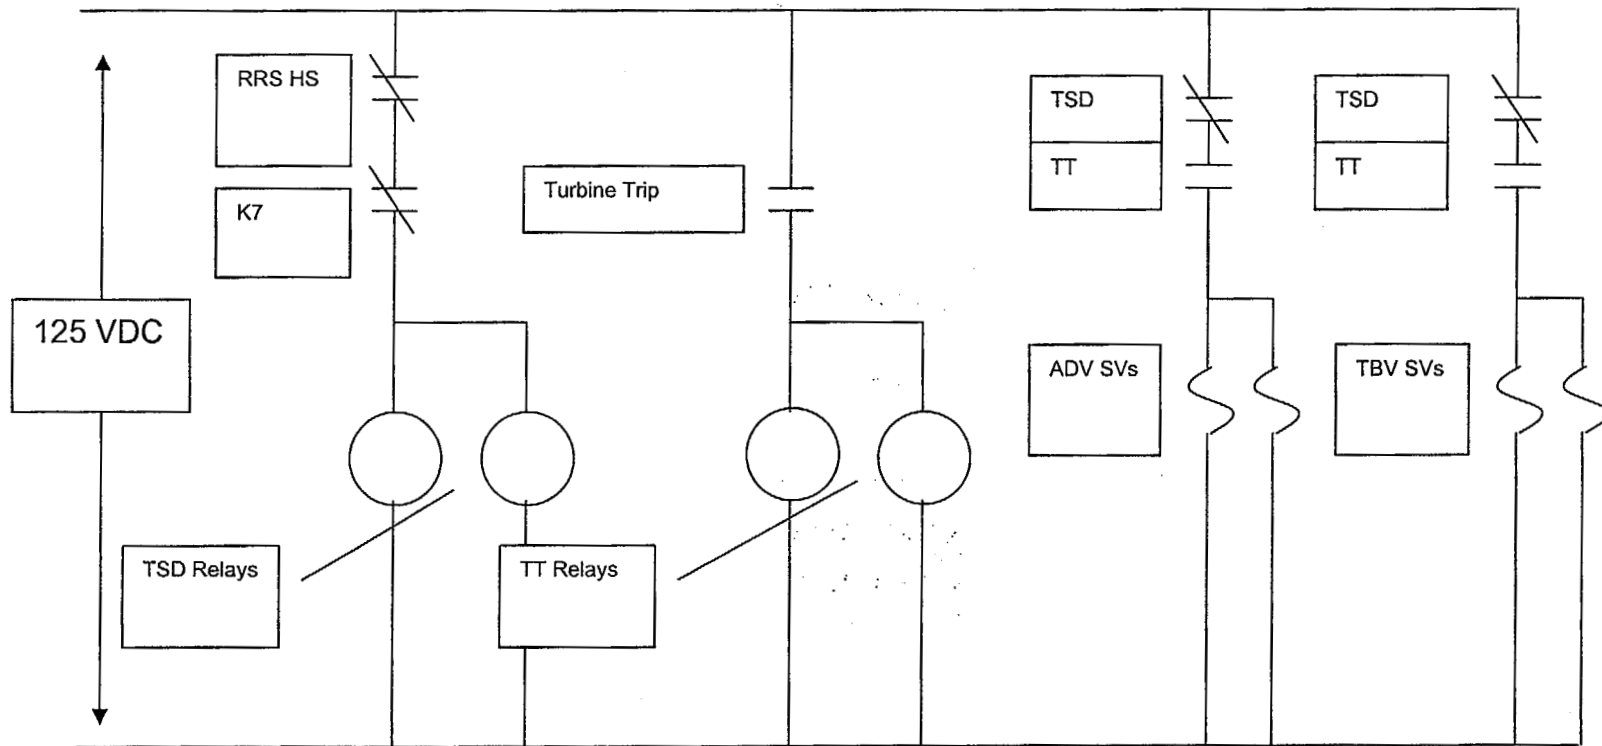
# Simplified sketch of the Reactor Regulating System Interface to the Quick Open Circuit

- K7 relay contacts underrated for application
  - Original design error by vendor ( > 30 years )
  - Vendor K7 circuit modification in 1992 resulted in increased contact current (missed opportunity, exacerbated error)
  - Design and design verification performed by vendor

K7 contacts shown with RCS temperature greater than 557° F. Below 557° F, the K7 relay is de-energized and the K-7 ADV/TBV contacts are open.

- Corrective Actions
  - Engineering issued to replace the K7 relay with one suitable for quick open circuit application
  - Modify the K7 relay installation to remove the effects of the underrated contacts
    - Unit One modified and Unit Two will be modified spring 2005 refueling outage
- Preventive Actions
  - Replace all K7 relays in both units with new Allied Control relays of the original design when received from the vendor.
  - Provided written expectations and training for OE review scope, focusing on addressing all issues related to a given event
    - Includes improved coordination of multiple system OE review.
  - Provided written expectations and training for Field Assistance Reports including Issue Reports for quality issues
