Letter No. 99008-05-001A

SUBJECT: Application for a Certificate of Compliance for the Mixed Oxide Fresh Fuel Package, Revision 1, DOCKET No. 71-9295

2.12.3.9 Pre-Test and Post-Test Leakage Rate Tests

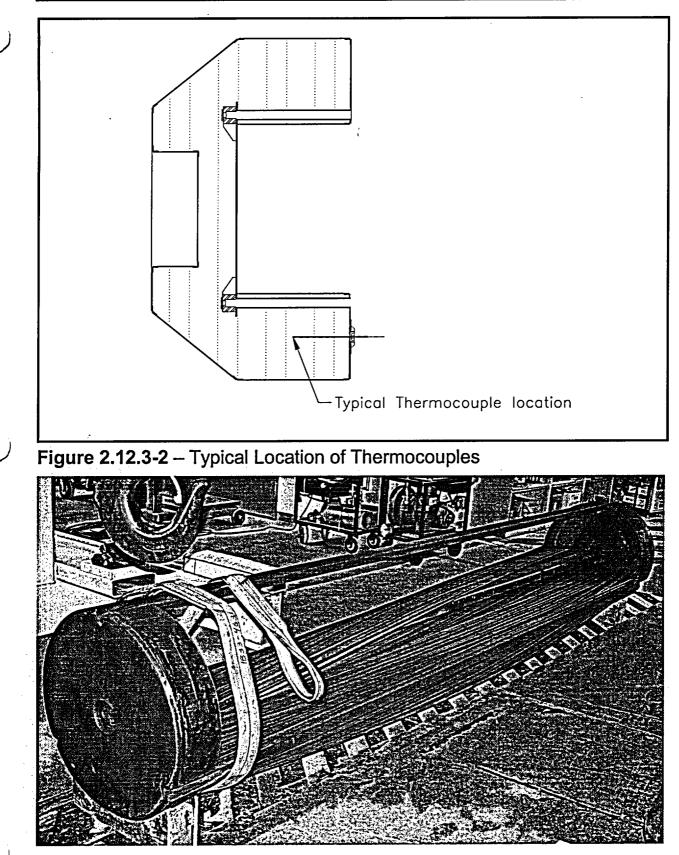
Figure 2.12.3-3 – Mock Payload (Shown Following Test Series 1)

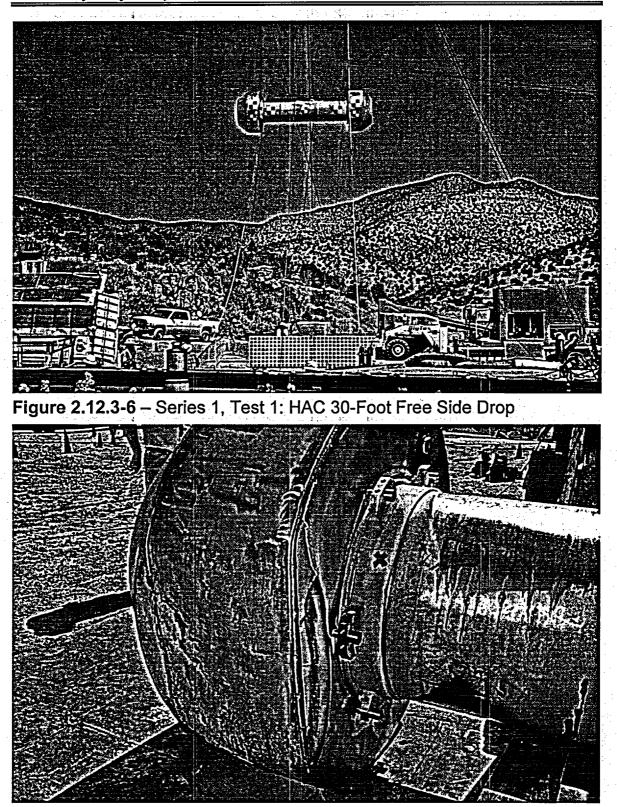
Figure 2.12.3-7 - Series 1, Test 1: View of Lid End Impact Limiter Damage (~28" Length)

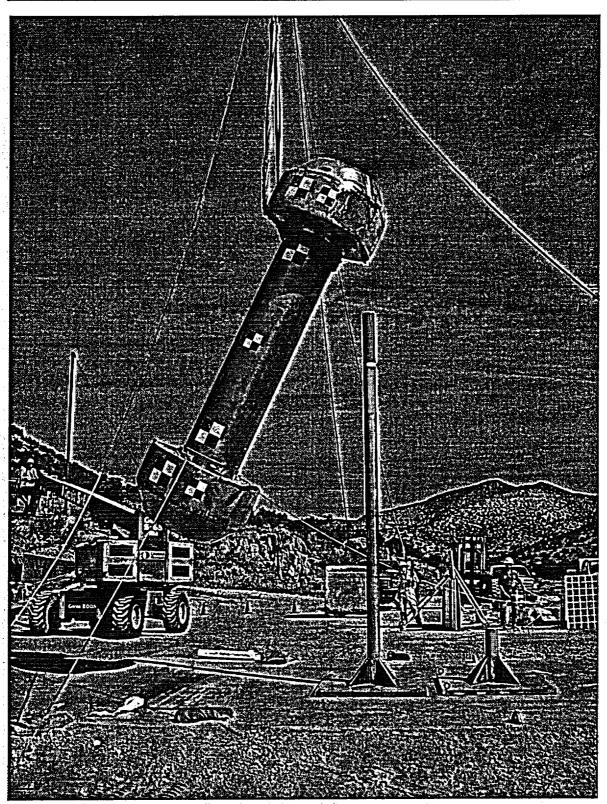
Figure 2.12.3-8 - Series 1, Test 2: HAC 40-inch Near Vertical Puncture Drop

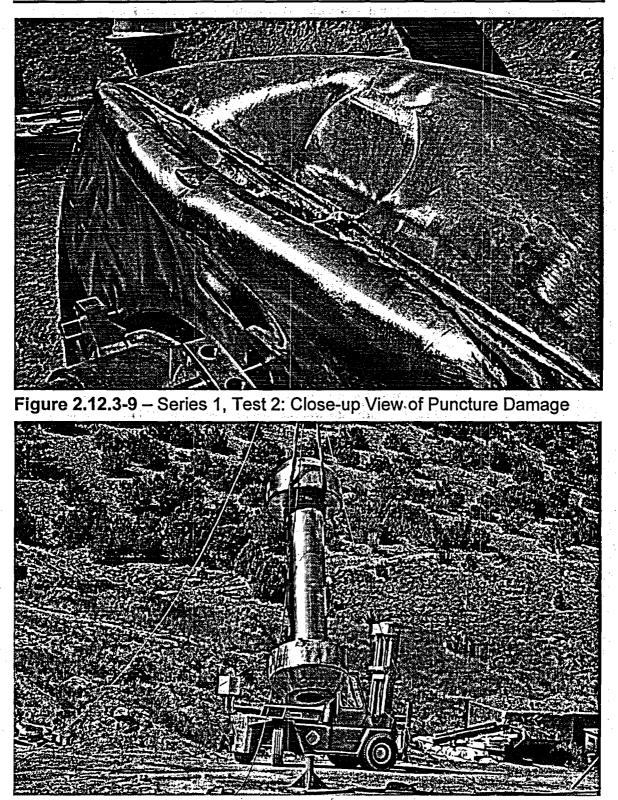
Figure 2.12.3-10 - Series 1, Test 3: HAC 65-Degree Oblique 40-Inch Puncture Drop

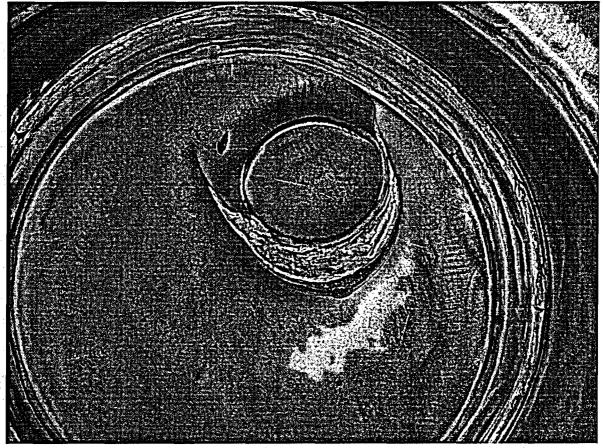
Figure 2.12.3-11 - Series 1, Test 3: Close-up View of Puncture Damage (~3" Deep)

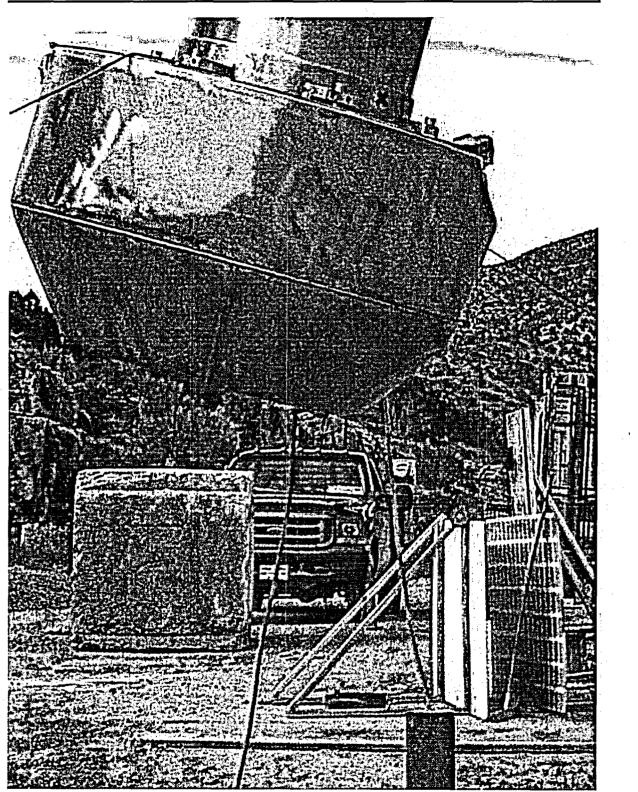
Figure 2.12.3-12 - Series 1, Test 4: HAC 75-Degree Oblique 40-Inch Puncture Drop

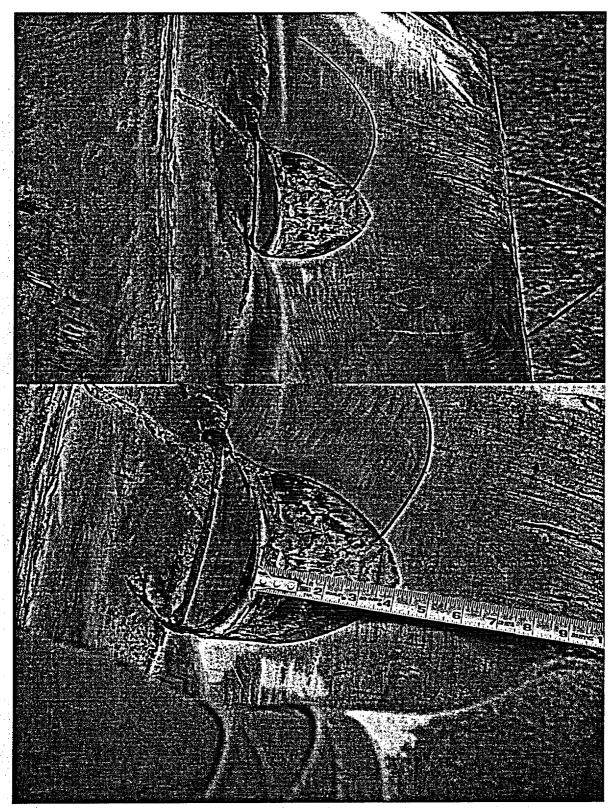
Figure 2.12.3-13 - Series 1, Test 4: Close-up Views of Puncture Damage (~4" Length)

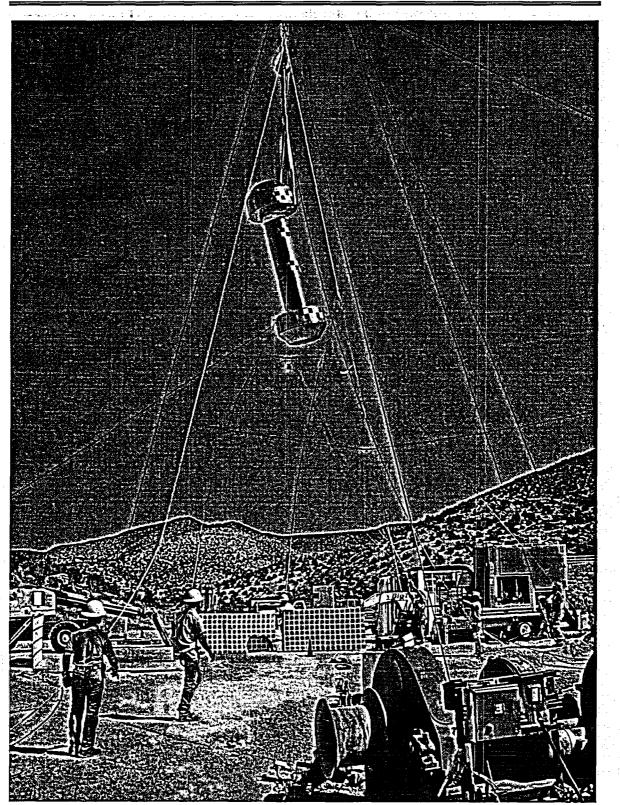
Figure 2.12.3-14 - Series 2, Test 1: HAC 80-Degree Oblique C.G.-Over-Corner 30-Foot Drop

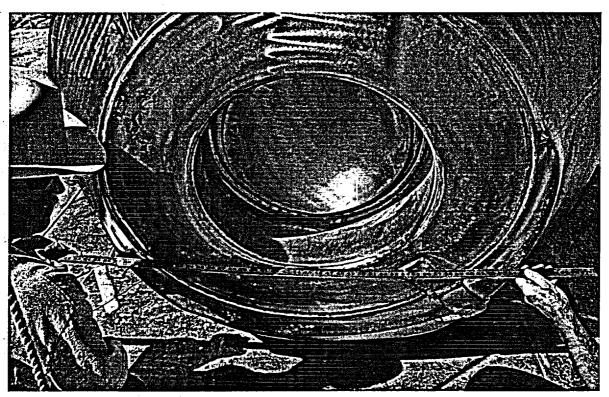
Figure 2.12.3-15 - Series 2, Test 1: Overall View of Impact Limiter Damage

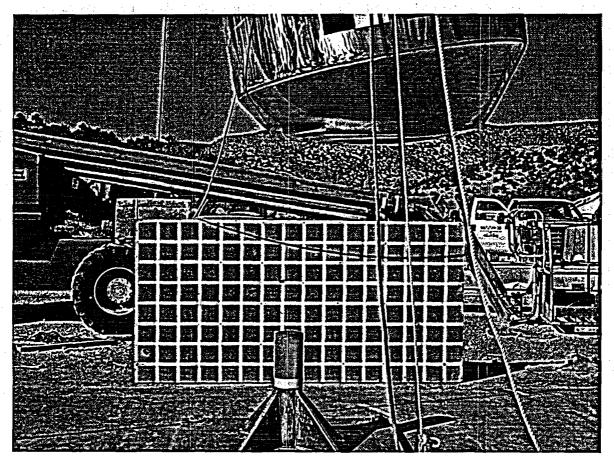
Figure 2.12.3-17 – Series 2, Test 2: HAC 80-Degree Oblique Puncture Drop

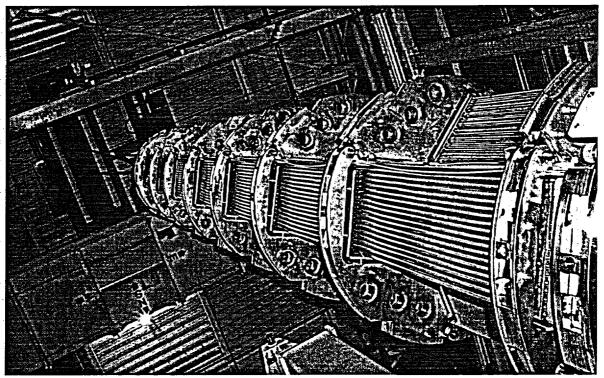
Figure 2.12.3-21 - Series 2: View from Bottom of Strongback (Clamp Arms Closed)

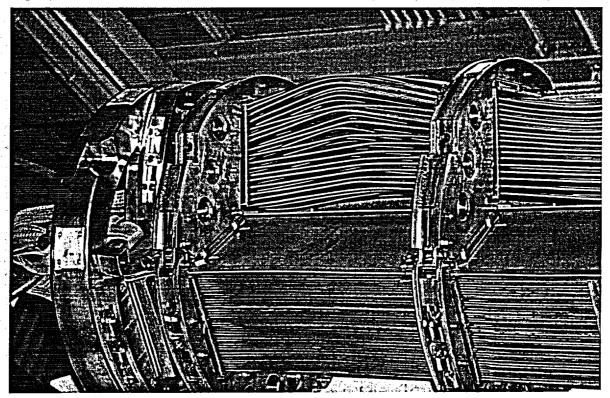
Figure 2.12.3-22 - Series 2: View of Worst Case Fuel Deformation (Nearest the Top Nozzle)
