Palo Verde Nuclear  
Generating Station

**Subject: Palo Verde Nuclear Generating Station (PVNGS)  
Unit 3  
Docket No. STN 50-530  
APS' 60-Day after Plant Restart Letter in Response to First Revised  
NRC Order EA-03-009, Item IV.E, NRC Bulletin 2003-02, Commitment  
No. 3 and NRC Bulletin 2004-01, Commitment No. 2 – U3R11**

**PVNGS' Unit 3 60-day Report Detailing the Inspection Results of  
the Reactor Pressure Vessel Head, the Bottom Mounted  
Instrumentation Nozzles and the Pressurizer Alloy 82/182/600  
Penetrations and Steam Space Piping Connections**

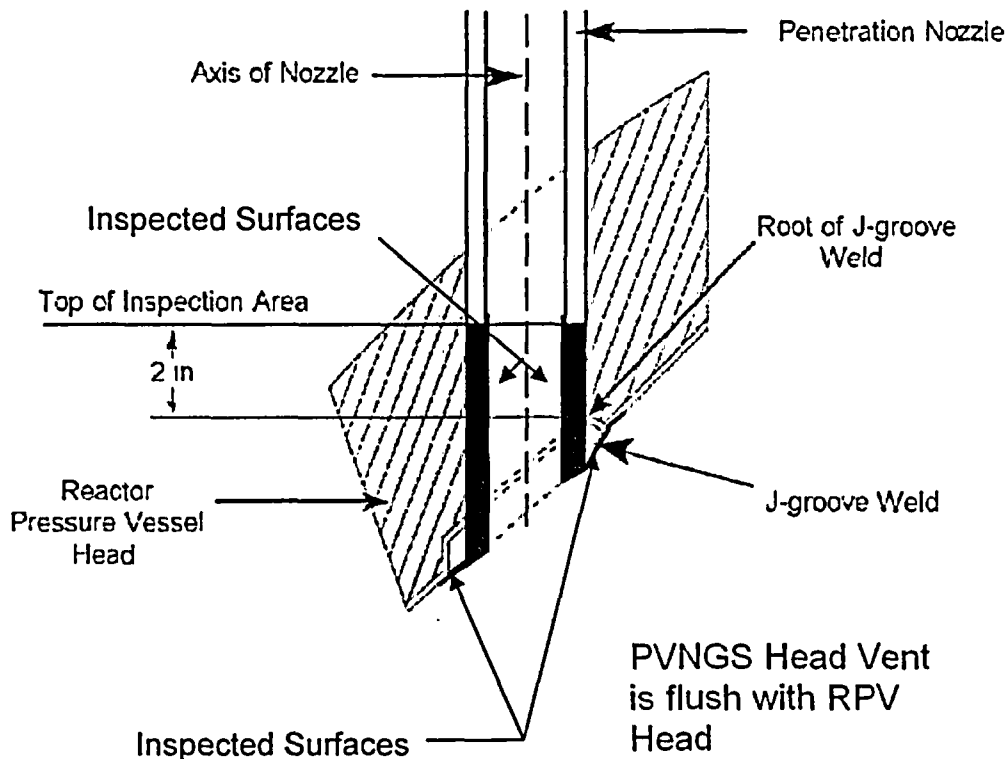
Figure 1

In preparation for the inspection identified in Section IV.C.(5)(b) of the First Revised NRC Order, APS modified the reactor head vent nozzle. The completed modification of the head vent nozzle removed and permanently relocated the internal orifice. Upon removal of the orifice, APS performed a surface examination (eddy current) of the J-groove weld and inside nozzle surface as required. The head vent nozzle does not protrude below the surface of the RPV head. As a result, there is no material below the J-groove weld to be examined (see Figure 1). No flaws were found during this examination.
