U3R11 SG Loose Part

Kevin Sweeney
System Engineering

Loose Part removed from SG 32

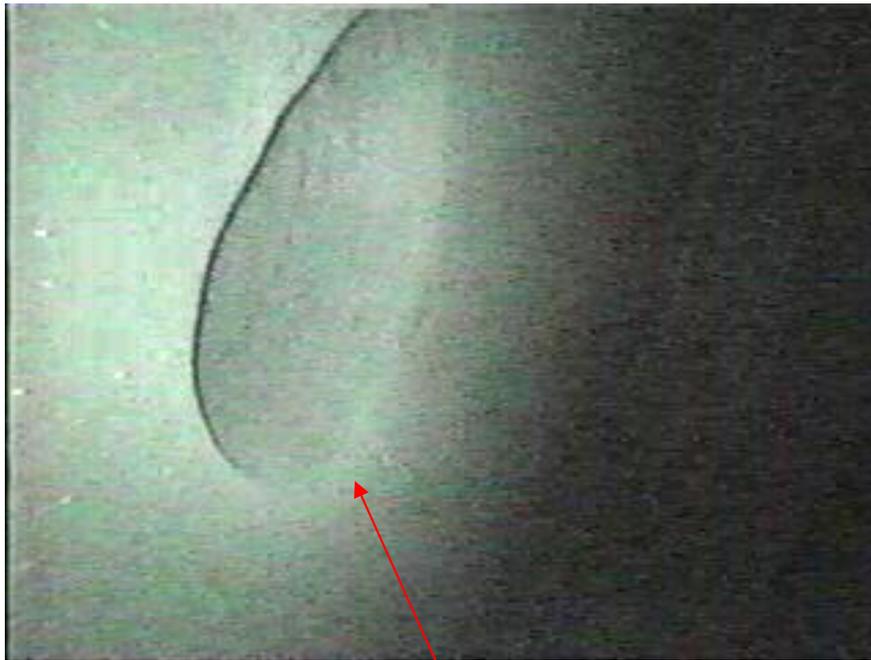
Inspection Results – Set Screw #5

Set Screw missing

- Eddy current results from U3R11 reviewed after FW Box FOSAR Findings
 - All calls from TSC to 03C
 - Three (3) tubes found with wear at 02C
 - R127C40 – 10% wear
 - R129C40 – 20% wear
 - R130C41 – 25% wear
 - Historical review indicated no previous wear or precursors
 - Further review indicated tubes directly inline with #5 hole
 - Confirmed by Westinghouse

- Recommended Actions – Unit 3
 - Three tubes with indicated wear
 - Plugged and Staked
 - Develop preventative plugging strategy for screw locations adjacent to deflector plates
 - Determined that five (5) tubes per location affected
 - Recommend plugging and staking each location in both steam generators
 - Twenty tubes (minimum) per SG
 - Reviewed ECT data in U2 OSGs and Unit 1
 - No indication of wear or wear precursor at any locations

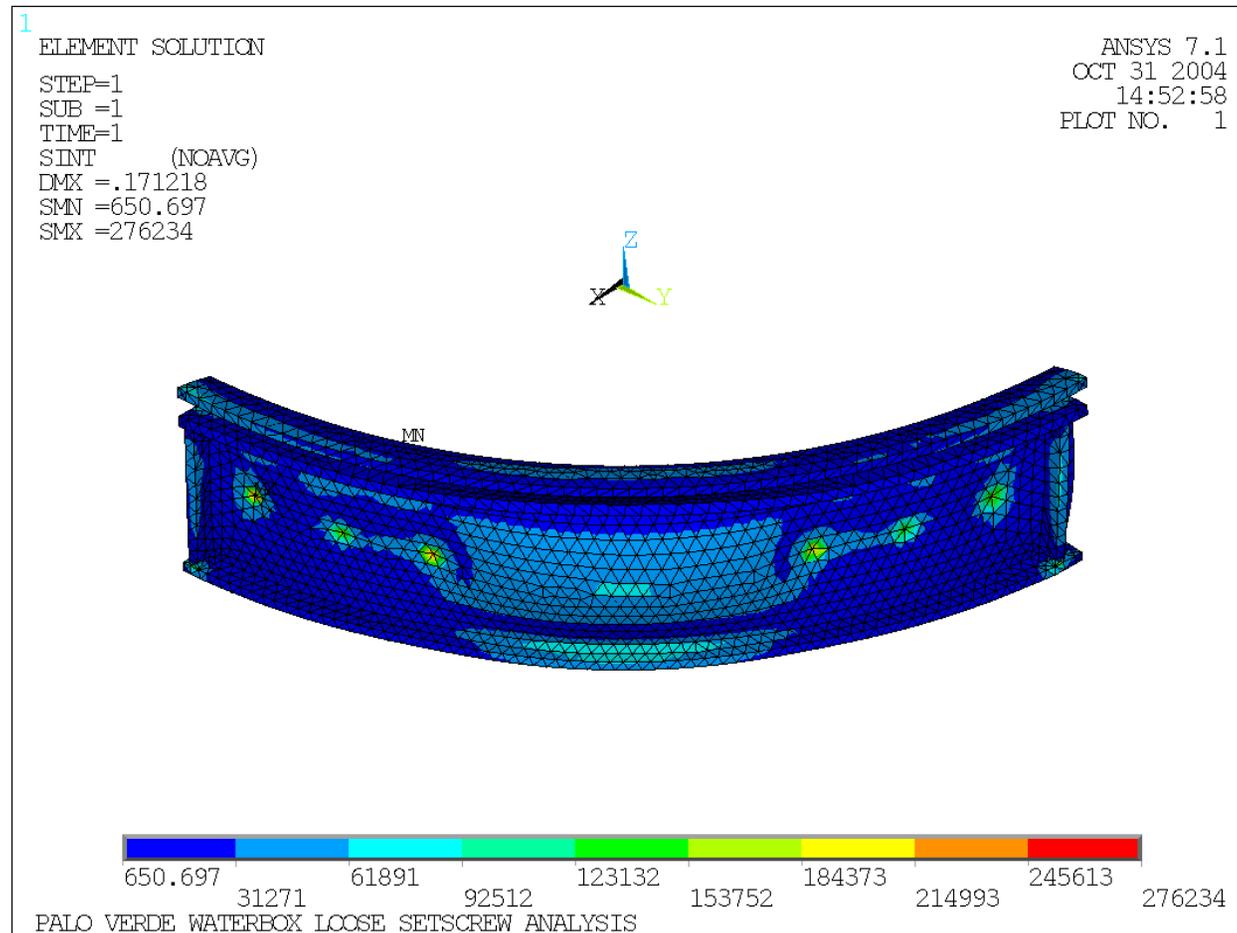
FEA Model Feedwater Box with screws missing

- Set Screw Design Function
 - Prevent Feedwater Box collapse during FWLB
 - Feedwater Box/Economizer not credited during FWLB
 - Assure negative impact to tubing not generated
- Analysis
 - Westinghouse developed 3-D FEA model
 - Assumed two (2) set screws per 90 degree section missing
- Results
 - Insignificant increase in elastically calculated stresses
 - Box deflects outwards away from tube bundle
 - Maximum displacement less than $\frac{1}{4}$ inch

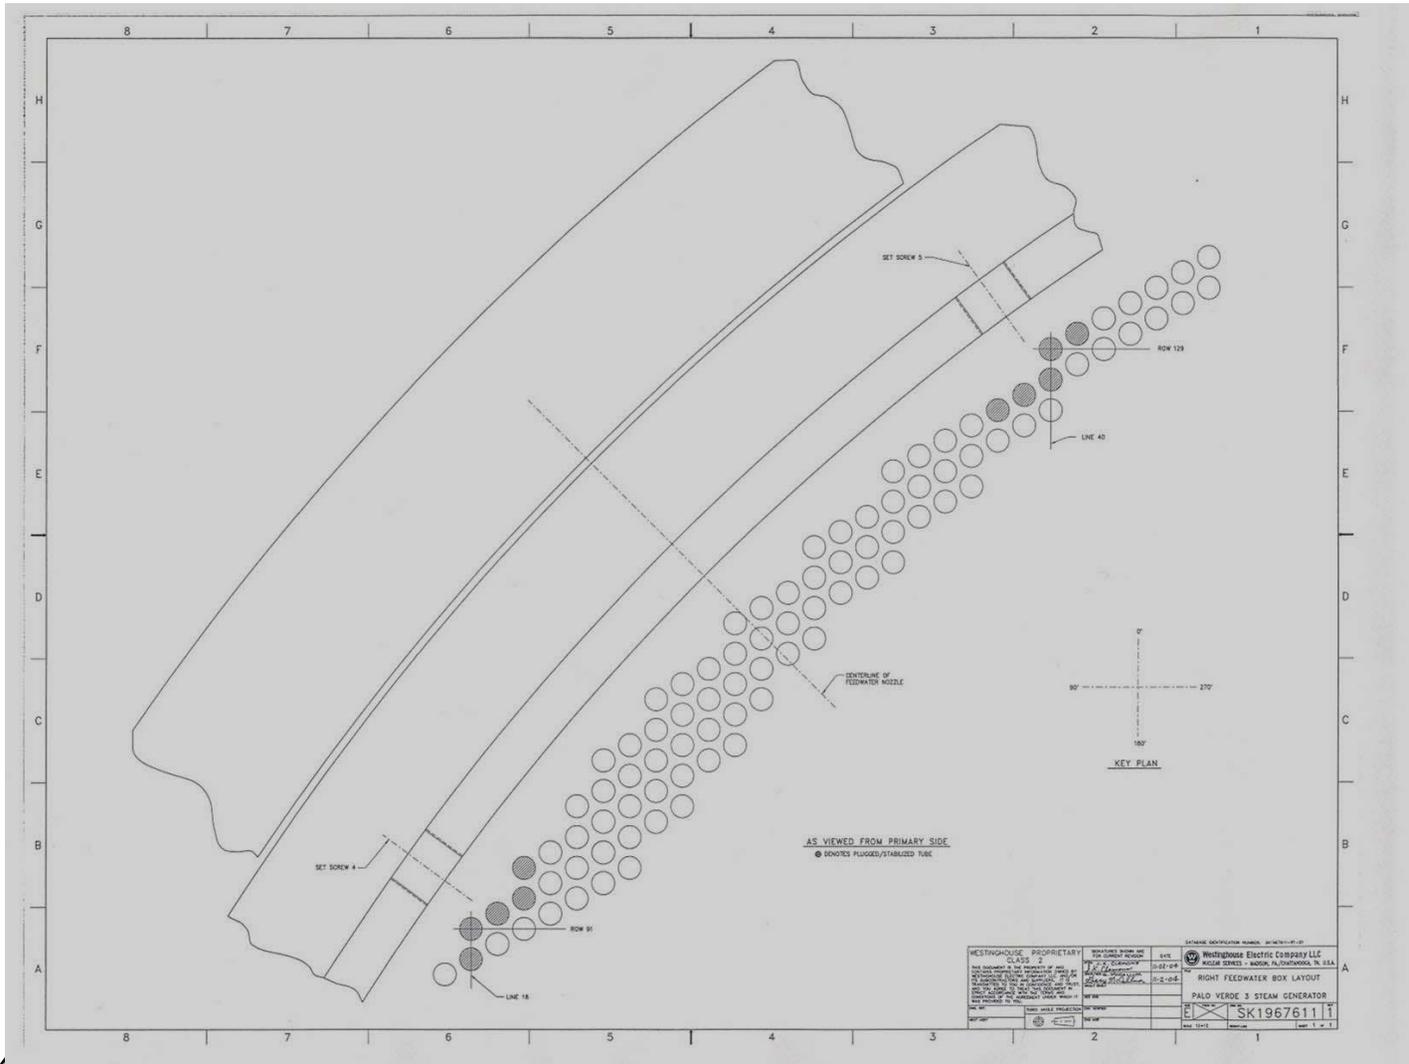
Tube Pattern – Streaming Flow

- Analysis Approach
 - FIV analysis
 - Similar to analytical effort performed for SG mods
 - Calculate stability ratio
 - Acceptance criteria - ≤ 1.0
 - Ratio > 1 – increased potential for fluid-elastic instability and wear
 - ATHOS model used
- Results
 - Stability ratio slightly greater than 1
 - Consistent with observed wear
 - Flow rates much less than cold leg corner phenomenon
 - 27 ft/sec vs 46 ft/sec
 - Negligible impact on SG performance (< 1 psi)
