UNITED STATES
NUCLEAR REGULATORY COMMISSION
OFFICE OF NUCLEAR REACTOR REGULATION
WASHINGTON, D.C. 20555

April 7, 2005

NRC INFORMATION NOTICE 2005-09: INDICATIONS IN THERMALLY TREATED ALLOY
600 STEAM GENERATOR TUBES AND TUBE-
TO-TUBESHEET WELDS

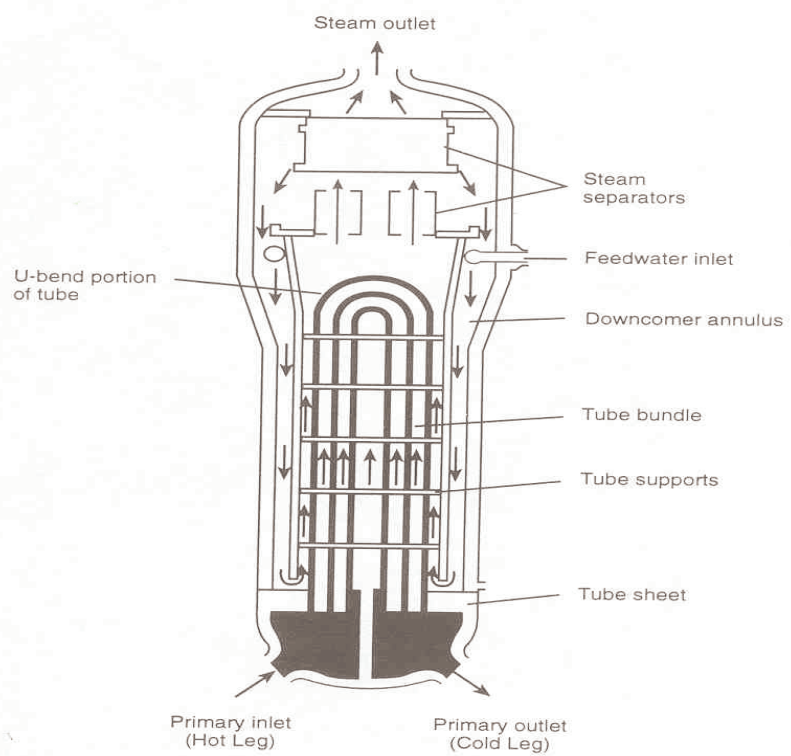
Figure 1

Catawba Nuclear Station, Unit 2, has four Westinghouse Model D5 recirculating steam generators. Each steam generator has approximately 4,600 tubes fabricated from thermally treated Alloy 600 (Figure 1). During fabrication of the steam generators, a portion of the U-shaped tubes are inserted into a thick plate called a tubesheet. The tubesheet is approximately 21 inches thick and has two holes for each tube (one hole on the hot-leg side of the steam generator and one hole on the cold-leg side). The lower end of the tubes were tack-expanded into the tubesheet for approximately 0.70 inch (Figure 2). This tack expansion is performed to facilitate welding of the tube to the primary side of the tubesheet. In the case of Catawba Unit 2, this region is frequently referred to as the tack roll region since the tack expansion was accomplished by mechanically rolling the tube into the tubesheet. The tack expansion forms a temporary expansion transition (i.e., a roll transition in the case of Catawba). Following welding, the tubes were hydraulically expanded for the full depth of the tubesheet. The transition from the expanded portion of tube within the tubesheet to the unexpanded portion of the tube at the top of the tubesheet is referred to as the expansion transition region of the tube.

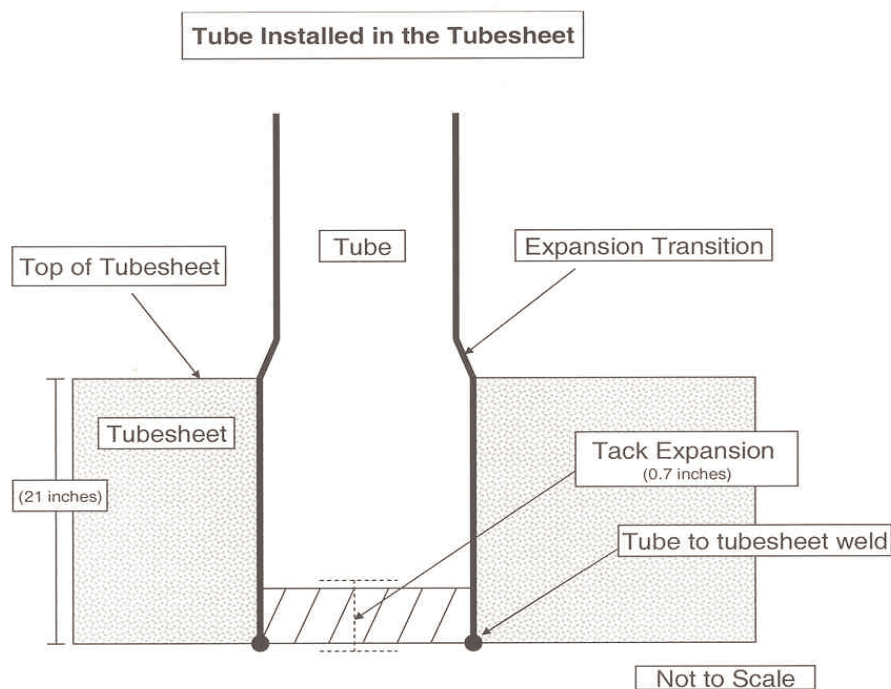
Figure 2

During these additional rotating probe examinations, no additional indications were found in the overexpanded (bulged) regions; however, several indications were found at the tube ends (tube-to-tubesheet weld) and one indication was found in the tack expansion region. At the tube ends, the licensee identified approximately 12 indications in steam generators A, B, and D. These indications were in the tube-to-tubesheet weld and were not visible during visual inspections of the weld. The indication in the tack expansion (the region of the tube expanded into the tubesheet to facilitate welding) was approximately 0.70 inch above the tube-to-tubesheet weld and was circumferentially oriented. It was estimated to be 330 degrees in circumferential extent and 100 percent through-wall.

In steam generator B, 9 tubes were found to have indications in the tack roll region. These indications were circumferentially oriented and consisted of either single or multiple cracks. No indications were found in the tack roll region in steam generators A, C, or D. In the tube-to-tubesheet weld region, 188 tubes in steam generator B, 1 tube in steam generator A, and 7 tubes in steam generator D contained indications in the tube-to-tubesheet weld. No indications were found in the tube-to-tubesheet weld region in steam generator C. Six tubes in steam generator B were identified with tube end (i.e., tube-to-tubesheet weld) indications that extended into the tube material. The indications in these tubes were axially and circumferentially oriented and consisted of either single or multiple cracks.

The licensee plugged the tube with the circumferential indications in the overexpanded region and the tubes with indications in the tack roll region. In addition, the licensee plugged the six tubes with indications in the weld region that extended into the tube material.
