Subject: Transmittal of the Follow-up Inspection Report on the Stream Bank Damage at the
Canonsburg, PA, Disposal Site

**Follow-up Inspection Report of the Stream Bank Damage
at the Canonsburg, Pennsylvania, Disposal Site**

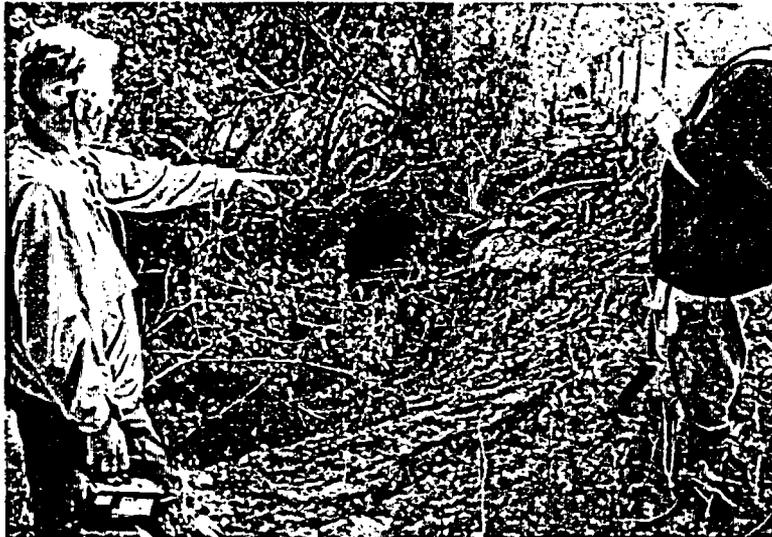
Chartiers Creek was out of its bank near perimeter signs P6 and P7 during the flood. Plant debris remaining in the fence indicates that floodwater remained out of the banks until immediately downstream of the Strabane Avenue Bridge. During the flood, soil eroded from the base of a large tree (2½' to 3' in diameter), which fell into the creek creating a large root ball void. The void is nearly semicircular; approximately 44 feet across, approximately 22 feet from the creek edge, and approximately 9 feet deep. Photographs 1 and 2 show the extent of the root ball void and encroachment to the disposal cell fence.

Photograph 1, Roy Woods and Ron Staubly inspecting the root ball void, 9/21/2004.

Repair of Area #1 will require removal and disposal of the large tree, and backfilling and compacting the void with pit run soil before placing surface rock erosion protection along the bank. Additionally, cleaning and removal of vegetation along the north and east fence lines, and moving approximately 400 feet of existing fence line approximately 15 feet from the current location should be conducted. Cleaning and filling the root ball void will require work in or near Chartiers Creek.

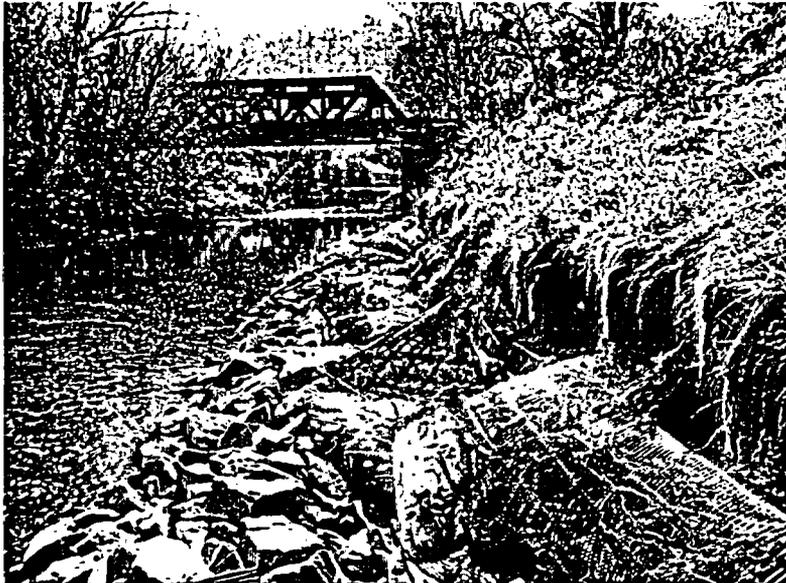
The region south of debris deposition for approximately 250 feet had soil stripped from between layers of geotextile reinforcement as shown in photograph #4. Geotextile reinforcement remains embedded in the slope, and the riprap rock toe remains in place.

Photograph #4, Previous Bank Stabilization, North End, Slope Erosion and Embedded Geotextile, (note railroad bridge upper left), 10/28/2004.

Repair of the region south of the debris deposition will require replacing rock riprap into the void created by soil erosion between layers of geotextile reinforcement to re-establish the slope.

Prior to placing rock, removal of loose vegetation and debris between geotextile layers should be performed. Upper geotextile layers should be folded back while rock is placed on the lower geotextile. When the depth of rock fill reaches the level of the overlying geotextile, the overlying geotextile should be folded down and the next layer of rock placed. This process will continue until the reconstructed rock slope conforms to the lower rock toe and upper reinforced vegetated slope.
