Subject: Transmittal of the Follow-up Inspection Report on the Stream Bank Damage at the
Canonsburg, PA, Disposal Site

**Follow-up Inspection Report of the Stream Bank Damage
at the Canonsburg, Pennsylvania, Disposal Site**

| FOLLOW-UP INSPECTION DRAWING CANONSBURG, PENNSYLVANIA, DISPOSAL SITE | |

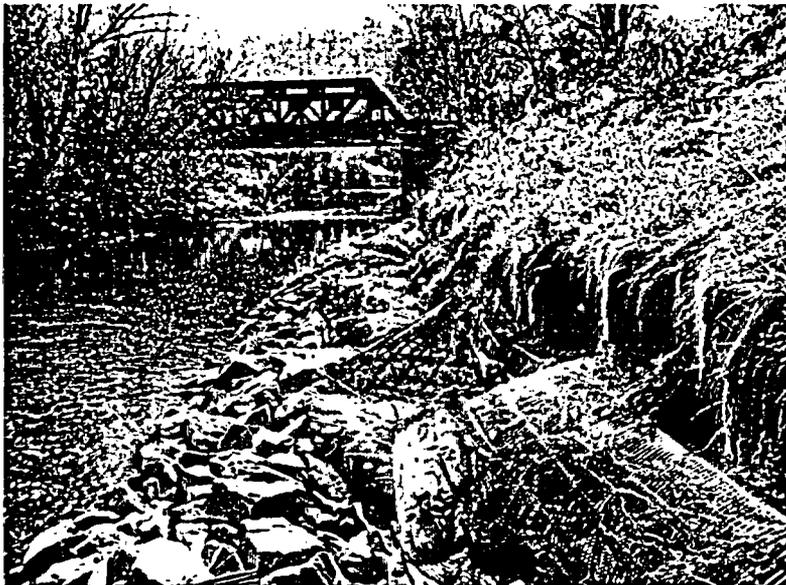
The region south of debris deposition for approximately 250 feet had soil stripped from between layers of geotextile reinforcement as shown in photograph #4. Geotextile reinforcement remains embedded in the slope, and the riprap rock toe remains in place.

Photograph #4, Previous Bank Stabilization, North End, Slope Erosion and Embedded Geotextile, (note railroad bridge upper left), 10/28/2004.

Repair of the region south of the debris deposition will require replacing rock riprap into the void created by soil erosion between layers of geotextile reinforcement to re-establish the slope.

Prior to placing rock, removal of loose vegetation and debris between geotextile layers should be performed. Upper geotextile layers should be folded back while rock is placed on the lower geotextile. When the depth of rock fill reaches the level of the overlying geotextile, the overlying geotextile should be folded down and the next layer of rock placed. This process will continue until the reconstructed rock slope conforms to the lower rock toe and upper reinforced vegetated slope.
