NUREG-XXXX

# **US Plant Experience with Cracking in Alloy 600 Components and Boric Acid Corrosion**

US Nuclear Regulatory Commission  
Office of Nuclear Regulatory Research  
Washington, DC 20555-0001

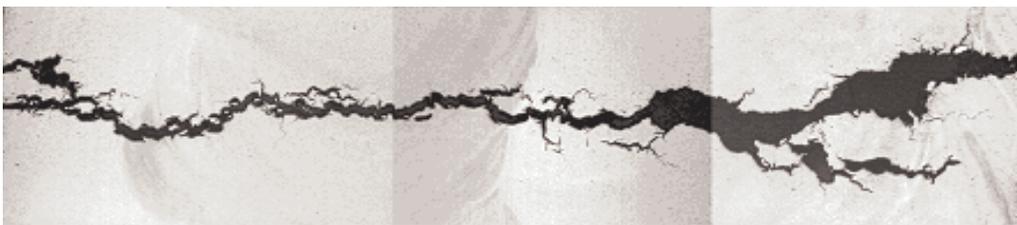
Figure 2. A metallograph showing the profile of a crack in the attachment weld of Nozzle #3 in the (now discarded) Davis-Besse reactor head (Ref. 1).

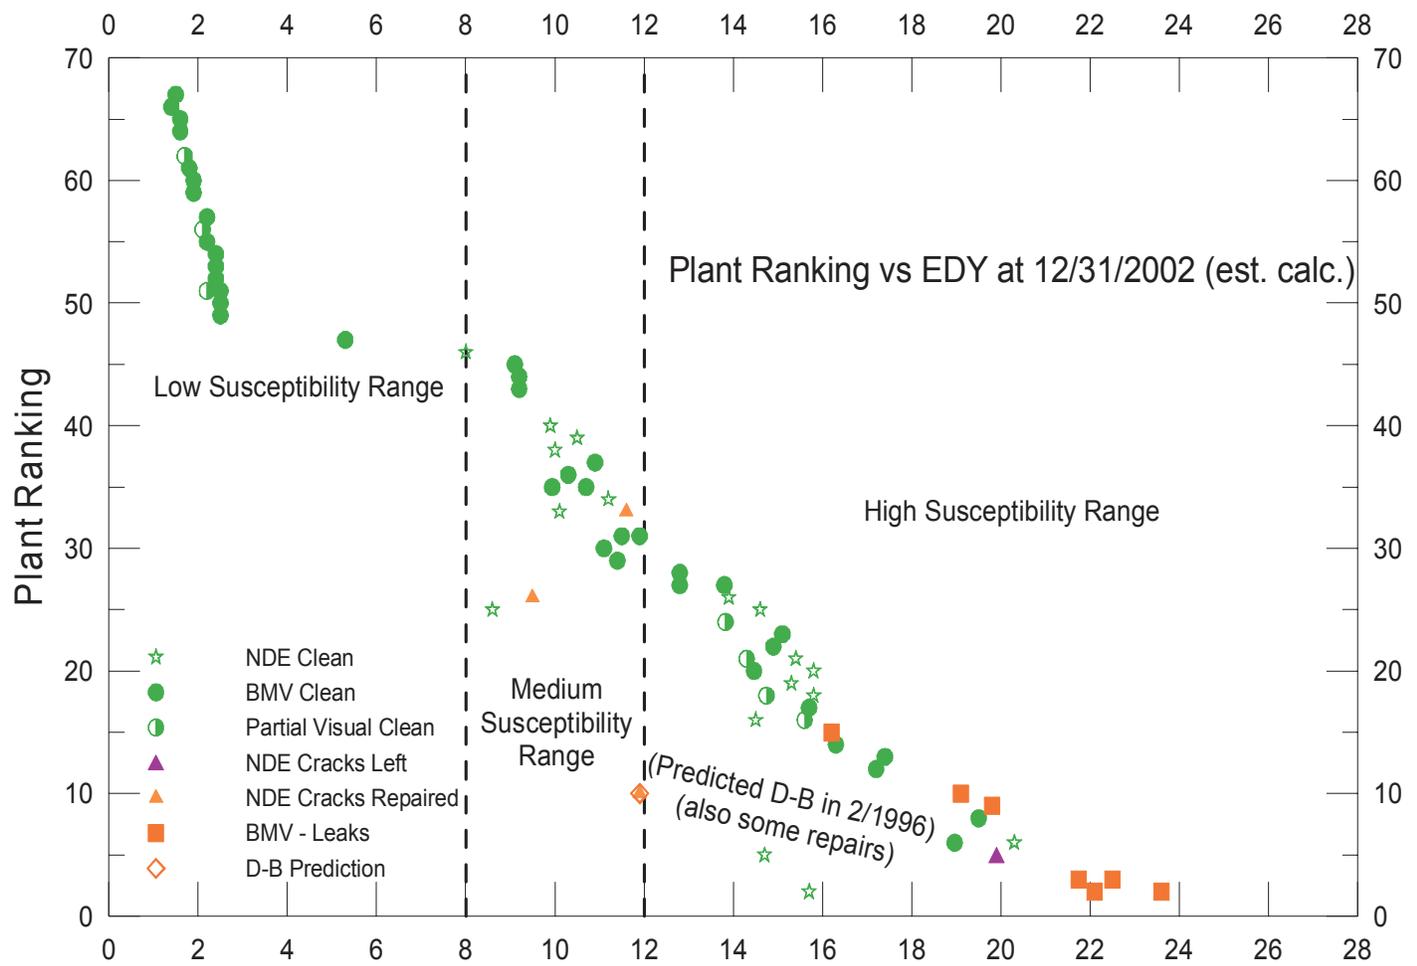
VHP nozzle inspection results indicate that the cracking susceptibility approach provided in Order EA-03-009 is effective in designating groups of plants for specific types of inspections, and do not indicate a need for revising the EDY model in the short term. However, the actual EDY calculation is becoming less of an issue due to reactor vessel head replacements. The cost of 100% volumetric inspection of heads, which is required at every outage for the high susceptibility plant, dictates that replacement of the head is an effective way to manage VHP nozzle cracking. As of March 2005, 14 U.S. plants replaced their reactor heads. With many of the high susceptibility plants replacing their heads with new Alloy 690 heads, most plants will fall into the low EDY susceptibility category.

Figure 3. Ranking of domestic plants according to the EDY formula, showing results of inspections, evidence repairs. Many plants are shown with multiple symbols, indicating a "clean" inspection at inspection by a different finding at a subsequent inspection (e.g., Oconee 2: clean NDE @ EDY=15.7, leaks a

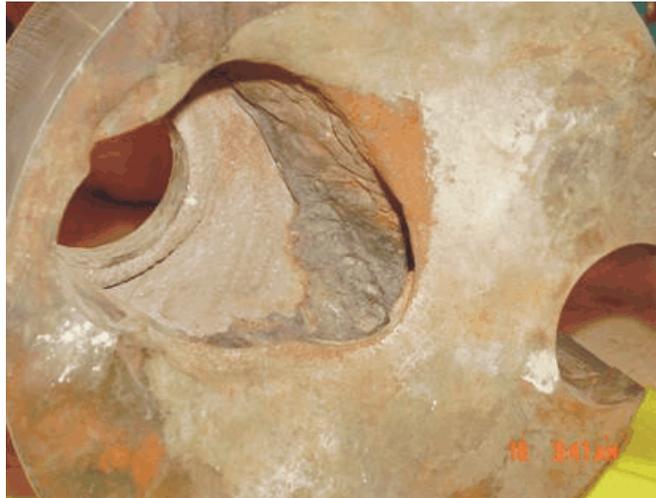
Degradation of the RPV head at Davis-Besse was discovered in March 2002. The integrity of the reactor coolant boundary was significantly compromised. A triangular cavity approximately 5 inches wide, 7 inches long, and completely through the low-alloy steel RPV head thickness was located downhill of VHP nozzle 3 approaching nozzle 11. The wastage consumed between 40 and 60 cubic inches of the vessel head. This reduced the reactor pressure boundary in the vicinity of the boric acid corrosion attack to a section of stainless steel cladding ranging in thickness from 0.199 inches to 0.314 inches. The cladding had an exposed surface area of 16.5 square inches and had deflected outward under system pressure. Additional boric acid wastage was also observed near VHP nozzle 2. Figure 4 is a photograph of the extensive corrosion loss experienced on the head at the Davis-Besse plant.

Figure 4. A photograph of the 18-inch diameter section of the discarded Davis-Besse head, containing the corrosion cavity created by leakage from the included nozzle (#3).

significant RPV head corrosion. The exact mechanisms that led to this corrosion are not fully understood. However, at the time of the event a root cause report was issued describing the industry's understanding of the contributing factors that lead to the event (Refs. 33, 35)
