RS-05-005

Dresden Nuclear Power Station, Units 2 and 3  
Renewed Facility Operating License Nos. DPR-19 and DPR-25  
NRC Docket Nos. 50-237 and 50-249

Quad Cities Nuclear Power Station, Units 1 and 2  
Renewed Facility Operating License Nos. DPR-29 and DPR-30  
NRC Docket Nos. 50-254 and 50-265

Subject: Submittal of Information Regarding Extended Power Uprate Vulnerability  
Reviews

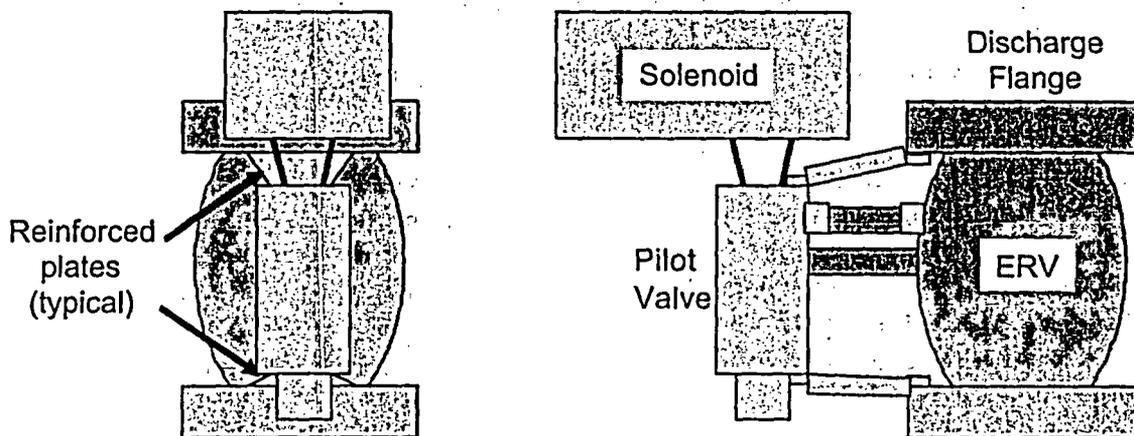
Figure 1. Plates Supporting the Ends of the Pilot Valve

*ERV Design Modification*

Based on the results of the dynamic analysis, correlation to the test data, and review of the actuator degradation, the long term recommendation is to replace the tie back support with a pilot valve modification (a reinforced plate bolted or welded to both ends of the pilot valve – see Figure 1 or some alternative which results in a significant relative stiffness change). This design modification will not eliminate the cause of the vibration but is considered economically feasible, since eliminating the acoustic vibration would entail significant main steam and branch line changes.

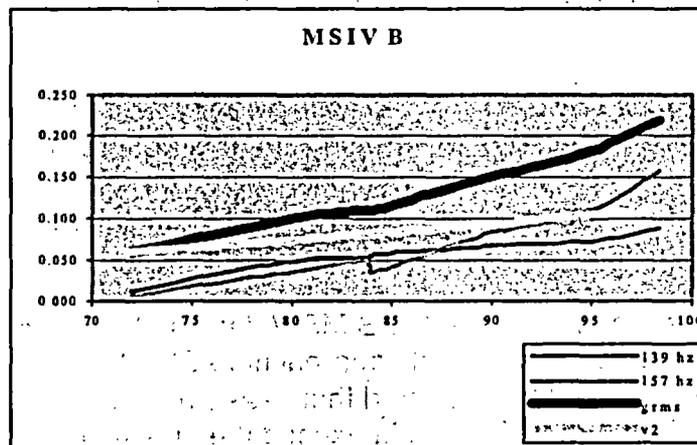
B MSIV

As can be seen, the amplitude of the vibrations increases with power and pronounced peaks are evident above the 80% power level for the 139 Hz and 157 Hz frequencies. In all cases, the amplitudes are relatively low in comparison with the qualification basis of 0.75g and the displacement velocities are below 0.1 in/sec. No damage is expected for these conditions.

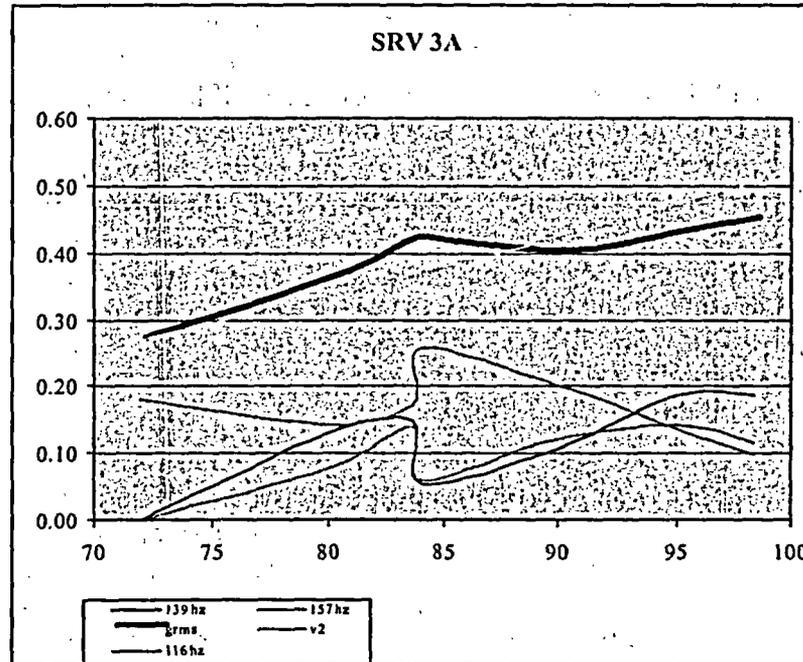
The data indicates that the vibration levels at the Target Rock valve continue to increase with power although the relative strength from different measured frequencies changes. The 116 Hz frequency is unique to the A MSL and is likely the result of harmonic response with the SRV internals.

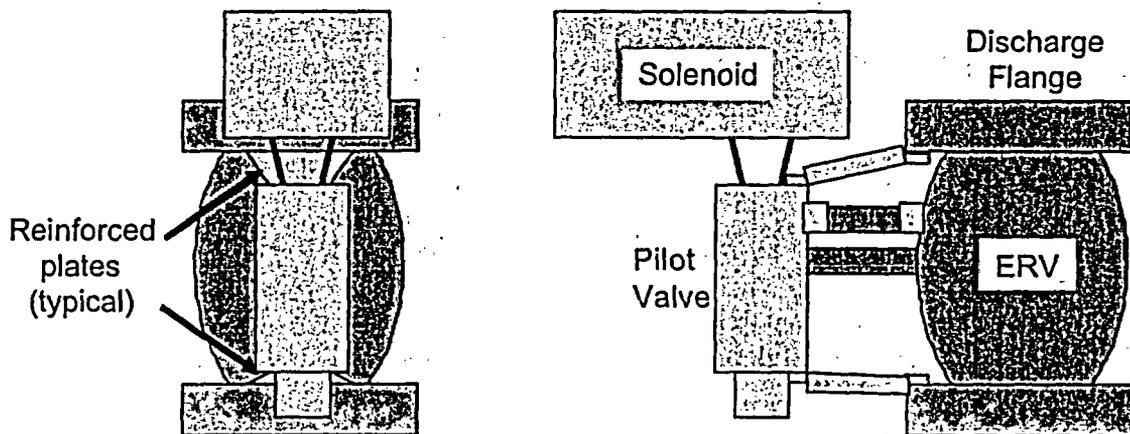
Figure 1. Plates Supporting the Ends of the Pilot Valve

### *ERV Design Modification*

Based on the results of the dynamic analysis, correlation to the test data, and review of the actuator degradation, the long term recommendation is to replace the tie back support with a pilot valve modification (a reinforced plate bolted or welded to both ends of the pilot valve – see Figure 1 or some alternative which results in a significant relative stiffness change). This design modification will not eliminate the cause of the vibration but is considered economically feasible, since eliminating the acoustic vibration would entail significant main steam and branch line changes.

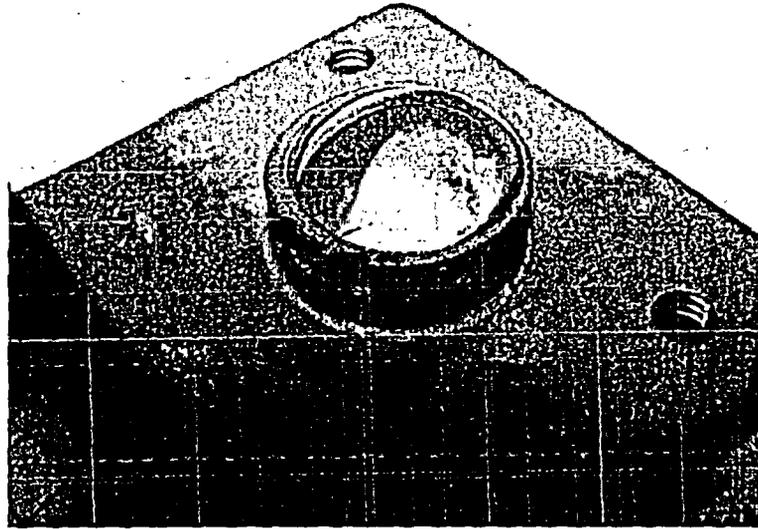
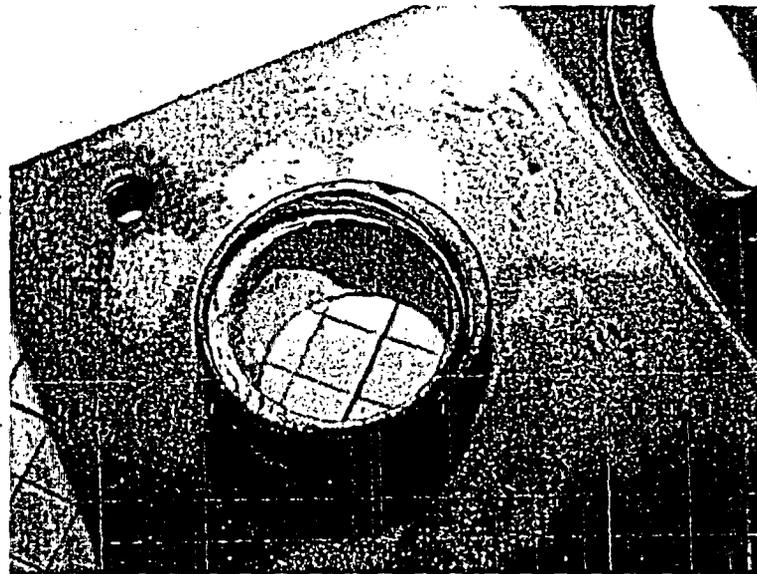
Figure 1: Wyle Labs Test Actuator Aging Test – Bushing Wear

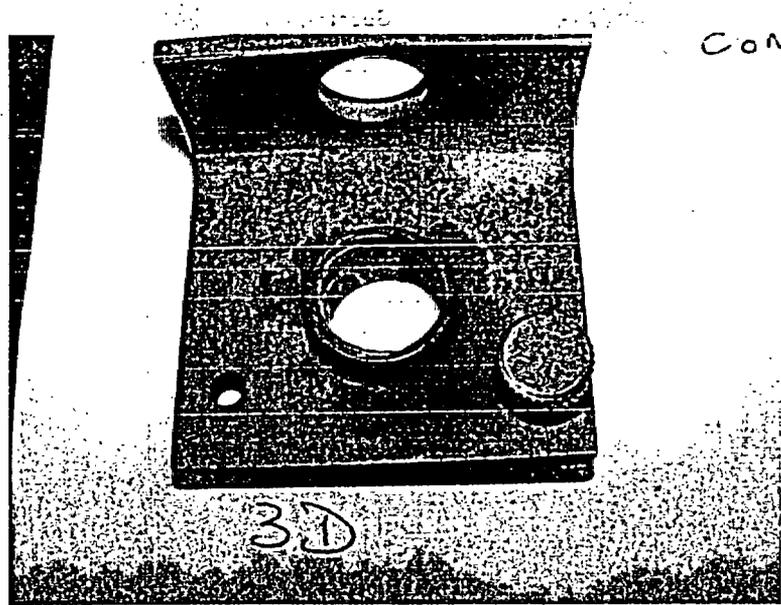
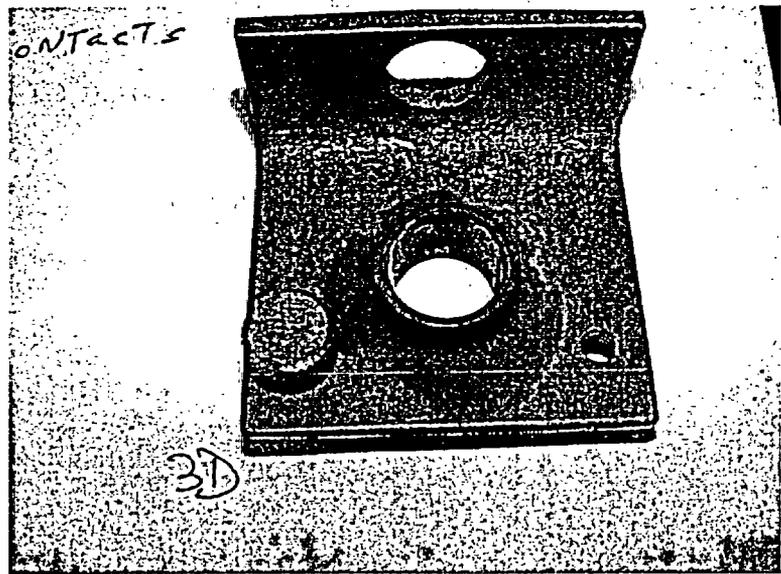
Figure 2: Wyle ERV 3D Actuator after 5 month EPU operation – Bushing Wear

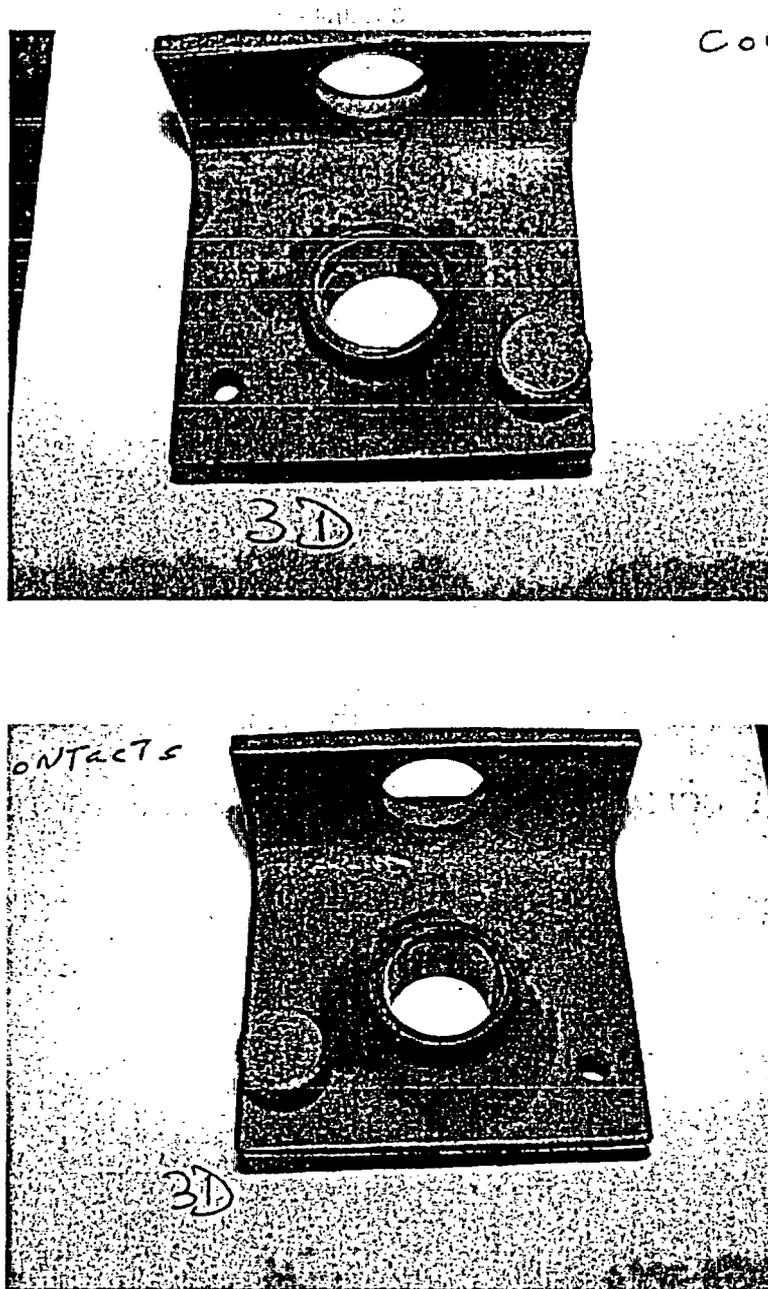
Figure 2: Wyle ERV 3D Actuator after 5 month EPU operation – Bushing Wear

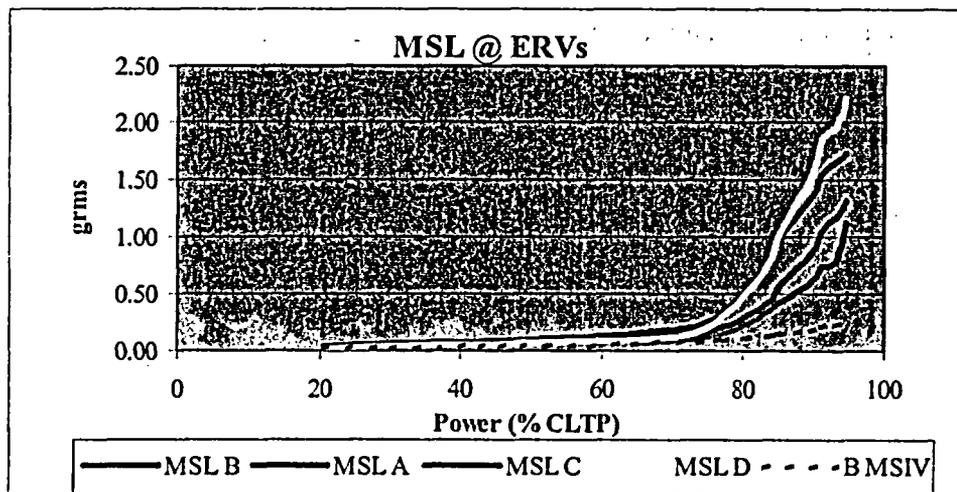
As can be seen the amplitude in the B and D ERVs (B and D MSLs) is somewhat larger than the magnitude of the A and C MSLs. The MSIV vibration (B MSL) is substantially lower than the vibration at the ERV inlet on the same steam line. Due to the similarity of amplitudes and geometry of the piping, the other MSIVs likely will have a similar response and be well within the 0.75g wear aging criterion and displacement velocity will be low.

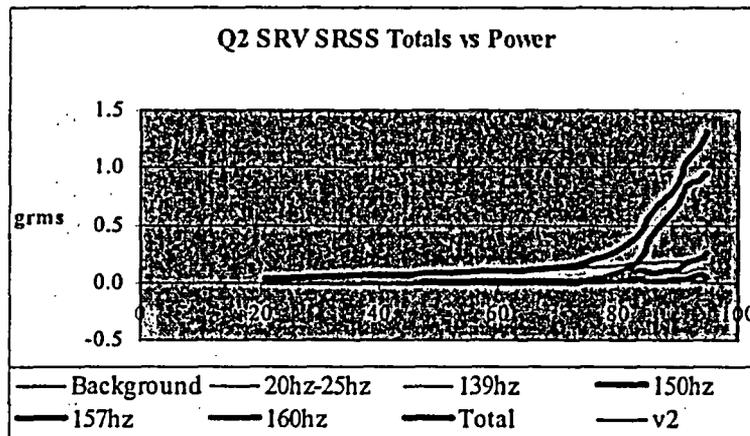
As can be observed, the vibration levels are dominated by the 157 hz peak and increase significantly beyond OLTP power. At 96% CLTP the vibration velocity is about 0.37 in/sec. An increased amplitude in the 160 hz frequency also is evident although not at a significant amplitude at the 96% CLTP operating condition.

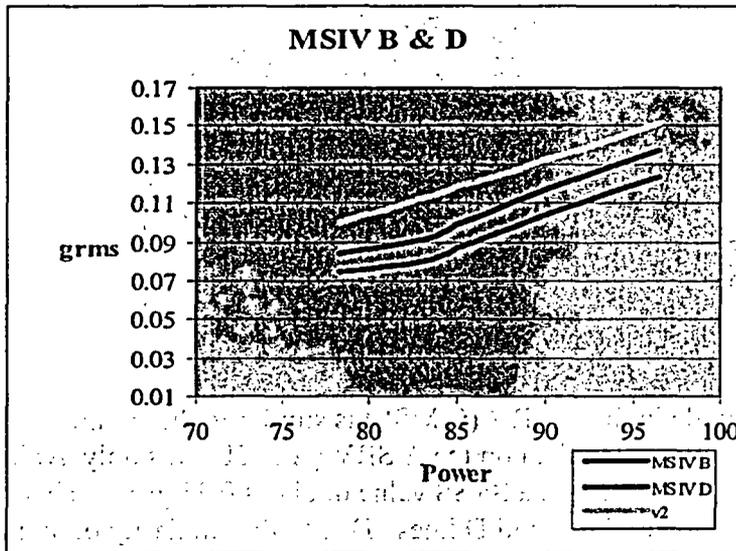
In all cases, the total amplitudes are relatively low in comparison with the qualification basis of 0.75g and the displacement velocities are below 0.1 in/sec. No damage is expected for these conditions.

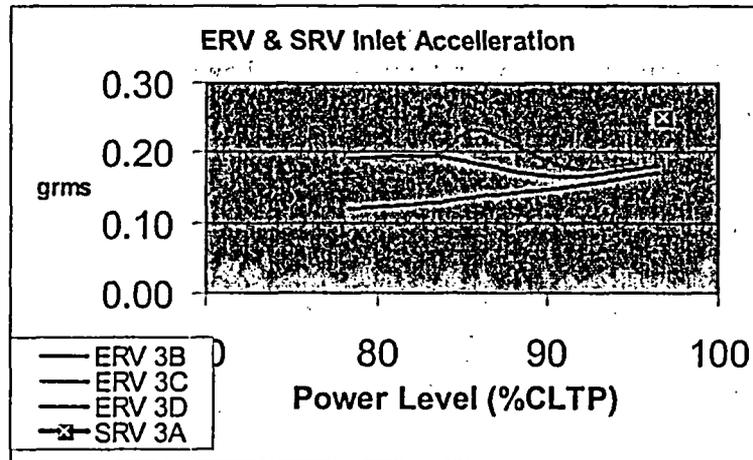
As can be seen the amplitude in the C ERV (C MSL) is similar to the B and D lines especially at EPU power. Vibration data on the A SRV (A MSL) was only available at approximately 96.7% CLTP and shows a SRSS value of about 0.25 grms. Therefore it too shows a similar amplitude to the B and D lines. Due to the similarity of amplitudes

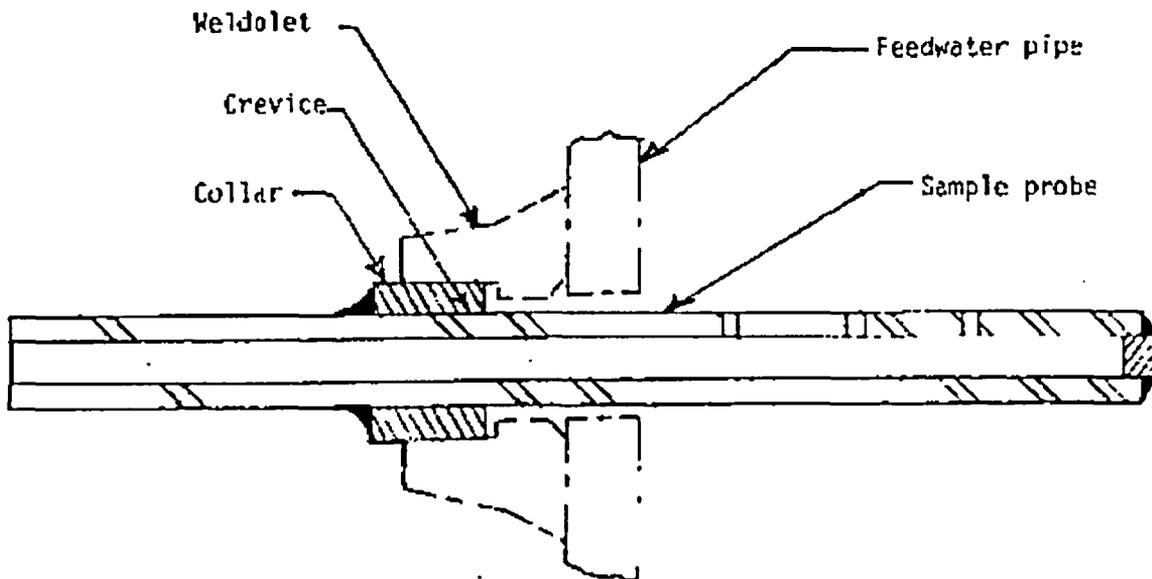
Figure 3: Original Isokinetic Probe Design

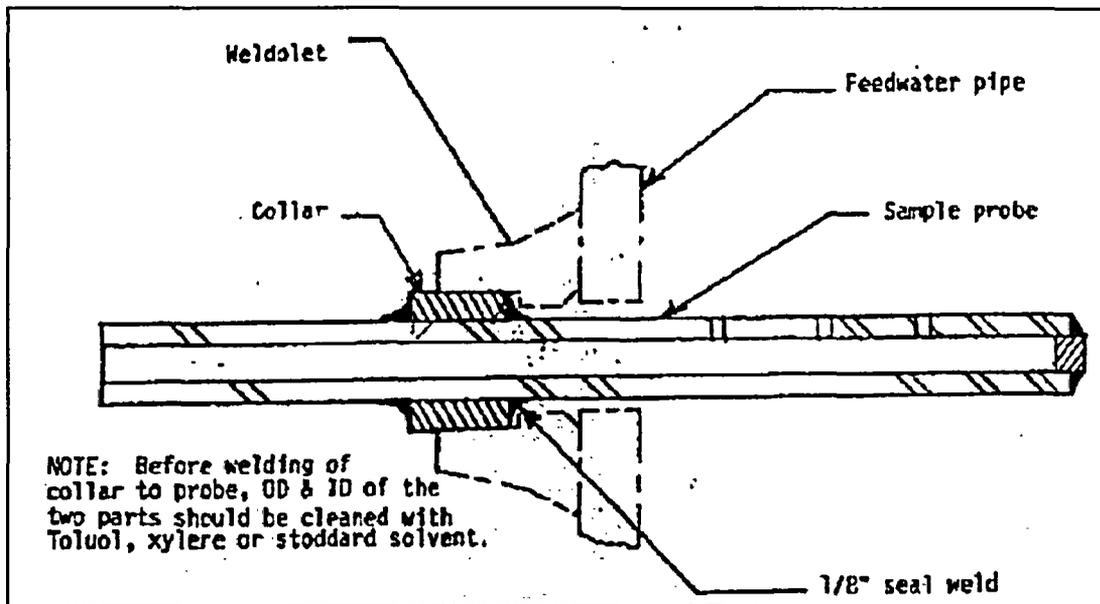
Figure 4: SIL 257 Recommended Probe

In 1977, GE SIL 257 addressed failure of the Condensate and Feedwater probes due to TGSCC. The addition of a seal weld was recommended to prevent TGSCC as outlined in SIL 257 and depicted in Figure 4. Of the six originally installed isokinetic probes, the Feedwater and CDE remain on each Dresden unit. Industry and Dresden experience has shown that in addition to TGSSC, this probe design is susceptible to fatigue failure from flow-induced vibration. Perry Nuclear Power Plant had a study completed which demonstrated that this design is able to fail due to an induced vibration called Karmen Vortex Street, where flow induced eddy vortices on the probe create vibrations. This vibration for this design is close enough in magnitude to the natural frequency to cause failure.
