Three Mile Island Unit No.1

**30TH YEAR REACTOR BUILDING TENDON
SURVEILLANCE (PERIOD 8)**

Topical Report No. 183
(Revision 00)

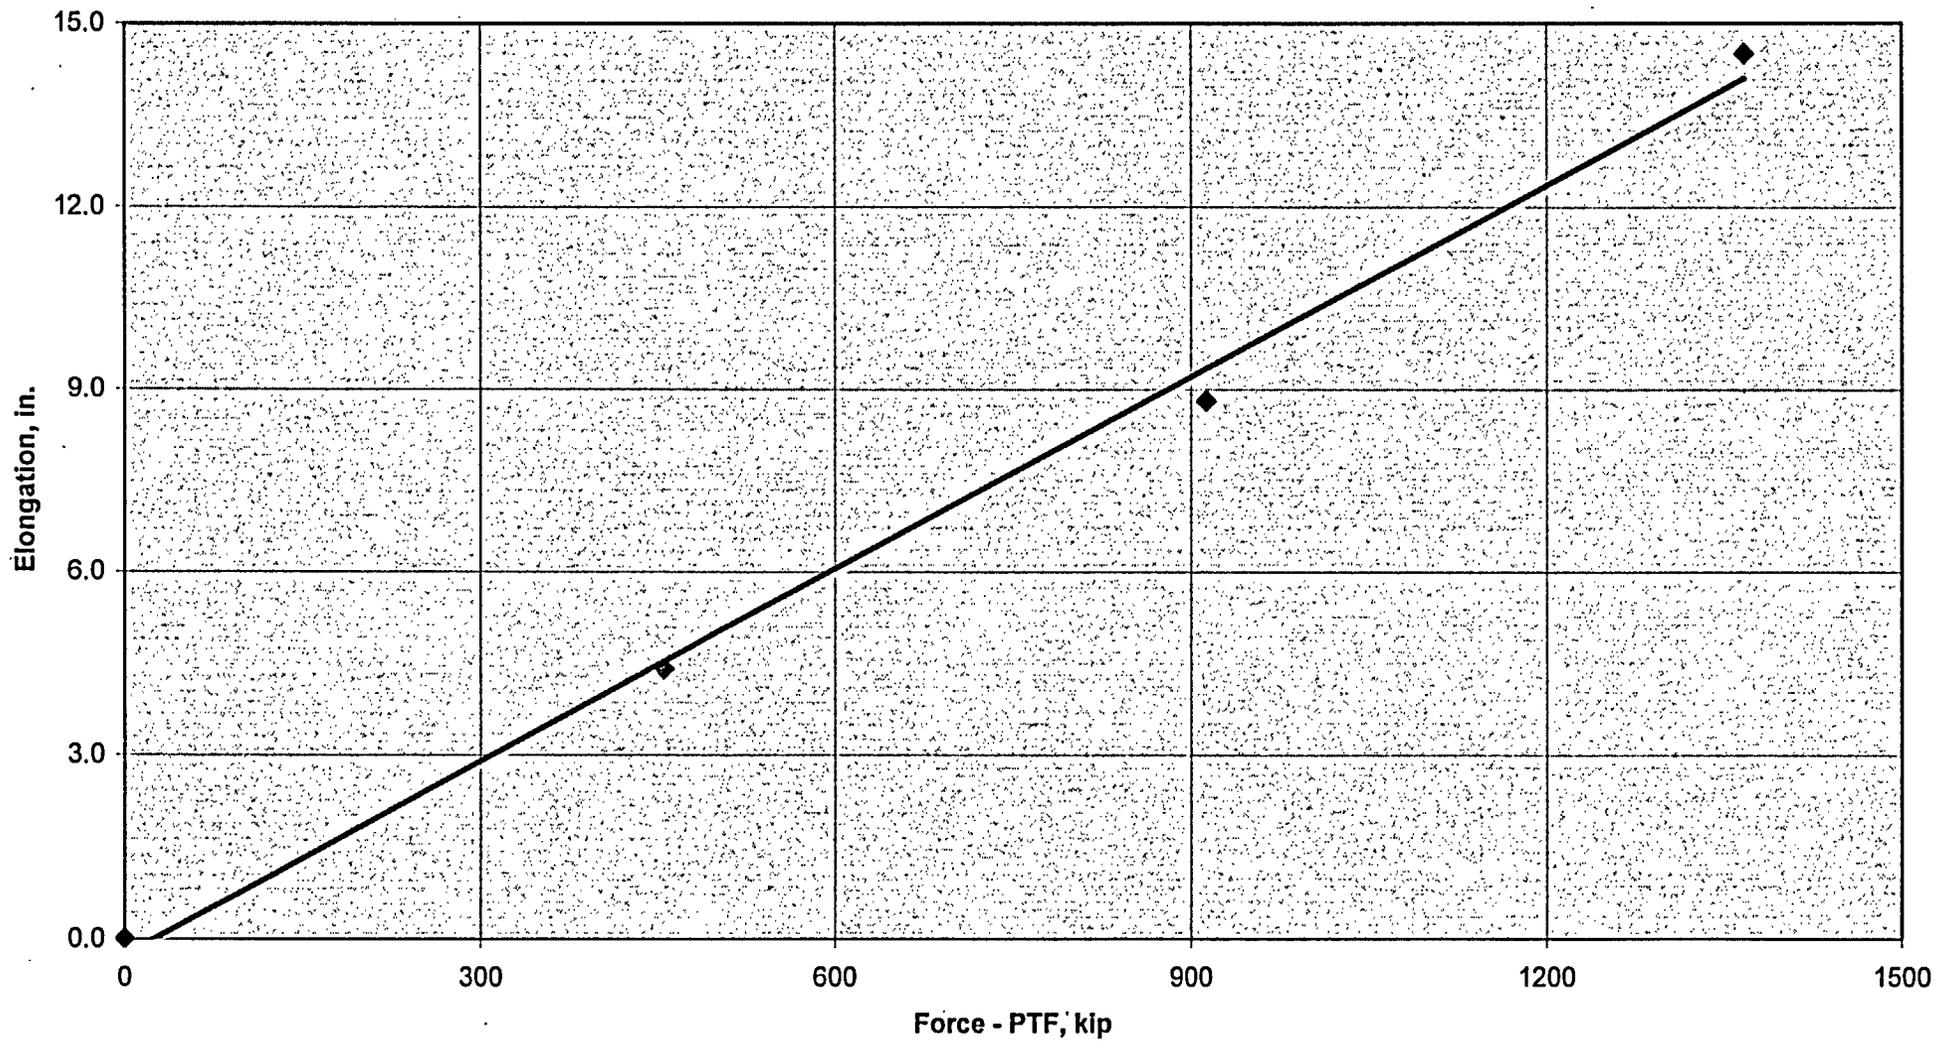
Figure 3-8
V-140 Elongation (Trial 1)

- Elongations measured during re-tensioning of de-tensioned dome and hoop tendons were within 10% of previously measure values. The elongation of V-140 exceeded the 10% limit, a condition attributed to anchor head rotation observed during the re-tensioning process. As a result, tendons V-137 and V-141 (like V-140, these curve around the equipment opening) were added to the surveillance sample, de-tensioned and re-tensioned. Since the elongations of these additional sample tendons met the acceptance criterion, since the V-140 anchor head experienced a large rotation during the initial re-tensioning and since the elongation of V-140 met the acceptance criteria during the second re-tensioning, the excess elongation of V-140 was accepted by evaluation.

All plots except that shown for the first V-140 trial are essentially linear, as expected. The initial three elongations shown for the first V-140 trial (Figure 3-8) are almost identical to those shown for the second trial in Figure 3-9. However, the OSF elongation measured during the first trial is significantly higher than that measured during the subsequent trial. This difference can be explained by the observed anchor head rotation.

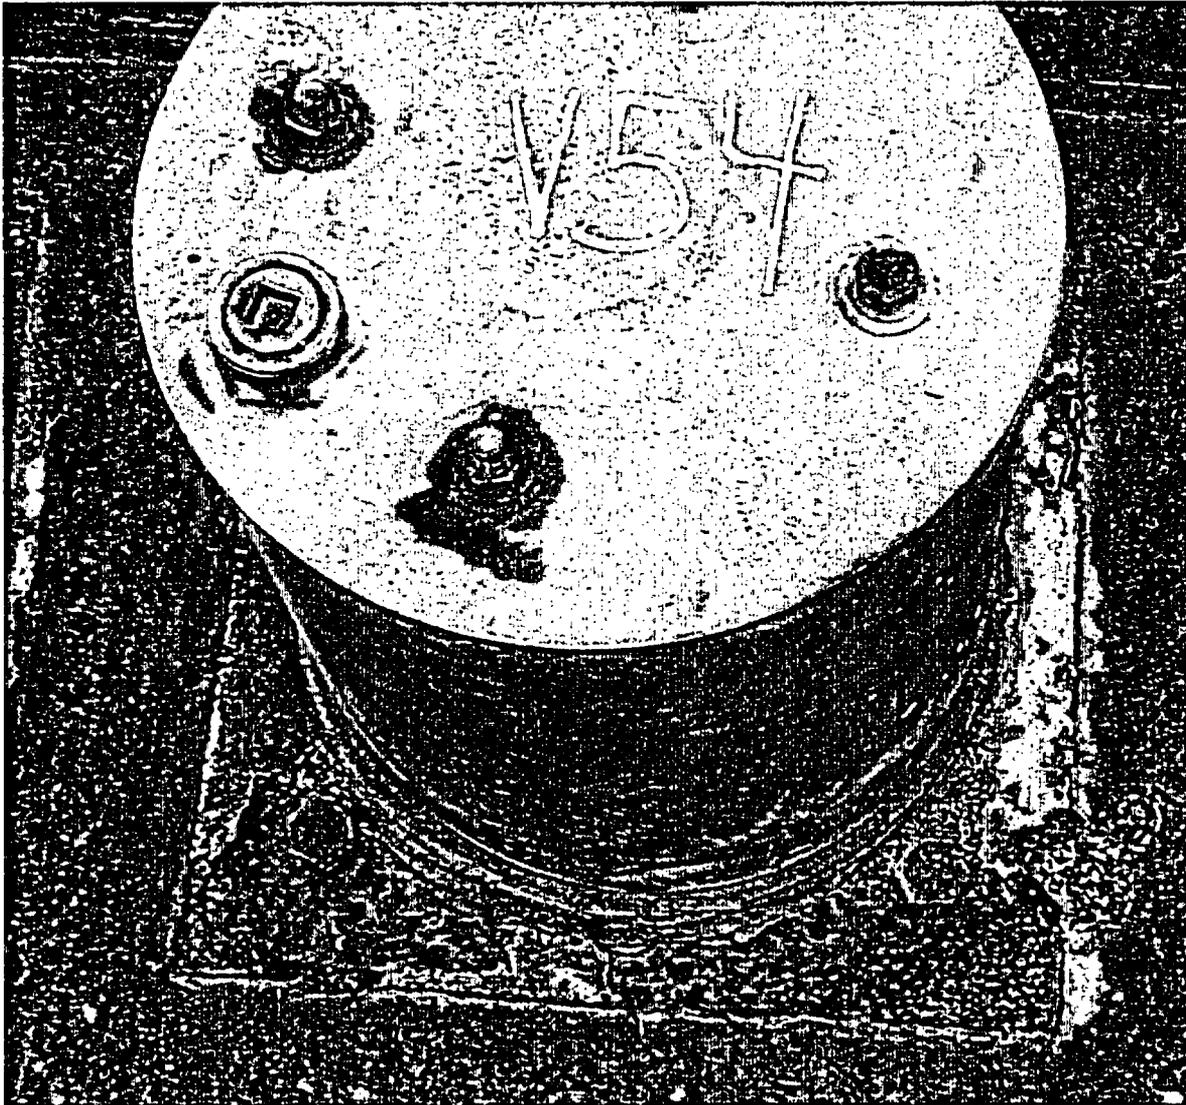
Figure 4-11
Vertical Tendon Upper End Bearing Plate Corrosion

- The coating has detached from significantly large areas on several vertical tendon upper end bearing plates. Some of these areas are heavily rusted. All areas with detached coating will be cleaned to bright metal, primed and painted to prevent further corrosion.
