**TENNESSEE VALLEY AUTHORITY - BROWNS FERRY NUCLEAR PLANT (BFN) -  
UNIT 2 - DOCKET 50-260 - FACILITY OPERATING LICENSE DPR - 52 -  
LICENSEE EVENT REPORT (LER) 50-260/2005-001-00**

<b>1. FACILITY NAME</b> Browns Ferry Unit 2	<b>2. DOCKET NUMBER</b> 05000260	<b>3. PAGE</b> 1 OF 6
--	-------------------------------------	--------------------------

**4. TITLE**  
Loss of High Pressure Coolant Injection (HPCI) Discharge Piping Keep-Fill

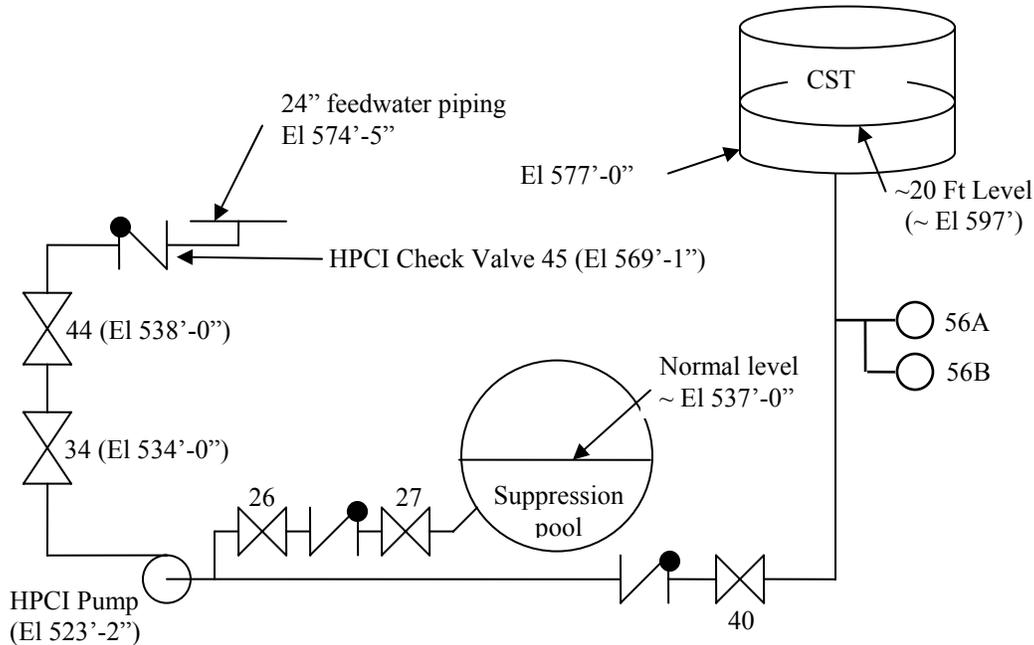
See the simplified sketch of the HPCI system below. To make the sketch and the following discussion more readable, the device function abbreviations and the unit/system code have been omitted.

The system alignment for stand-by readiness has the pump suction aligned to the CST via normally open valve 40. Series suppression pool suction isolation valves 26 and 27 are normally closed. Inboard discharge isolation valve 44 is normally closed, while the outboard discharge isolation valve 34 is normally open. The discharge piping elevation at the point of connection with the feedwater system piping is approximately 574 feet (above sea level), while the normal water level in the CST is at an approximate elevation of 597 feet. This net elevation difference, along with the atmospheric pressure above the CST tank water inventory, is adequate to keep the HPCI discharge piping full during stand-by conditions. Level switches 56A and 56B monitor the suction piping water inventory, and the switches operate in a one-out-of-two logic to initiate suction source transfer if low water level is sensed. When this logic actuates, suppression pool valves 26 and 27 will automatically open. Valve 40 will automatically close when both 26 and 27 are fully open.

In the subject event, the inboard isolation valve 44 had been placed in the open position with its power removed in support of maintenance activities which affected the power source. With both the 34 and 44 valves open, the discharge piping up to elevation 569 was in direct communication with the rest of the system. While the system was so aligned, level switch 56A spuriously operated due to degraded insulation on the wiring connections to the switch. The associated system logic initiated a HPCI suction transfer from the CST to the suppression pool. All valves operated per the plant design during this transfer. Given the elevation difference between the upper portions of the HPCI system discharge piping and the suppression pool water level, and the warmer temperature of the water in the HPCI piping physically near the operating main feedwater line, some voiding likely occurred in the upper elevations of the HPCI discharge piping.

The maintenance alignment in existence at the time of this event was key. If the HPCI inboard discharge valve had been closed in the normal stand-by readiness alignment, the water column on the discharge side of the pump which would have required supporting by the suppression pool level and its overpressure would have been approximately 30 feet shorter. No system voiding will occur if a suction transfer takes place with HPCI in the normal stand-by alignment.
