Point Beach Nuclear Plant, Unit 1
Docket 50-266
License No. DPR-24

Supplement to Spring 2004 Unit 1 (U1R28) Steam Generator Examination Report

**ENCLOSURE
SUPPLEMENT TO SPRING 2004 UNIT 1 (U1R28) STEAM GENERATOR
EXAMINATION REPORT**

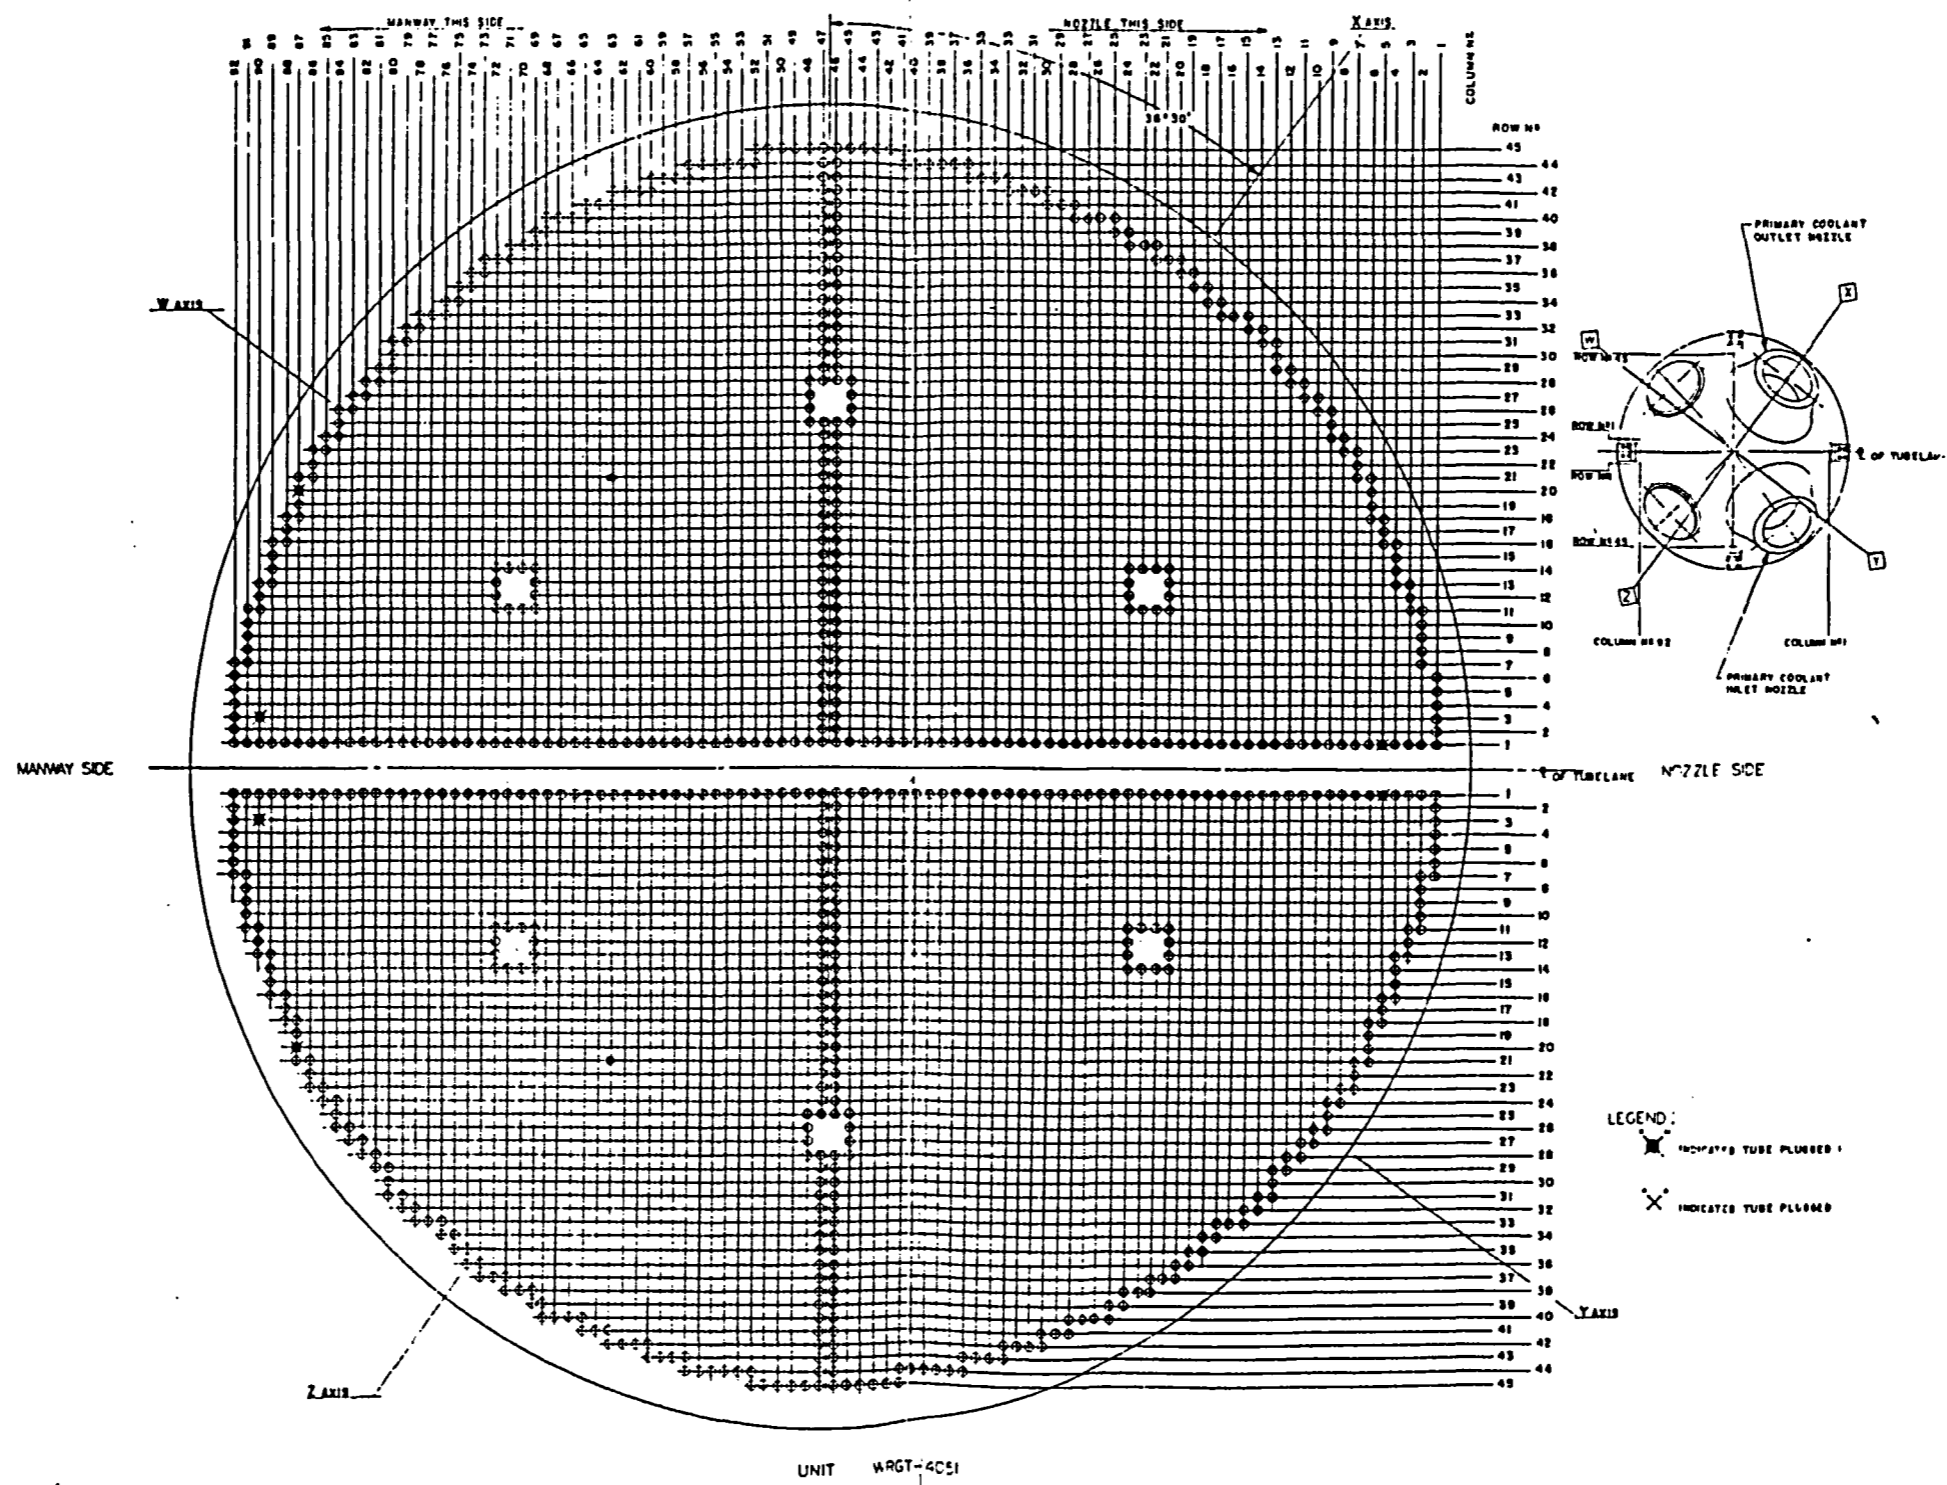
FIGURE 5-10A — Tube Hole Layout - Unit A
Point Beach No. 1 - WRGT 4051

Anti-Vibration Bar Wear in Steam Generator A			
Row	Column	Location	Percentage Lost
32	14	Anti-Vibration Bar 3	5
33	18	Anti-Vibration Bar 3	25
33	18	Anti-Vibration Bar 4	16
35	18	Anti-Vibration Bar 2	10
38	22	Anti-Vibration Bar 3	12
40	25	Anti-Vibration Bar 2	6
40	27	Anti-Vibration Bar 3	5
34	33	Anti-Vibration Bar 1	10
34	33	Anti-Vibration Bar 2	7
33	37	Anti-Vibration Bar 4	9
45	41	Anti-Vibration Bar 1	6
45	41	Anti-Vibration Bar 4	7
40	42	Anti-Vibration Bar 1	12
38	43	Anti-Vibration Bar 1	23
38	43	Anti-Vibration Bar 2	23
45	43	Anti-Vibration Bar 1	13
45	43	Anti-Vibration Bar 4	8
40	44	Anti-Vibration Bar 3	13
40	47	Anti-Vibration Bar 3	10
33	48	Anti-Vibration Bar 3	13
45	49	Anti-Vibration Bar 1	19
19	54	Anti-Vibration Bar 2	12
19	54	Anti-Vibration Bar 4	12
38	54	Anti-Vibration Bar 3	25
35	56	Anti-Vibration Bar 1	14
35	56	Anti-Vibration Bar 2	27
19	61	Anti-Vibration Bar 1	12
19	61	Anti-Vibration Bar 2	15
19	61	Anti-Vibration Bar 4	6

31	63	Anti-Vibration Bar 2	20
31	63	Anti-Vibration Bar 3	10
34	65	Anti-Vibration Bar 3	9
34	65	Anti-Vibration Bar 4	15

Anti-Vibration Bar Wear in Steam Generator A			
Row	Column	Location	Percentage Lost
33	66	Anti-Vibration Bar 1	20
33	66	Anti-Vibration Bar 2	13
33	66	Anti-Vibration Bar 3	5
39	68	Anti-Vibration Bar 4	9
34	69	Anti-Vibration Bar 1	3
34	69	Anti-Vibration Bar 2	11
27	71	Anti-Vibration Bar 2	6
27	71	Anti-Vibration Bar 3	10
27	71	Anti-Vibration Bar 4	5
32	71	Anti-Vibration Bar 2	11
33	71	Anti-Vibration Bar 2	13
33	71	Anti-Vibration Bar 3	6

Mechanical Wear Above the Top of Tube Sheet Hot Leg in Steam Generator A				
Row	Column	Percent	Location	Inches above tubesheet
37	20	4	Tubesheet Hot Leg	+0.63
37	20	1	Tubesheet Hot Leg	+0.74
42	30	5	Tubesheet Hot Leg	+0.59
43	33	5	Tubesheet Hot Leg	+0.64
44	36	6	Tubesheet Hot Leg	+0.67
45	41	4	Tubesheet Hot Leg	+0.73
45	42	3	Tubesheet Hot Leg	+0.7
45	43	1	Tubesheet Hot Leg	+0.65
45	44	4	Tubesheet Hot Leg	+0.62
45	45	10	Tubesheet Hot Leg	+0.65
45	46	7	Tubesheet Hot Leg	+0.62
45	47	5	Tubesheet Hot Leg	+0.66
43	60	7	Tubesheet Hot Leg	+0.61
42	63	1	Tubesheet Hot Leg	+1.42
42	63	1	Tubesheet Hot Leg	+2.49
42	63	11	Tubesheet Hot Leg	+0.61
31	80	3	Tubesheet Hot Leg	+0.66

17 indications in 14 tubes

Wear Indications At Cold Leg Supports in Steam Generator A				
Row	Column	Percent	Location	Inches above support
39	24	12	Support 3 Cold Leg	+0.49
41	65	18	Support 2 Cold Leg	+0.53
21	85	10	Support 2 Cold Leg	+0.49

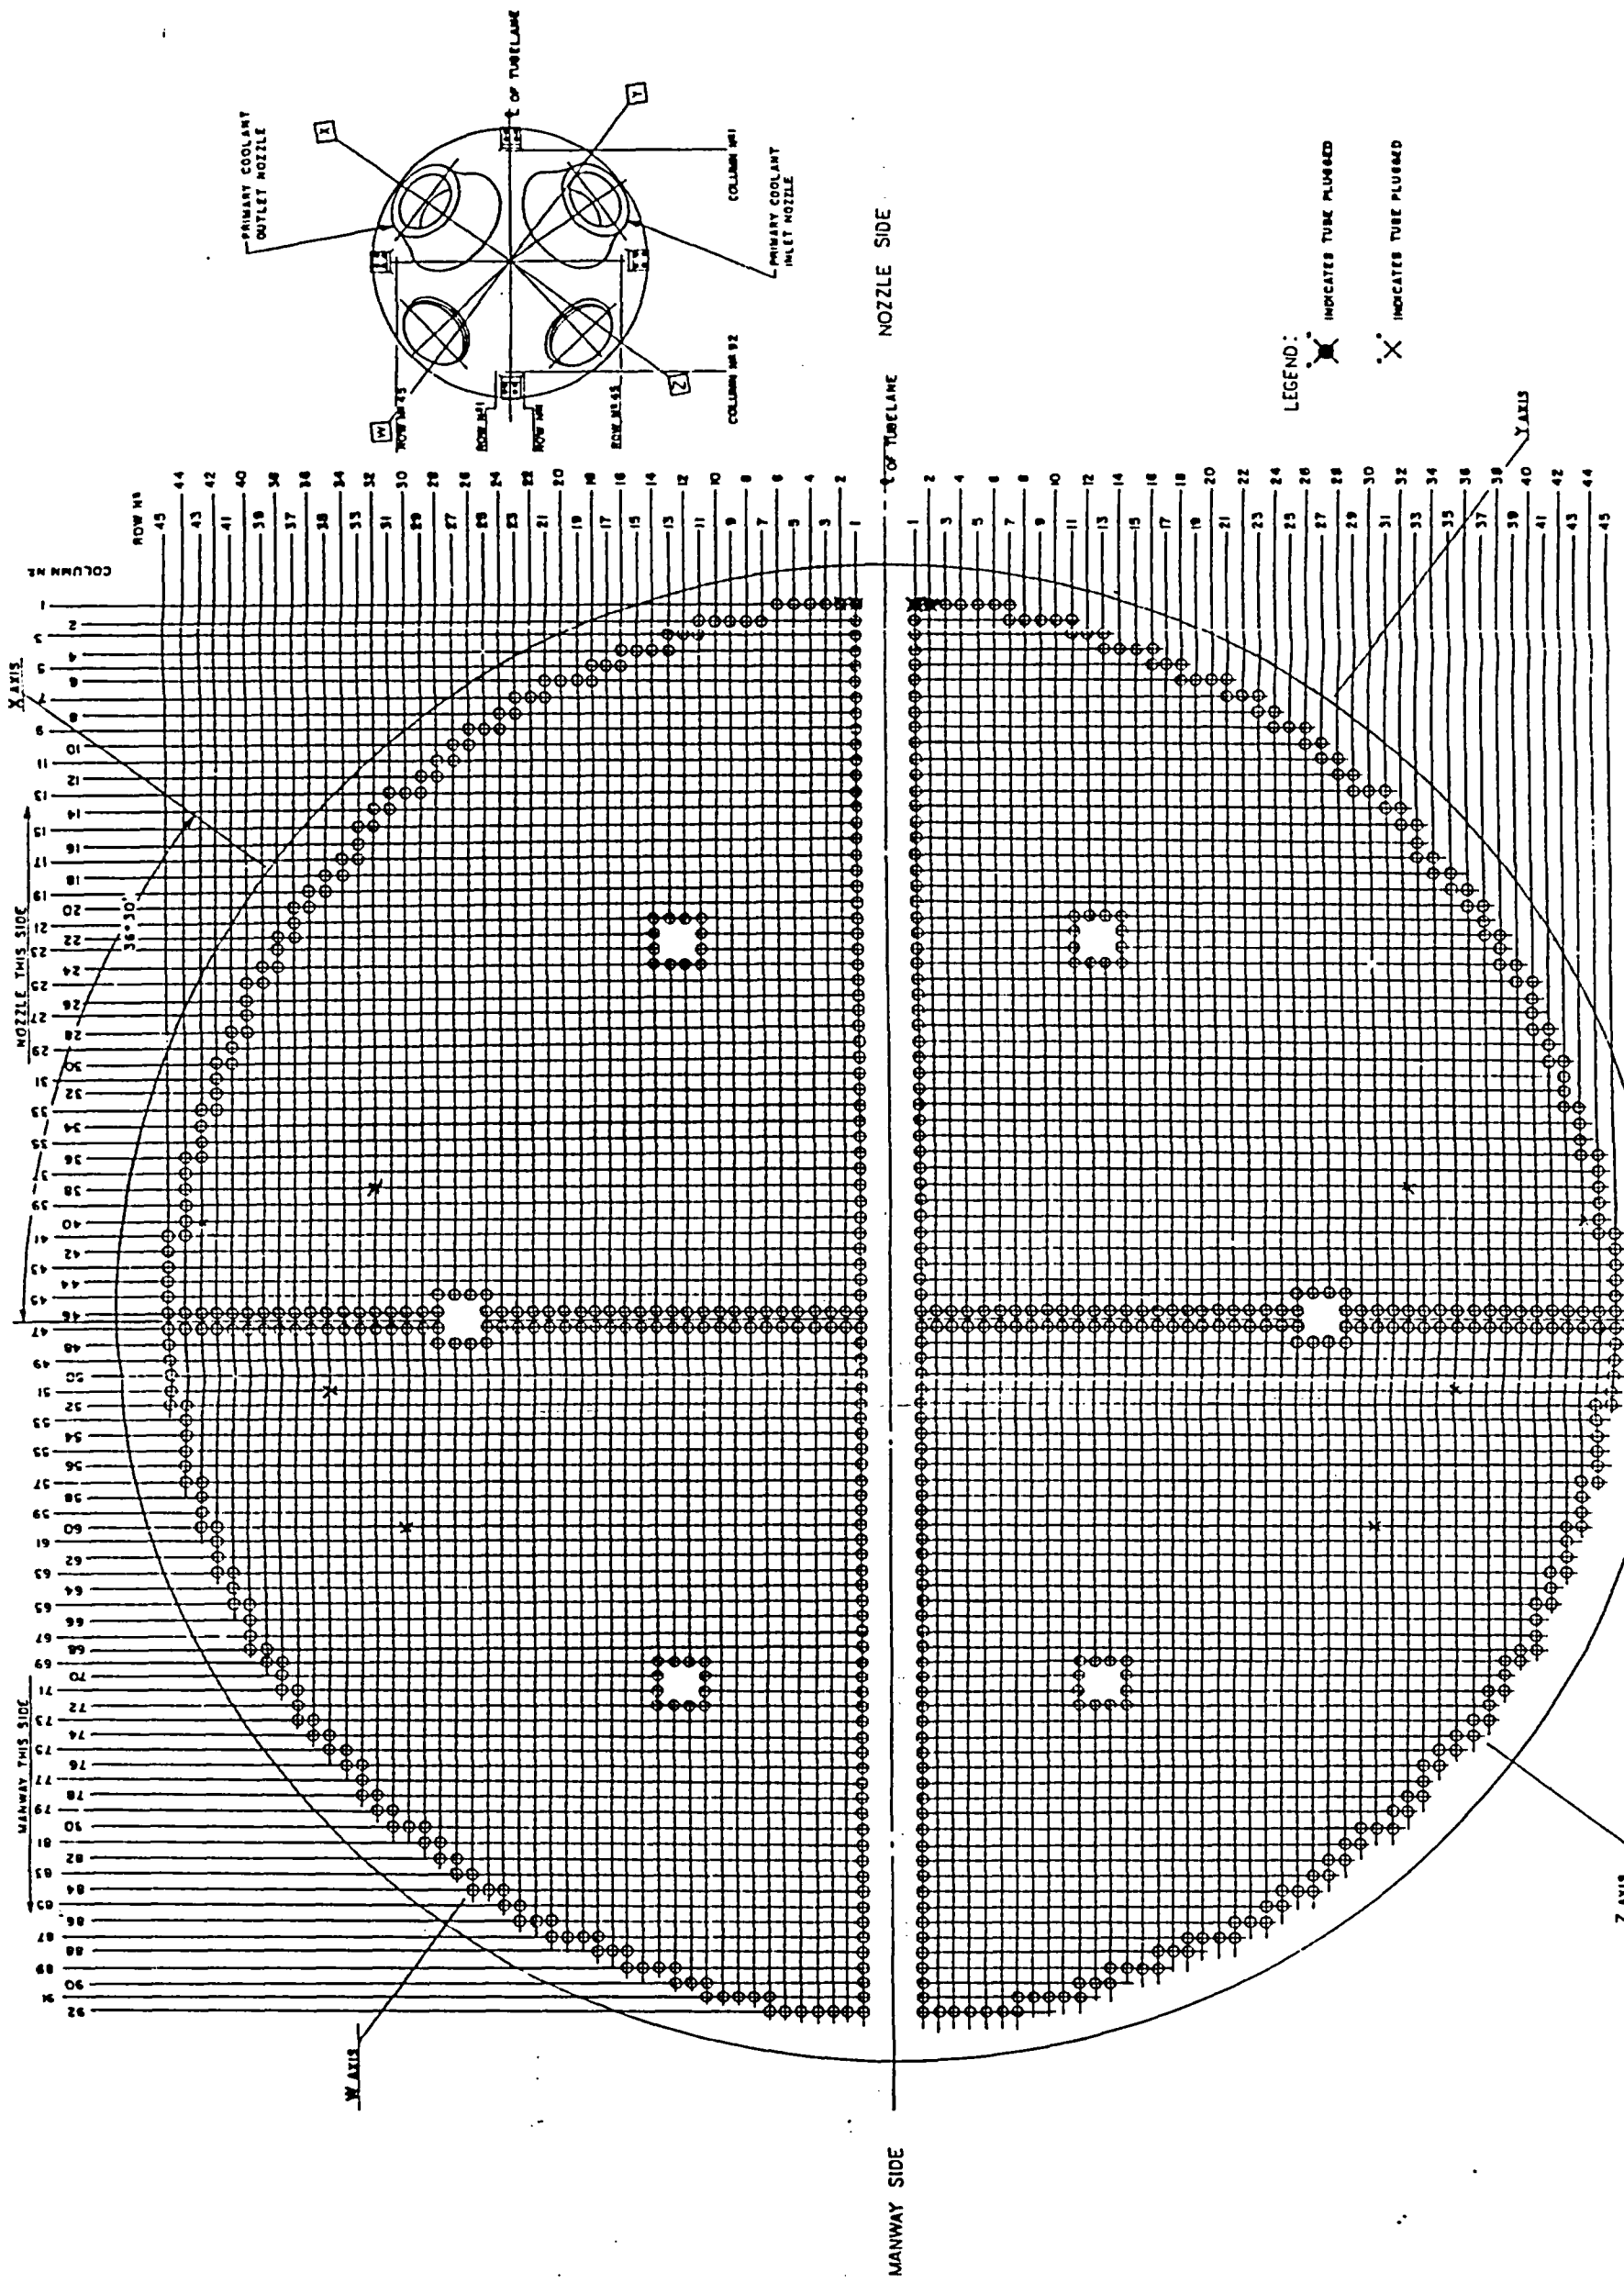
FIGURE S-103 - Tube Hole Layout - Unit B Point Beach No. 1, WRGT 4052

Anti-Vibration Bar Wear in Steam Generator B			
Row	Column	Location	Percentage Lost
32	32	Anti-Vibration Bar 3	13
23	33	Anti-Vibration Bar 1	11
23	33	Anti-Vibration Bar 2	15
23	33	Anti-Vibration Bar 3	25
19	36	Anti-Vibration Bar 3	9
32	44	Anti-Vibration Bar 3	8
45	44	Anti-Vibration Bar 1	14
32	46	Anti-Vibration Bar 2	15
32	46	Anti-Vibration Bar 3	18
45	46	Anti-Vibration Bar 1	13
32	49	Anti-Vibration Bar 1	18
32	49	Anti-Vibration Bar 2	15
44	54	Anti-Vibration Bar 1	8
22	58	Anti-Vibration Bar 1	9
22	58	Anti-Vibration Bar 2	21
22	58	Anti-Vibration Bar 3	19
22	58	Anti-Vibration Bar 4	14
32	70	Anti-Vibration Bar 1	11
32	70	Anti-Vibration Bar 2	17
33	71	Anti-Vibration Bar 1	19
33	71	Anti-Vibration Bar 2	10

Mechanical Wear Above the Top of Tube Sheet Hot Leg in Steam Generator B				
Row	Column	Percent	Location	Inches above tubesheet
1	92	9	Tubesheet Hot Leg	+6.16

1 indication in 1 tube

Possible Loose Part (PLP) Investigated in Steam Generator B – No wear				
Row	Column	Location	Inches above tubesheet	
42	49	Tubesheet Hot Leg	+0.3	
43	49	Tubesheet Hot Leg	+0.27	
43	51	Tubesheet Hot Leg	+0.84	
43	52	Tubesheet Hot Leg	+0.32	
44	52	Tubesheet Hot Leg	+0.13	
44	53	Tubesheet Hot Leg	+0.12

A visual inspection of SG B did not identify any loose parts in this region. No loose parts had been indicated in SG A.
