From: "Kemp, Brian" <Brian.Kemp@nmcco.com>
To: <hkc@nrc.gov> - H-Chernoff, MLL
Date: Tue, May 11, 2004 1:07 PM
Subject: May 11 rev2.ppt

Point Beach Nuclear Plant Unit 1 – Spring
2004 RPV Head Inspection Results

Conference Call
Tuesday May 11, 2004

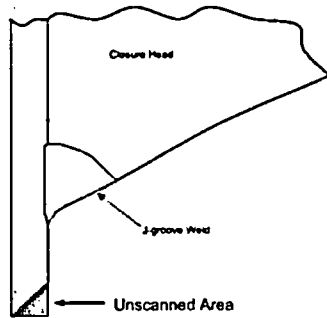
UT Limitations – Tube Bottom at OD

- Due to design of blade type UT probes, a small area on the bottom OD of tubes is unexamined
- Generic issue with the Areva blade tool

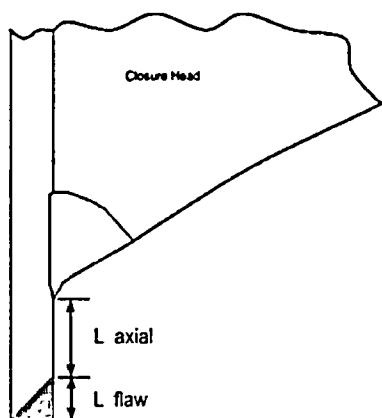
UT Limitations – Tube Bottom at OD

- Flaw assumed in the unexamined area (L flaw) and grows axially through the scanned area L axial (minimum is 0.41")

- Using conservative PBNP crack growth rate data (2×10^{-5} in/yr) derived from MRP-55, this worst-case flaw will take over 2.3 years to reach the J-groove weld
- Relaxation to Order EA-03-09 will be requested

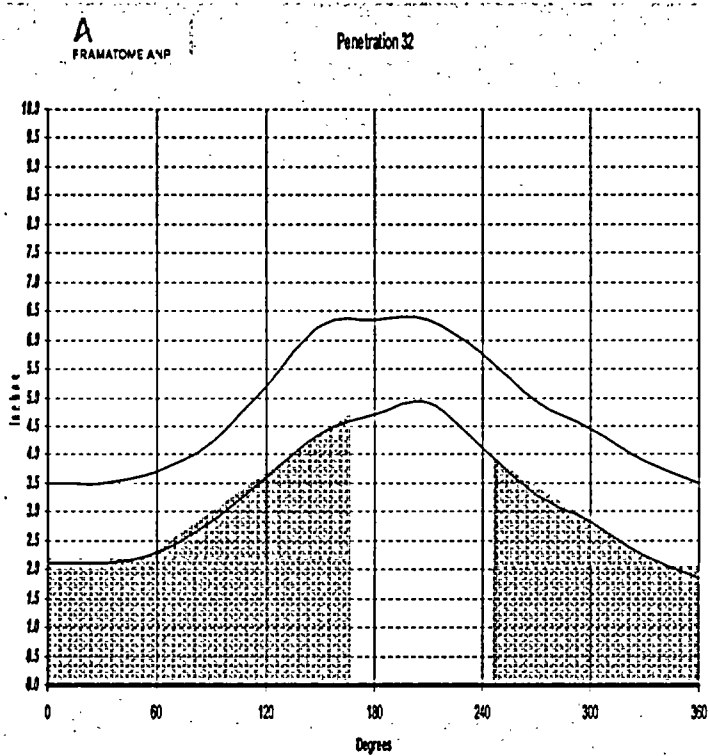
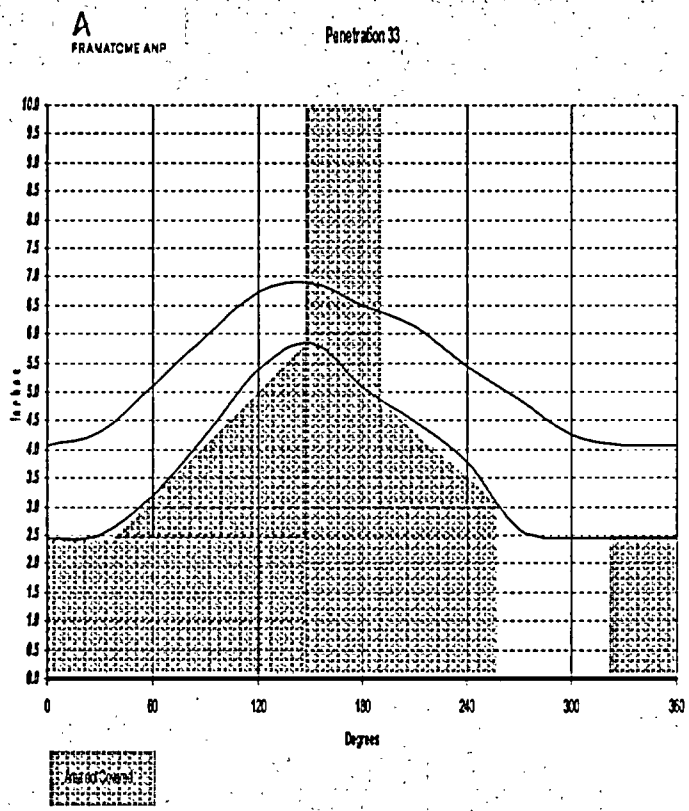
UT Limitations – Nozzles 32 & 33

- 2004 Results (w/o sleeve removal)
 - Nozzle 32
 - 360° of coverage above and in the weld zone
 - 99° coverage below the weld
 - Nozzle 33
 - 300° of coverage above and in the weld area
 - 57° coverage below the weld
- Ability to remove and reattach thermal sleeve to support additional inspections is difficult

- Circumferential flaw above the Nozzle 33 J-groove weld assessed
 - Initial flaw size of 60° (i.e., 300° of UT coverage)
 - Using WCAP-14000 and MRP-55 crack growth rate data, it would take an undetected flaw 30 years to grow to a allowable length (300°)

- The SIA analysis assumed only 80% coverage during U1R28 (actual ~ 95%)
 - The SIA analysis assumed only 50% coverage in outer ring nozzles 26 - 33
- The results indicate an insignificant difference in the probability of leakage compared to that of full coverage
 - Differences do not warrant additional man-Rem required for thermal sleeve removal

- Thermal sleeve removal is very difficult for these nozzles due to the removal and welding process performed in 2002
- Relaxation from EA-03-09 will be sought for the limitation in coverage
 - Structural Integrity Associates (SIA - Riccardella) analysis supports minor limitations in coverage
 - This work was presented to NRR in February 2004 in preparation for the outage

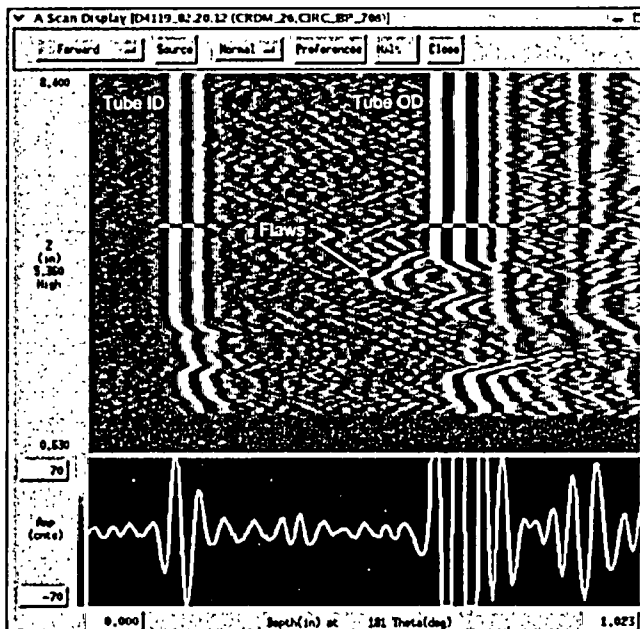
Nozzle 26 Indications

- Large UT signal detected at the weld root (downhill location - 180°)
- Signal attributed to a fabrication weld repair performed during construction

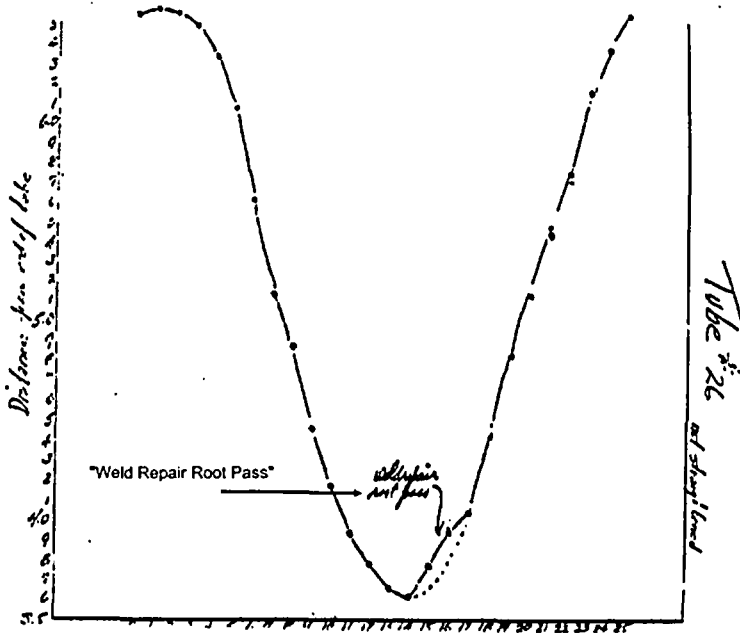
Nozzle 26 Indications (Cont.)

- weld repair performed at this location
- 1969 inspection report

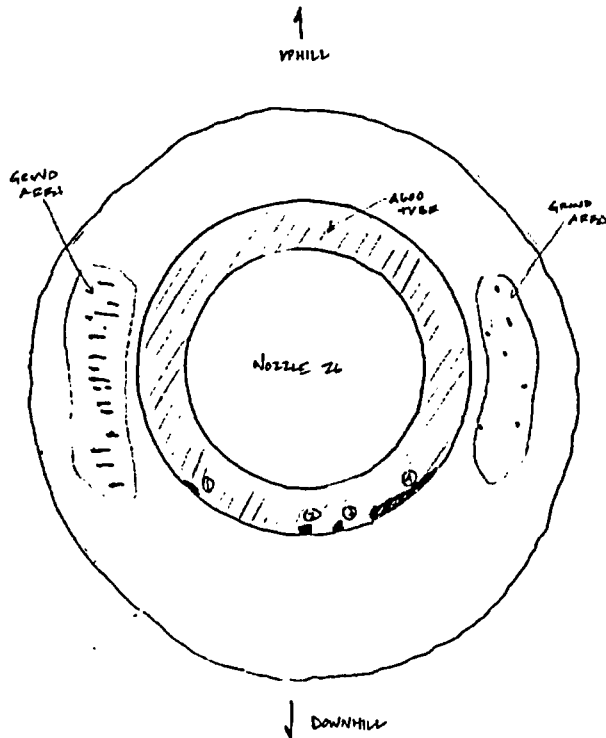
Nozzle 26 Indications (Cont.)

- PT and UT signals superimposed
- Correlation between UT and PT signals
- Additional repair stresses

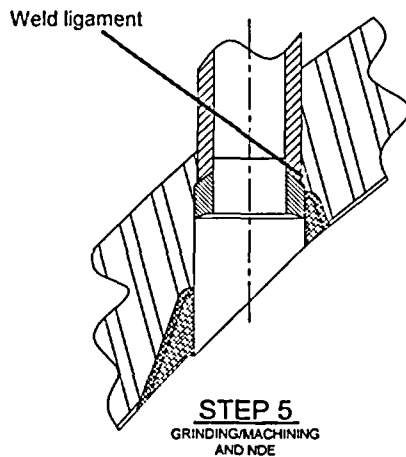
Nozzle 26 Weld Overlap Condition

- With small diameter (132") heads, the repair A52 weld will come into contact with the existing A182 J-groove weld
- Unique design challenge for the Westinghouse 2-loop plants

- Crack growth rates (CGRs) in the Alloy 52 material are very low
- The analysis therefore conservatively assumed Alloy 600 CGRs (MRP-55)
- Analysis demonstrated that a worst-case flaw in the A82/182 would take in excess of 1.5 EFPY to go through the remaining Alloy 52 weld (0.26" weld ligament assumed)
- Separation via grinding was considered but determined to not be appropriate due to very high dose

- Actual weld ligament will be ~ 0.44 inches & the worst-case flaw would take over 2 years to pass through the A52 fusion zone
- Revised IDTB relief request will be processed using actual dimensions

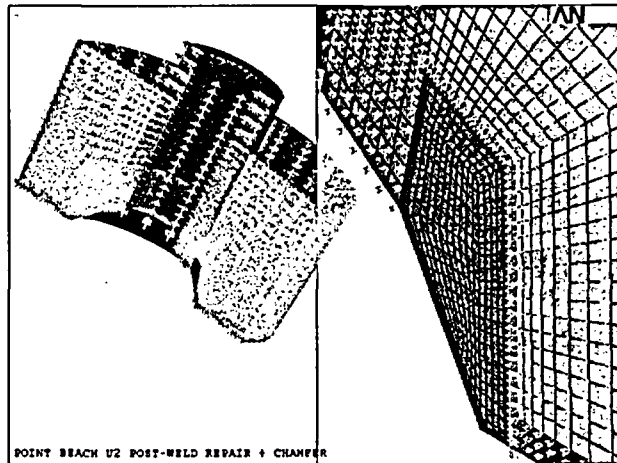
Nozzle 26 Weld Overlap Condition (cont.)

- NMC met with NRR on October 6th 2003 & February 19th 2004 to discuss this issue
