SUBJECT: SAFETY EVALUATION FOR POINT BEACH NUCLEAR PLANT
UNIT 1, SUPPLEMENTAL ADDITION TO RELIEF REQUEST
MR 02-018-2 FOR CRDM REMNANT J-GROOVE WELD
REPAIR OVERLAP (TAC NO. MC3221)

SAFETY EVALUATION BY THE OFFICE OF NUCLEAR REACTOR REGULATION
SUPPLEMENTAL REPAIR SUBMITTAL
RELIEF REQUEST MR 02-018-2
POINT BEACH NUCLEAR STATION UNIT 1
NUCLEAR MANAGEMENT COMPANY
DOCKET NUMBER 50-266

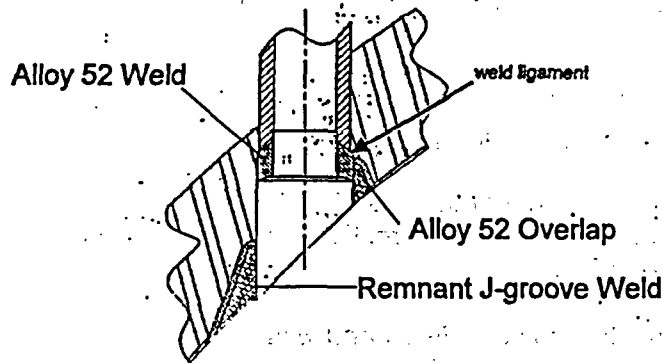
The Alloy 52 repair weld overlap on the Alloy 82/182 remnant J-groove weld condition noted by the licensee occurs due to the high radius of curvature for a Westinghouse two-loop design of the RVCH. Figure 1 below shows the condition which occurs on the uphill side of outer ring RVCH nozzles:

The licensee postulated that the remnant J-groove weld was completely cracked and that a 0.50" ligament of sound metal remained at the Alloy 52 weld overlap. The staff noted that the licensee had applied the Alloy 600 crack growth (MRP-55) rate to determine the amount of time before a postulated flaw in the remnant J-groove weld would grow through the ligament. The staff's conclusion is that using the MRP-55 model for this specific weld overlap configuration is not conservative, and that a more representative model will be gained by using an Alloy 82/182 crack growth rate.

The staff notes that published data verifies the appropriateness of the licensee's assumption that a 0.100" root defect may exist at the weld triple point of the Alloy 82, Alloy 600 and ferritic material of the RPV head. The results of the analysis indicated that assuming a 0.100" root defect contacts the fully cracked remnant, the time required for the assumed flaw to propagate through the remaining ligament would be 1.39 EFPY of operation. This is nearly the remaining amount of time the licensee will operate before retiring the RVCH from service since the

licensee intends to replace the Point Beach Unit 1 head after 1.5 EFPY of operation. Based on the conservative assumptions in the licensee's revised calculations, the staff concludes that it would take in excess of 1.5 EFPY for a flaw to propagate through the J-groove weld with an overlap condition, and is therefore acceptable.
