Point Beach Nuclear Plant

Industrial Safety Issues and Poor Work Practices During Nozzle Dam Installation

RCE 253

CAP55527

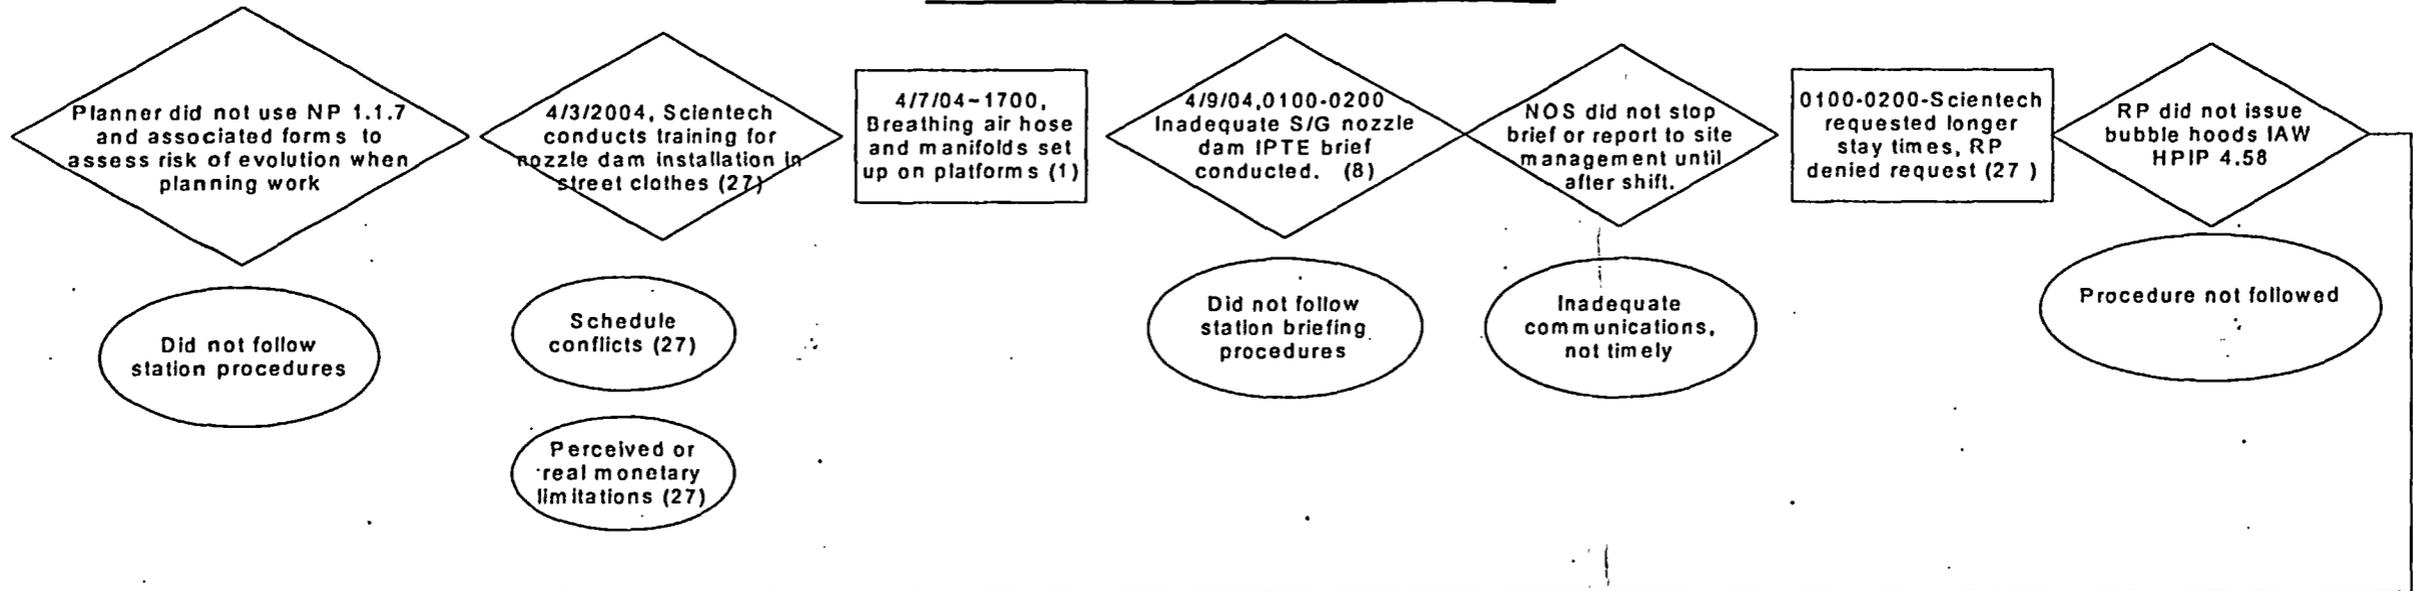
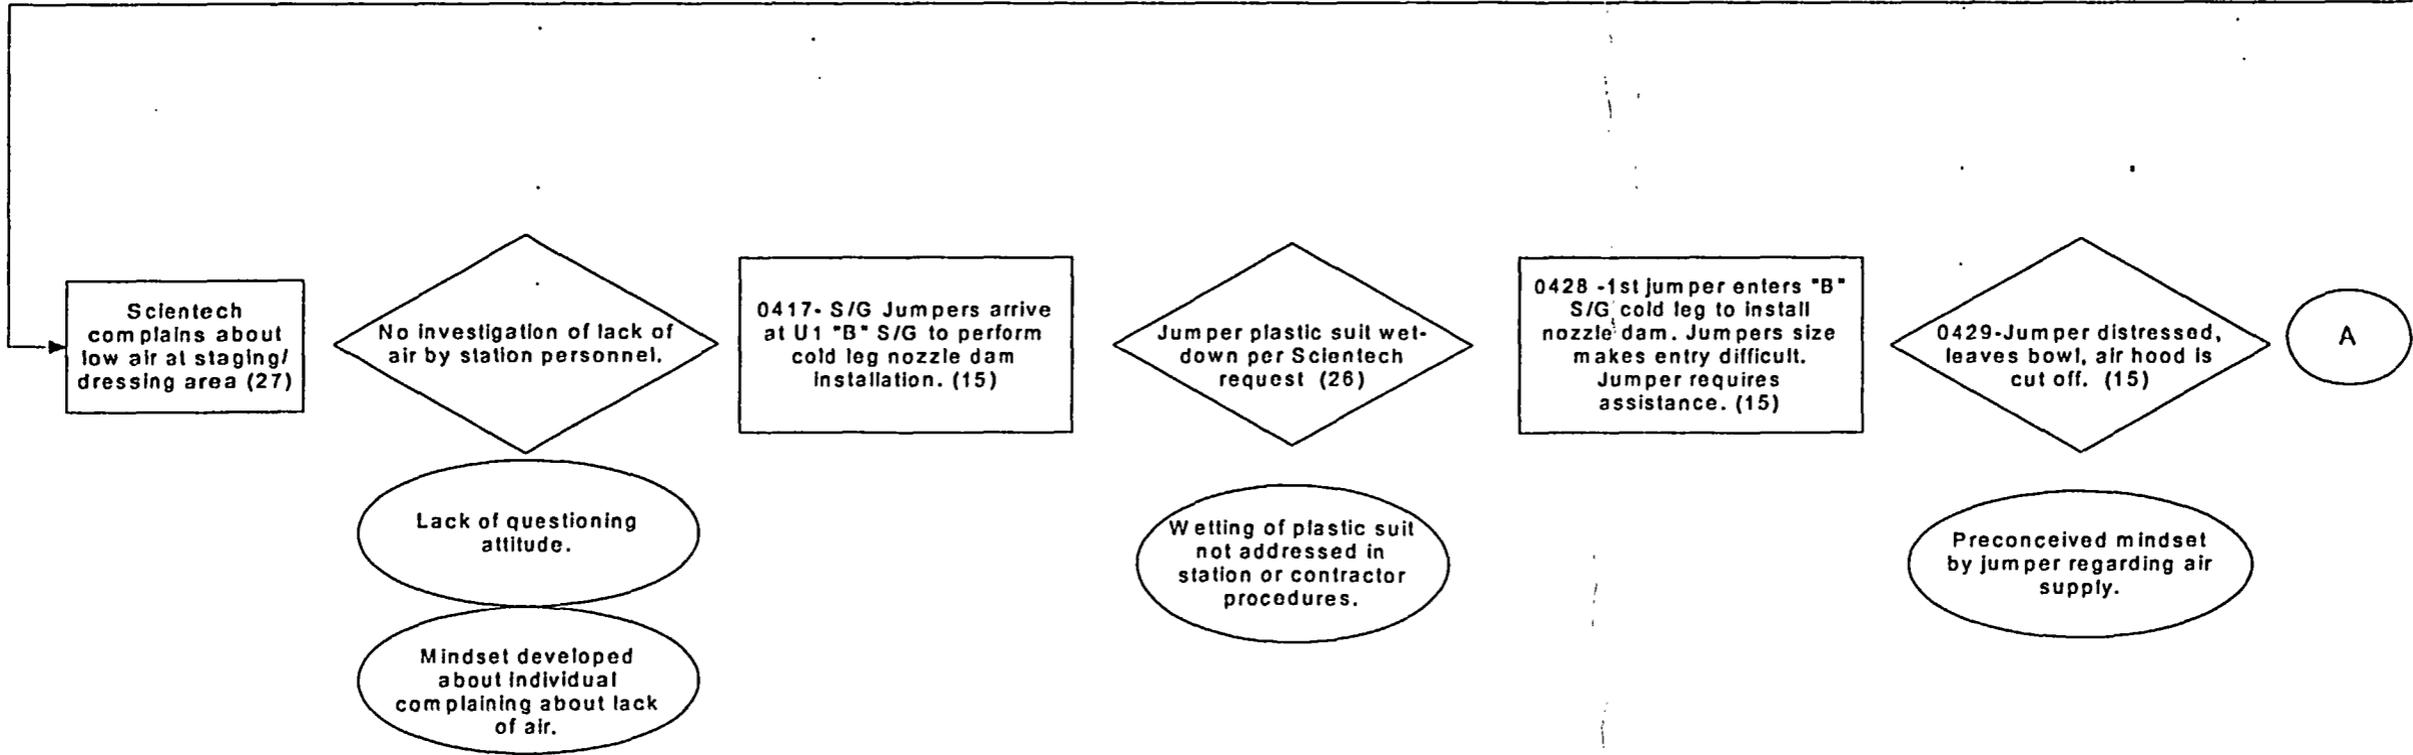
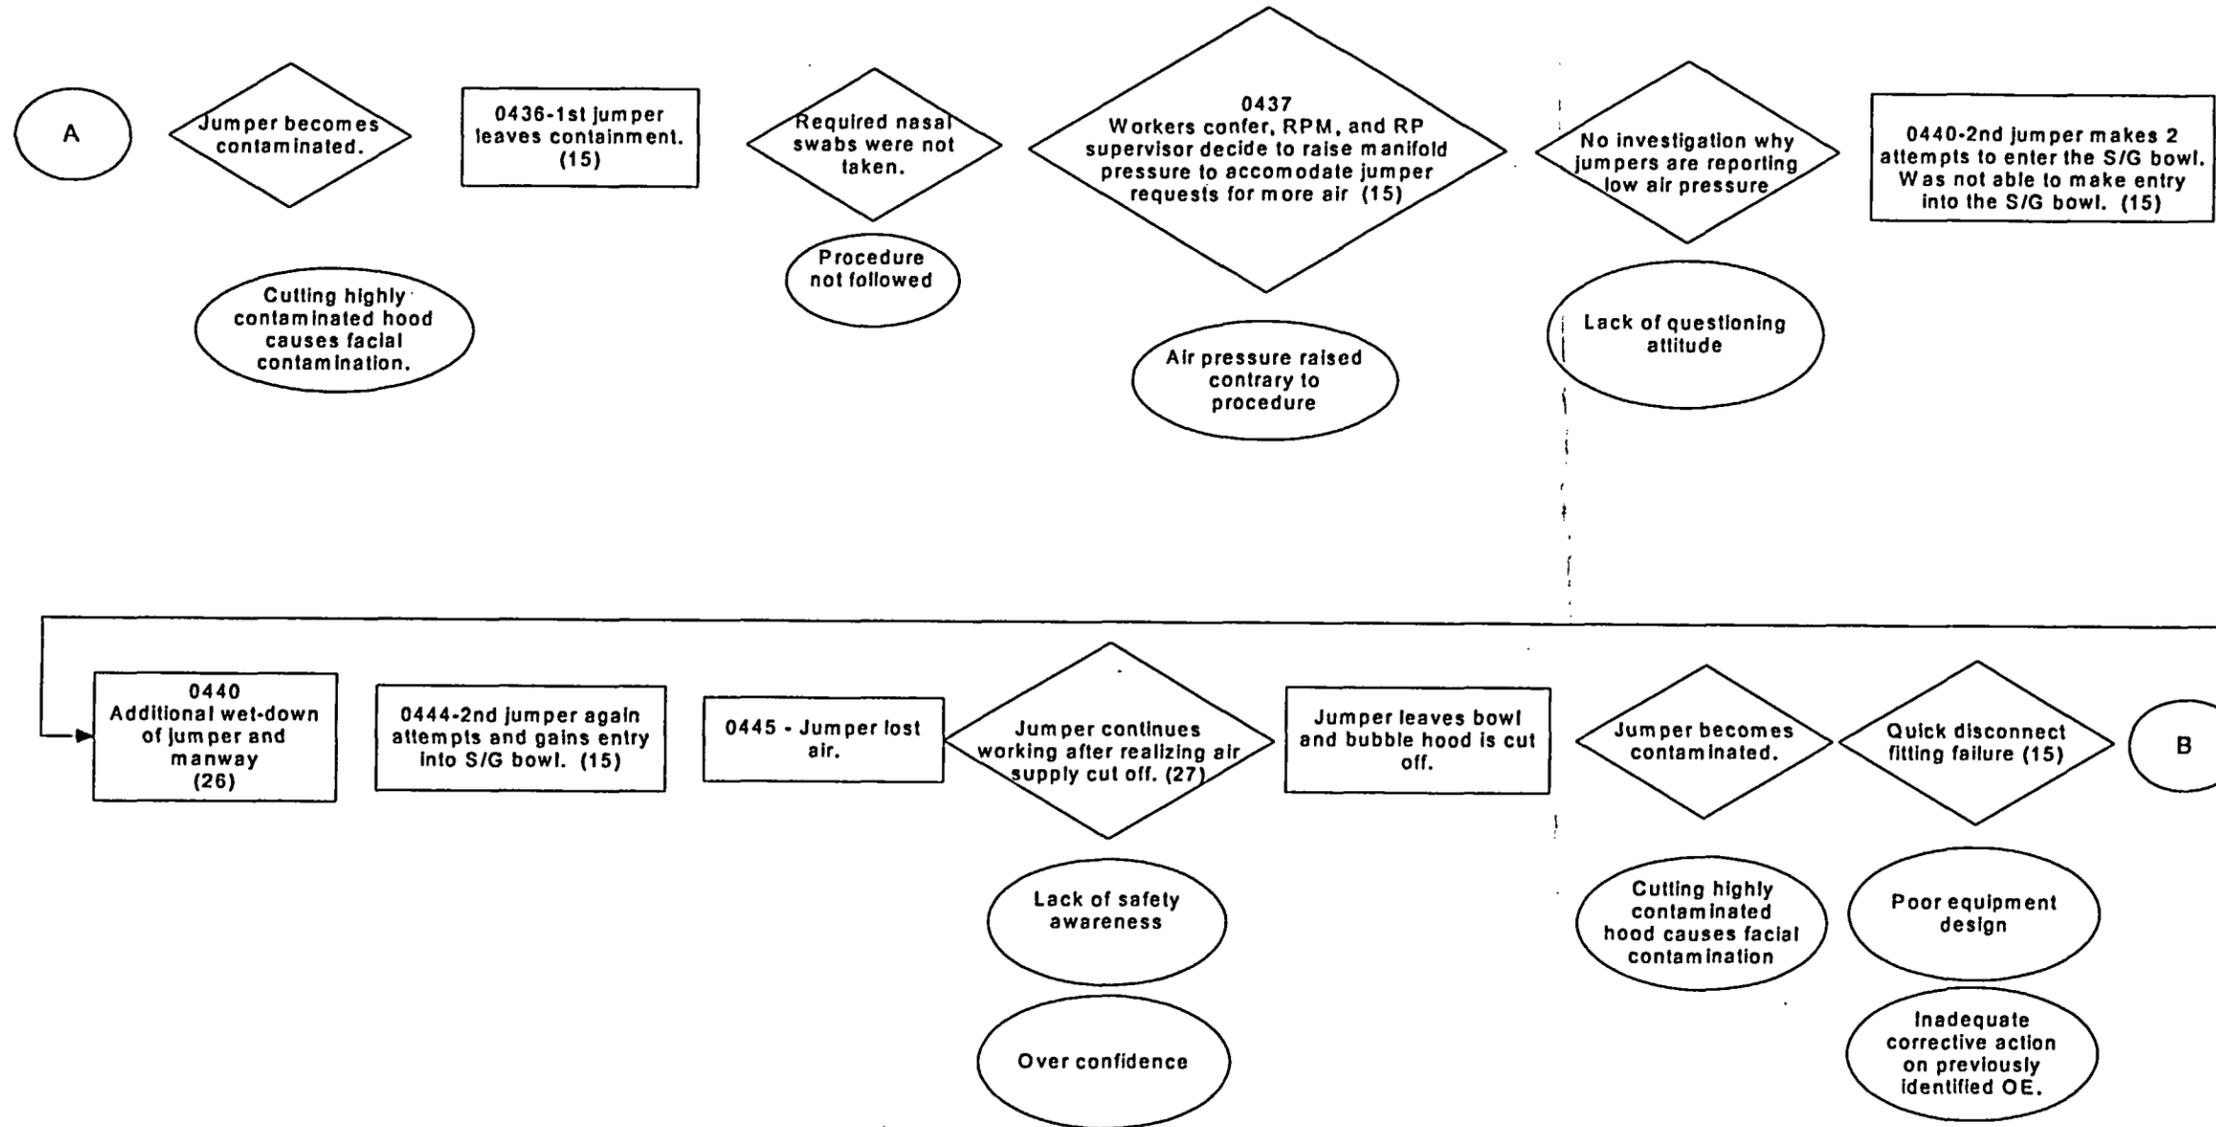
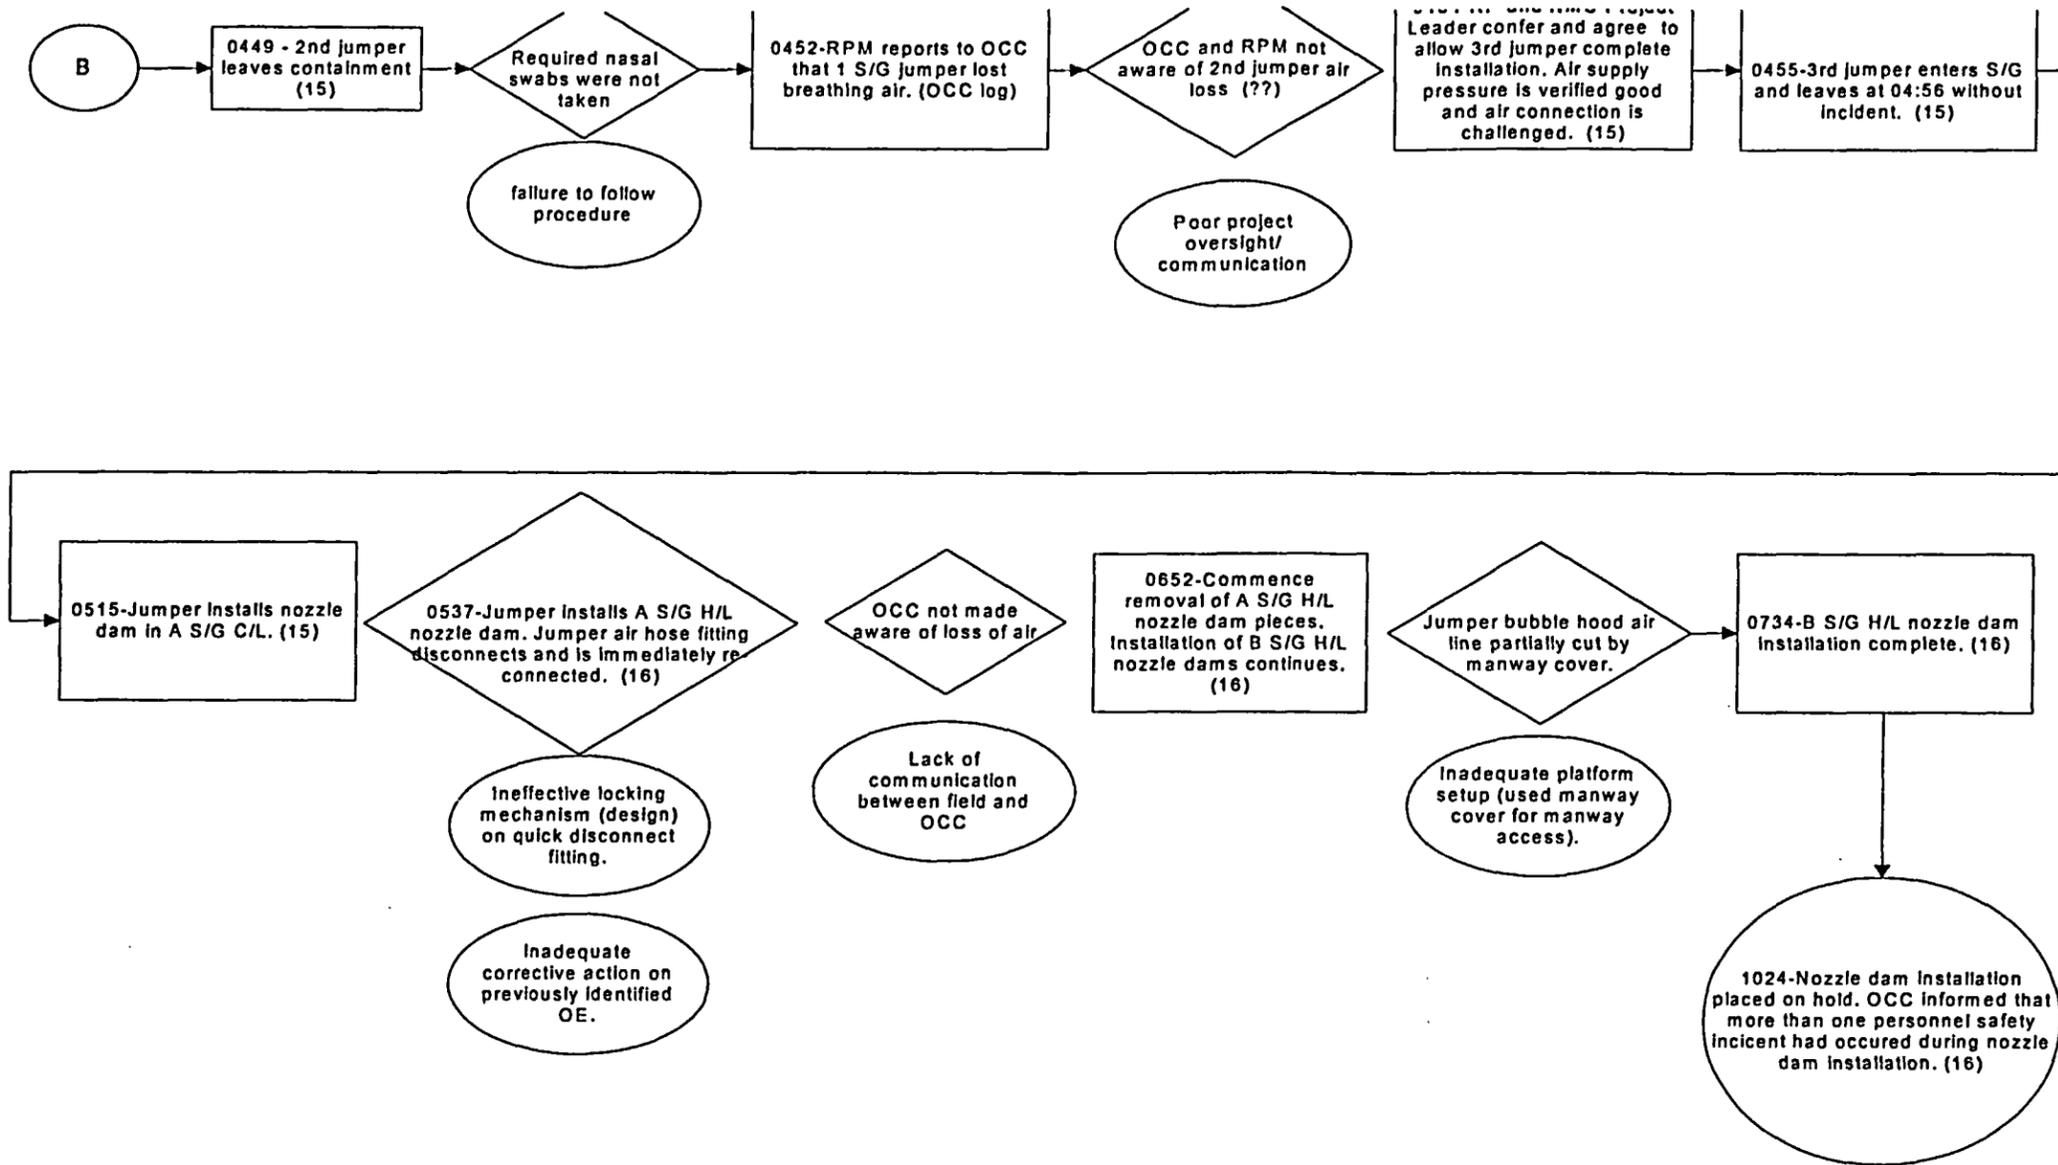
Attachment A – Event & Causal Factor Chart

An Event & Causal Factor Chart (E&CF) (Attachment A) was used to initially construct a timeline of events that occurred on April 9th, 2004, during steam generator nozzle dam installation. The timeline was used to determine actions that were considered inappropriate for the tasks being performed, which then required further analysis to determine a root and contributing causes. This timeline of events, or Event and Causal Factor Chart, identified more than 20 inappropriate actions during installation of steam generator nozzle dams. Those inappropriate actions were then used as problem statements and analyzed for cause using Tap Root methodology.

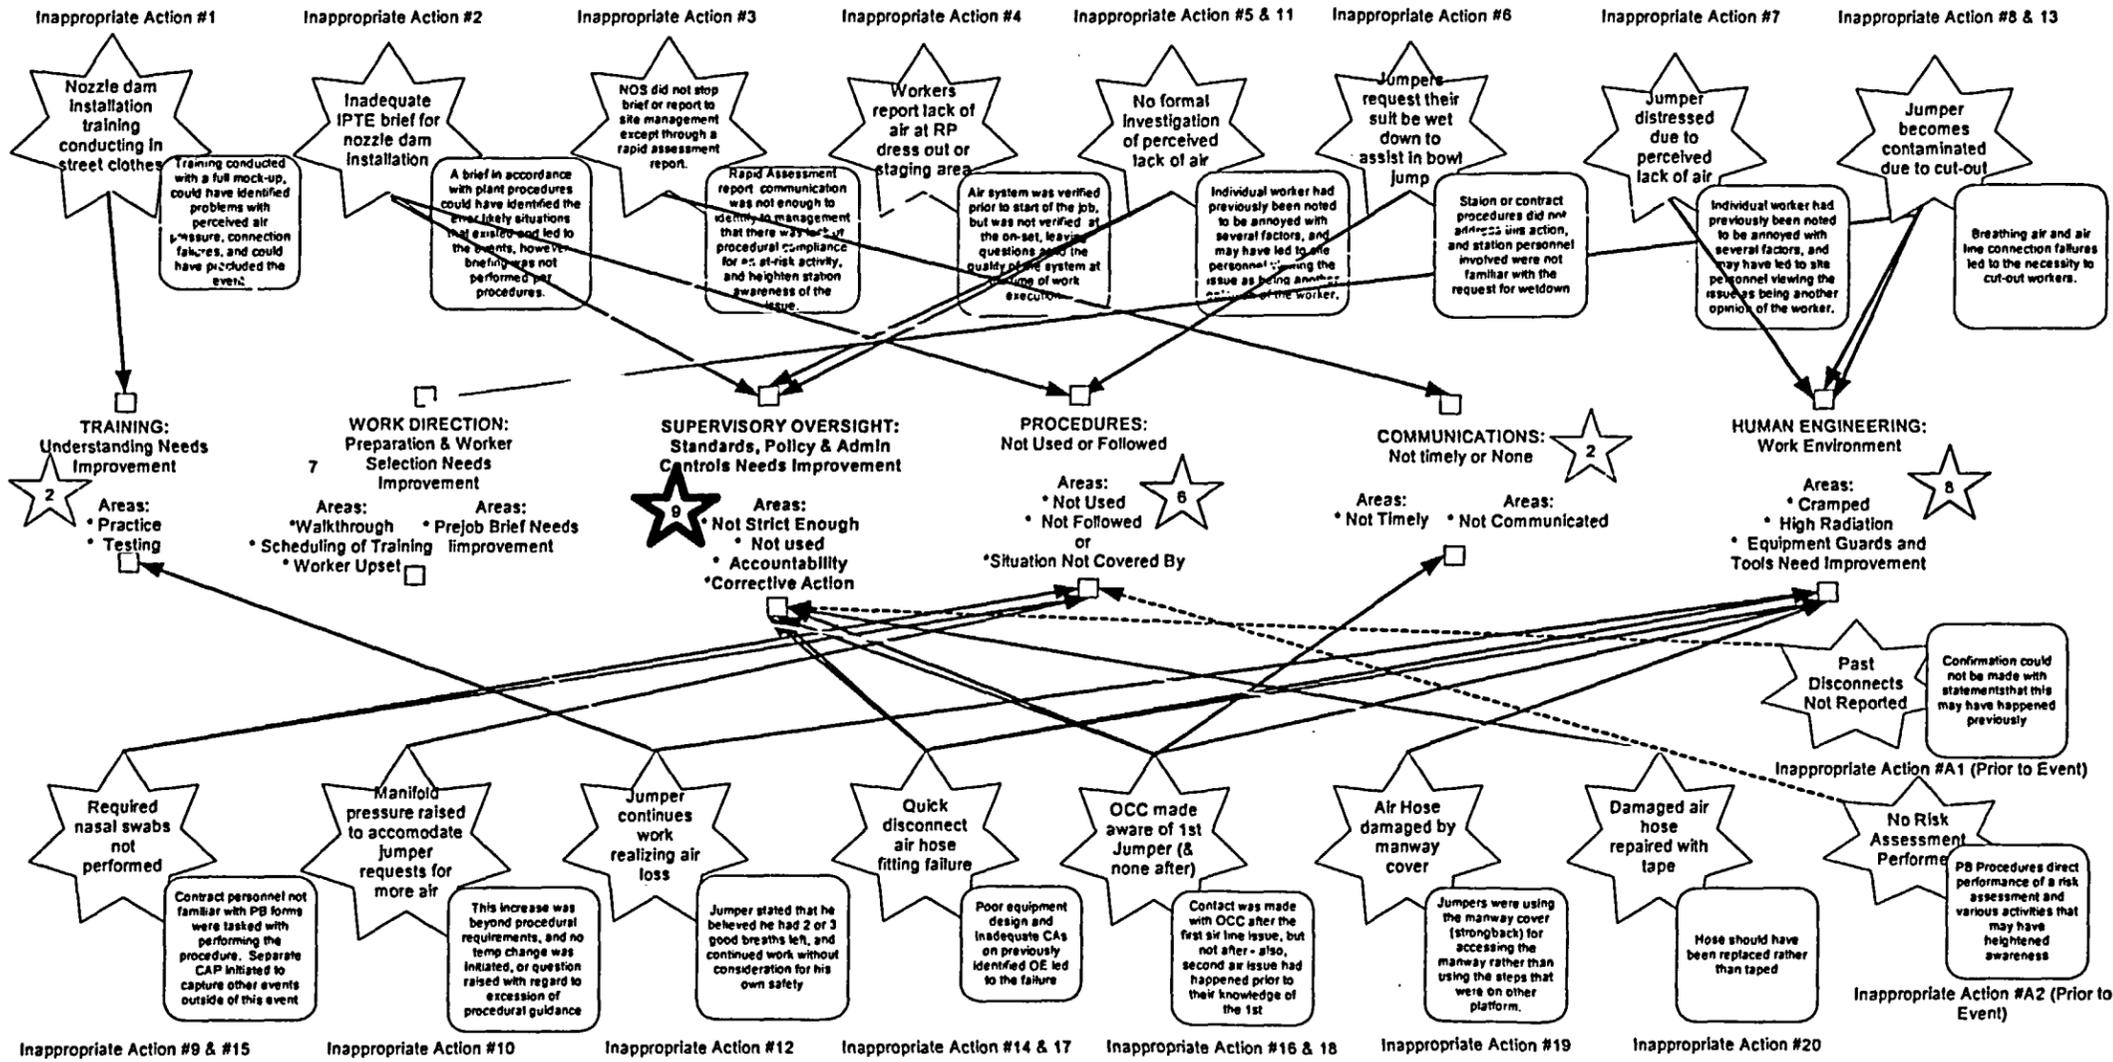
Attachment B – Failure Analysis & Conclusions

A Failure Analysis (Attachment B) was used to identify the underlying cause of the inappropriate actions that were identified on the E&CF Chart. Six common themes were identified for the inappropriate actions, with charting identifying the most common theme throughout the events. Supervisory Oversight had the highest number of “inputs” and was identified as the cause of at least nine (9) of the inappropriate actions that occurred. Supervisions policies, administrative controls, and the use of corrective action were consistently not strict enough, not utilized, or not accountable for inappropriate actions that led to poor work practices and safety anomalies during a high-risk evolution. When asked “Why”, management response was that they were focused on other elements such as the Radiological aspects of the job (Radiation Protection Management), while Program Engineering Management stated that they did not recognize the task as being high-risk and therefore did not apply the necessary oversight. Considered to be Significant Contributors to the events was Work Direction and Procedures. Supporting those facts were: Inadequate scheduling of training, poor worker selection, and inadequacies in pre-job briefings and walkthroughs. Also, procedures were not used, not followed or situations were not covered, and therefore significantly contributed to the unacceptable events that took place during planning and execution of nozzle dam installation.

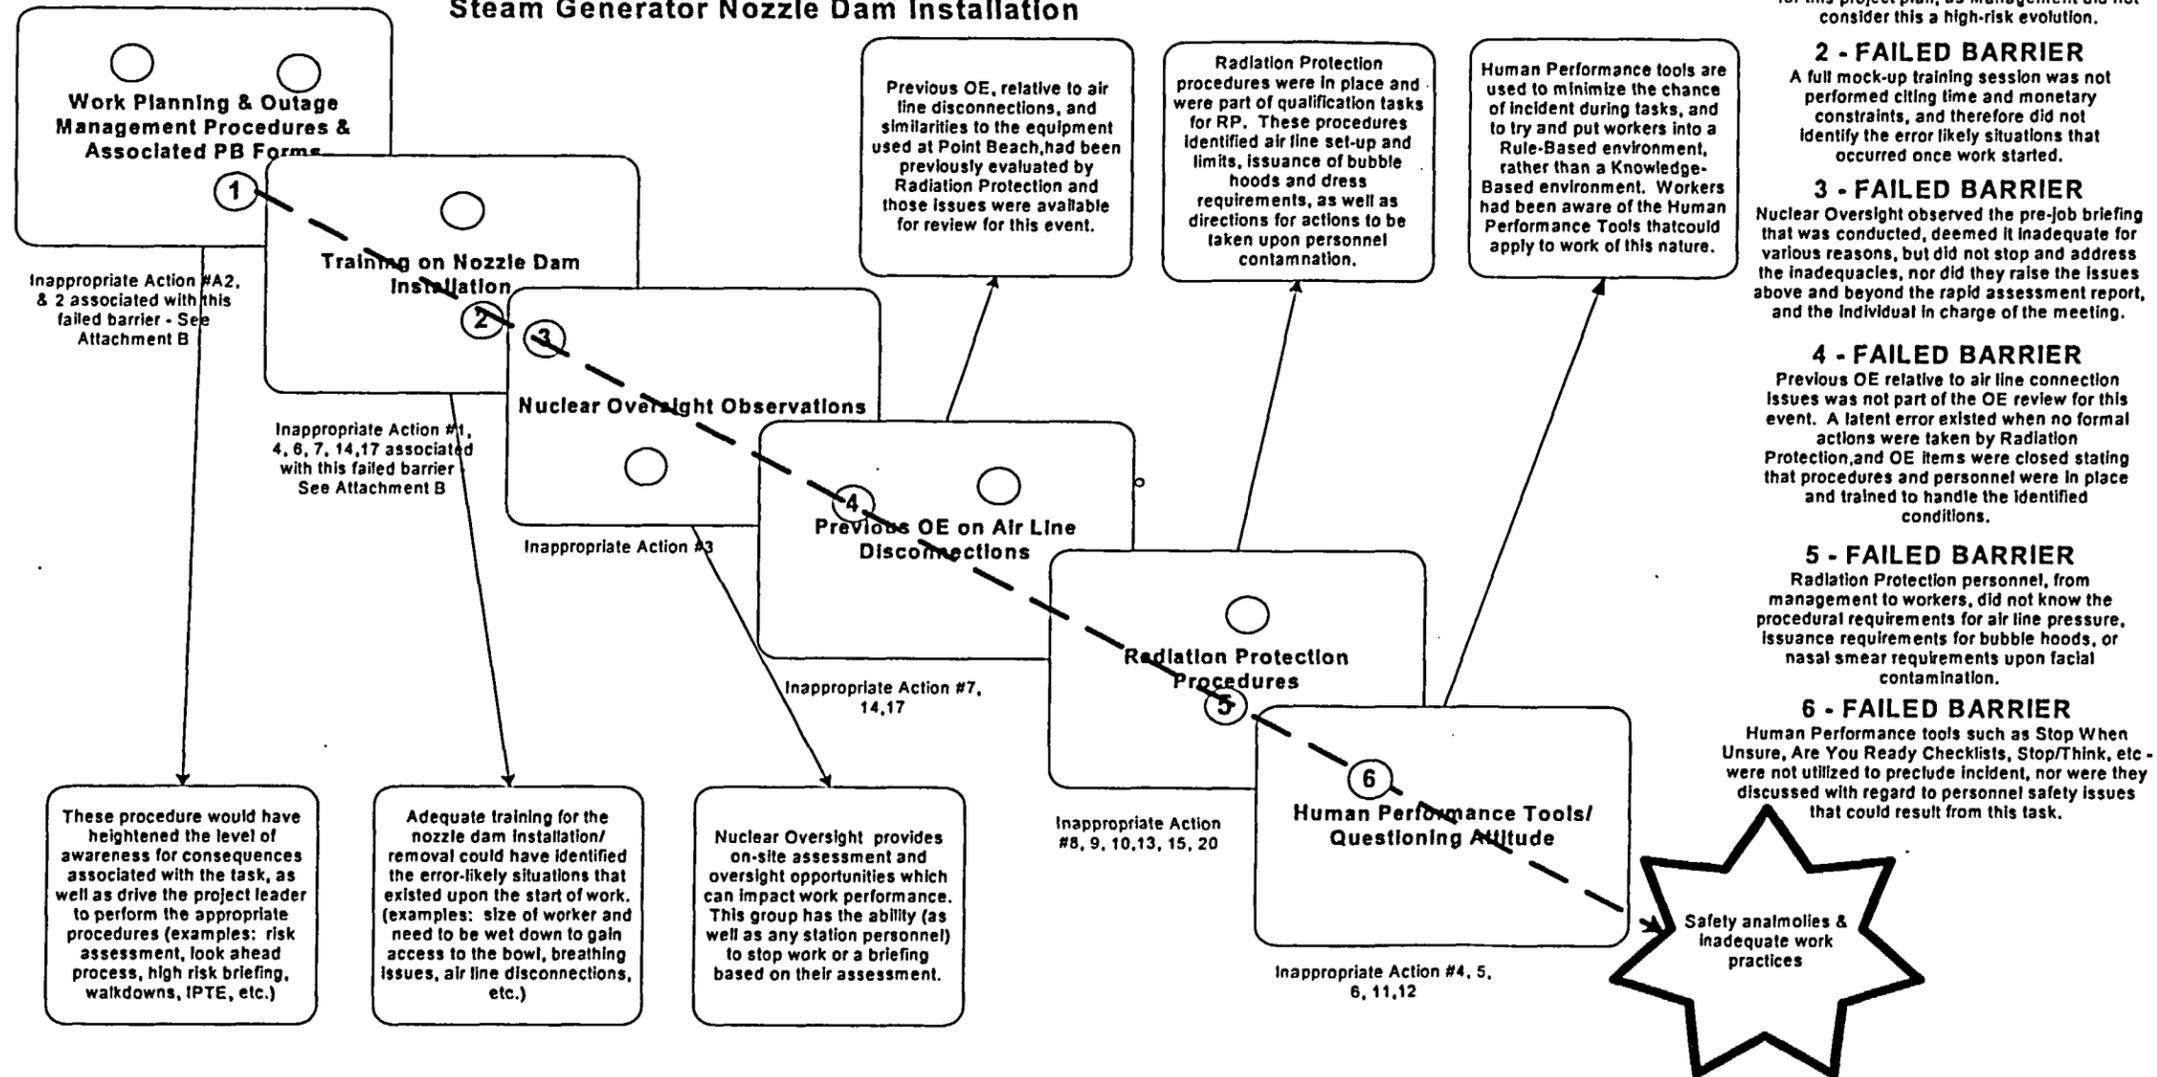
Attachment C - Barrier Analysis - Safety Anomalies & Inadequate Work Practices During Steam Generator Nozzle Dam Installation

A Barrier Analysis was performed (Attachment C) to determine what barriers were in place at the time of the event, and determine any failures that may have occurred in those established barriers. Six barriers were identified that, if utilized, would have prevented the inappropriate actions that took place during the steam generator nozzle dam installation. Barriers included: Work Planning and Associated Outage Management Procedures, Training for nozzle dam installation/removal, Nuclear Oversight observations, Operating Experience, Radiation Protection Procedures, and Human Error Reduction Tools. Each failed barrier, independently, would have impacted performance, however, when all six in combination failed, it led to the

safety anomalies and inadequate work practices that were experienced during nozzle dam installation. The Analysis concludes that organizational effectiveness issues exist, as all barriers that were put in place for successful task performance, failed to be utilized to the extent necessary to prevent incident. This analysis then led to a Task Analysis of the process in place to plan this project, that should have included all barriers in it's performance.

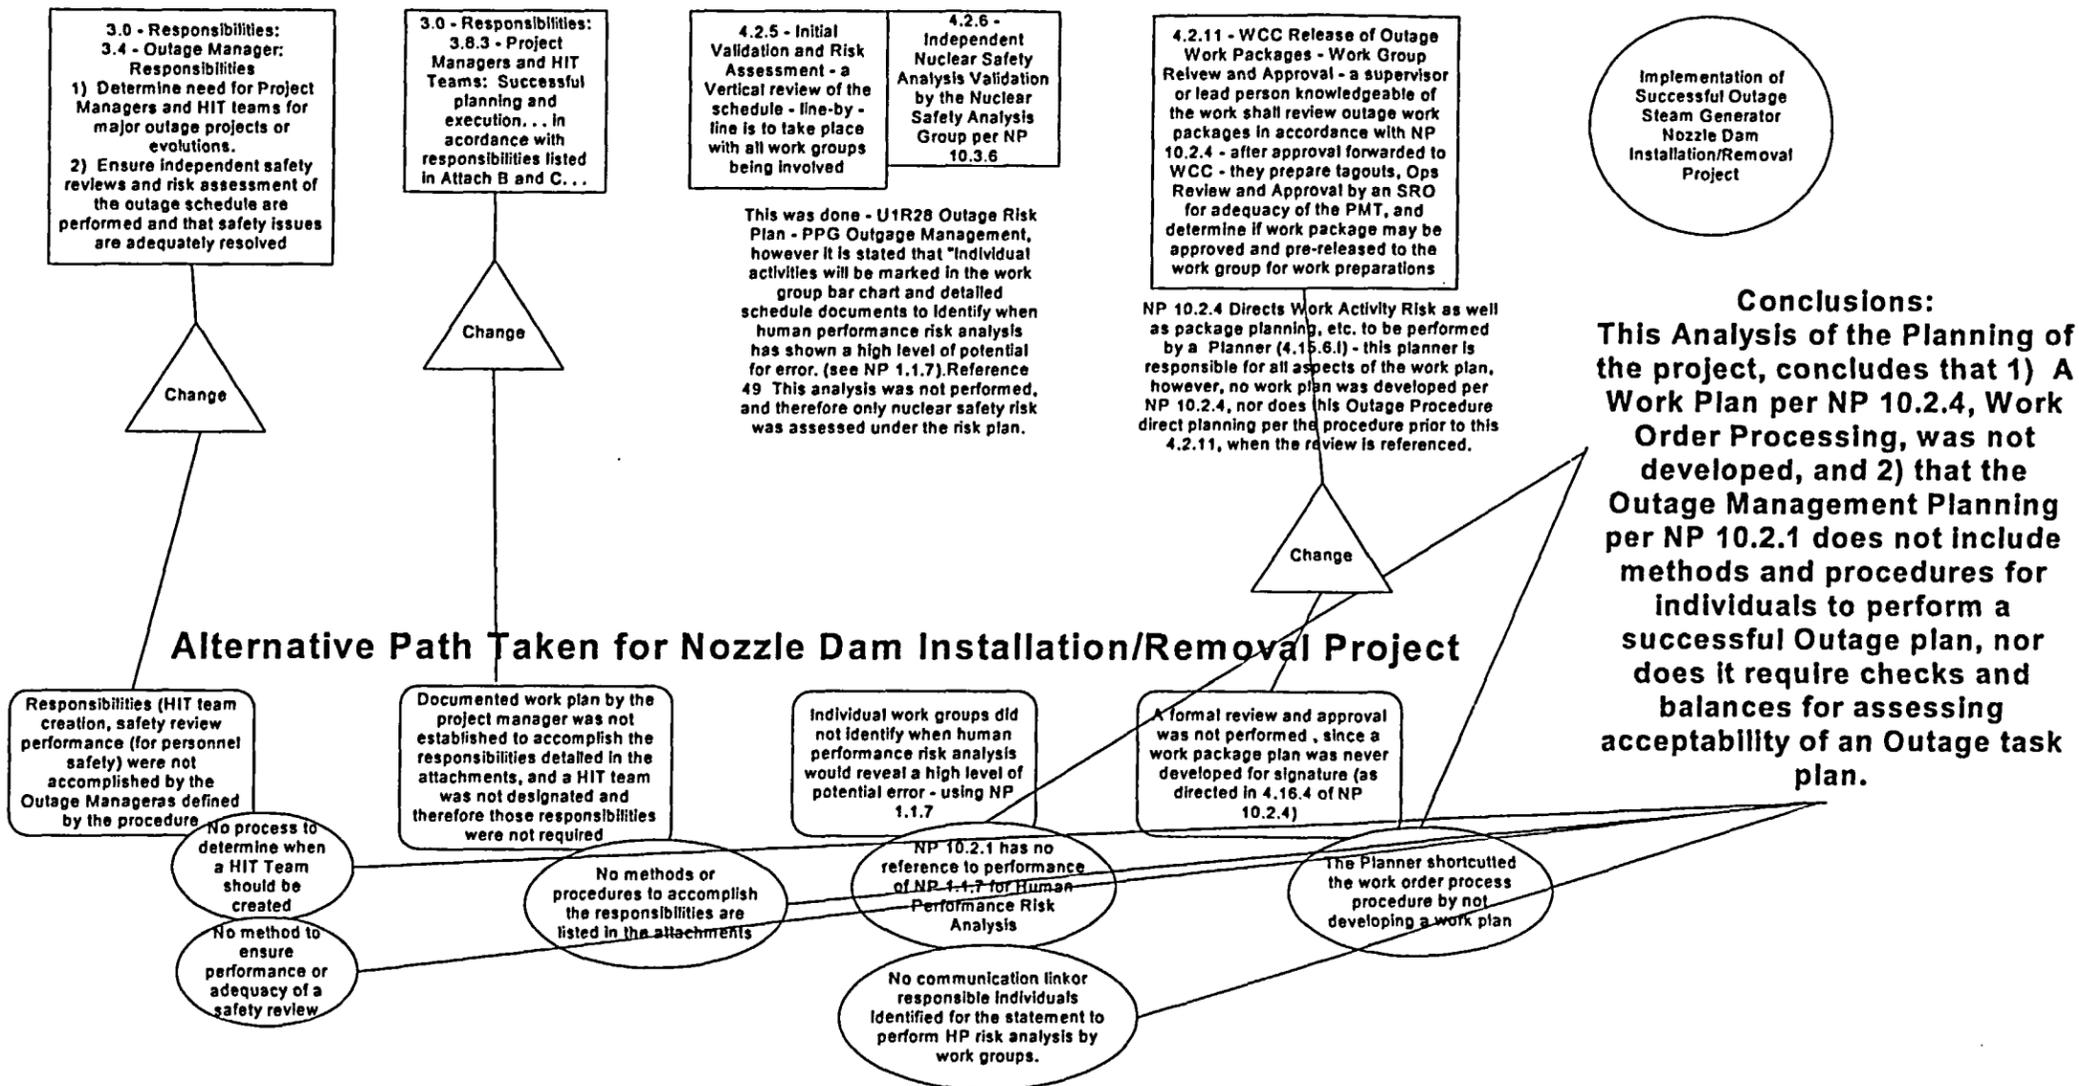
Attachment D – Task Analysis of Outage Project Plan for This Task

Supporting details for inadequate work plan: A work order to perform nozzle dam installation/removal was generated in December of 2003. This work order was written as a Priority 5, Type "Z" – Elective Maintenance activity, and categorized with a risk of "H – MU Multiple Risks". According to Planning personnel at Point Beach, this "H-MU" would have generated PBF-9812, Categorization and Mitigation of Risk (associated with NP 1.1.7, Managing Work Activity Risk). This form details that a risk category of High, as was the case for this work order, would have had to consider 12 different compensatory actions which included, but were not limited to, a complete look-ahead plan, utilization of high risk pre-job briefing process, FLS and Manager attendance and conduct of pre-job briefing to ensure adequacy, critical step identification, etc. This form, along with the associated PBF forms that would have been generated upon initiation, were not located and the evaluation did not identify that any mitigation or assessment of risk was performed. This detailed plan was necessary to promote teamwork among the various work groups involved with the task, identify the consequences associated with an IPTE task, and ultimately identify the critical actions necessary to successfully implement the task.
