Subject: LER -2005-001-00 [Reactor Scram 109 on  
February 11, 2005, Due To Loss Of Service Transformer 11]

Grand Gulf Nuclear Station, Unit 1  
Docket No. 50-416  
License No. NPF-29

**4. TITLE**  
Reactor SCRAM Due to Loss of Service Transformer 11 Caused By Animal Intrusion

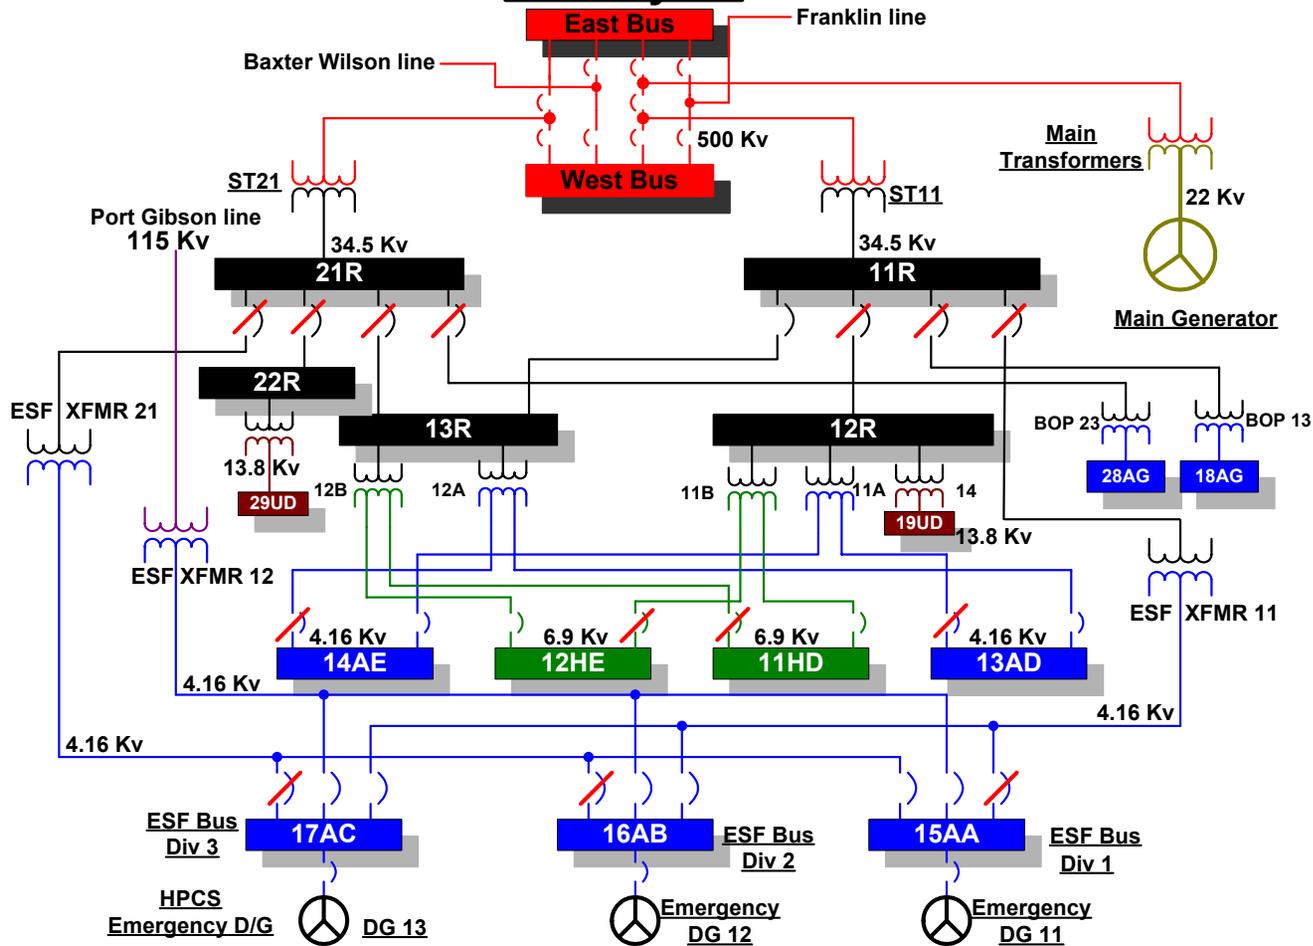
**Grand Gulf Nuclear Station  
Distribution Switchyard**

The ground fault was the result of an animal intrusion which resulted in a bridging of the 34.5 kV bus work of Service Transformer ST11. A dead raccoon was found with indications that it had shorted two phases. Upon entry of the 34.5 kV switchyard, it was discovered that the animal intrusion fence had been de-energized via the "On/Off" switch. It could not be determined how long this condition had existed.

Immediate Corrective Actions - An inspection of the animal intrusion fence (electrified) was added to the daily Operations rounds to ensure the fence remains energized. A lock was added to the gate enclosing the affected breaker.
