Research Reactor Center

University of Missouri-Columbia

SUBJECT: Licensee Event Report

Licensee Event Report No. 05-01 – March 10, 2005
University of Missouri Research Reactor

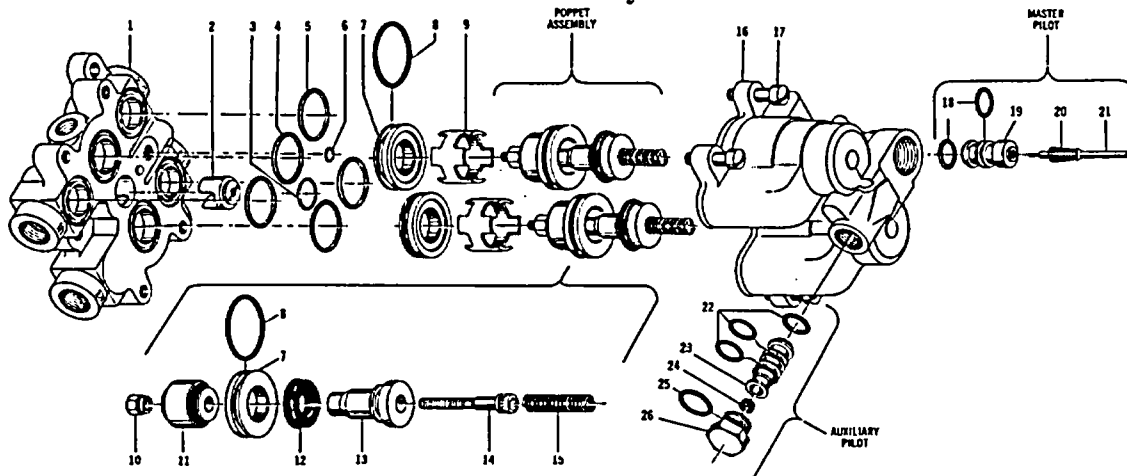
Containment Airlock Door Three-Way, Dual Solenoid-Pilot Valve

When a door is in the fully closed position, the rotary limit switch energizes the closing solenoid, which aligns the three-way valve to inflate a gasket mounted in the door facing, thus sealing the door. The three-way valve then remains in the "latched" position, as depicted on page 4, after the solenoid de-energizes. When a door is in the fully open position, the rotary limit switch energizes the opening solenoid, which aligns the three-way valve to vent the sealing gasket to atmosphere. The three-way valve then remains in the "unlatched" position after the solenoid de-energizes. The purpose of using a dual solenoid is to prevent the three-way valve from getting out of phase. The position of the three-way valve will not change if the same solenoid is energized twice in succession (the opposite solenoid must be energized to reverse the valve).

Upon investigation, it was determined that the inner airlock door three-way, dual solenoid-pilot valve had not remained in the "latched" position following the door closing cycle. Once the closing solenoid de-energized, the three-way valve returned to the "unlatched" position, thereby venting air pressure from the sealing gasket resulting in a loss of containment integrity. The three-way valve bonnet and dual solenoid-pilot control assembly were replaced. The door was then cycled five times to verify proper adjustment and operability.

This event has been entered into the MURR Corrective Action Program as CAP 05-0021 and any additional improvements or corrective actions will be considered. This type of airlock door failure had never previously occurred at MURR. The removed air control valve was disassembled and the exact cause of the valve failing to remain in the "latched" position could not be determined. Some of the possible causes include a loss in magnetic field strength of the control solenoid, undetectable wear of the latching mechanism or wear debris or dirt which prevented the valve from latching. Although sufficient spare valves and solenoids do exist for the foreseeable future, this particular vendor no longer supports this style valve. The facility's engineering staff is researching a possible future replacement for this valve.

When the Limiting Condition for Operation regarding containment integrity was not satisfied with respect to the personnel airlock doors (Technical Specification 3.4.a), the reactor was immediately scrammed and placed in the secured condition. This is the fastest way to restore Technical Specification compliance. The three-way valve bonnet and dual solenoid-pilot control assembly were replaced. The personnel airlock was placed back into service and tested before being determined operable. The reactor was refueled and returned to 10 MW operation with Reactor Manager's approval at 21:35, March 10, 2005.
