Palo Verde Nuclear  
Generating Station

**Subject: Palo Verde Nuclear Generating Station (PVNGS) Unit 3  
Docket Nos. STN 50-530  
Unit 3, Refueling 10, Outage (U3R10) Steam  
Generator Tube Inspection Request For Additional  
Information (RAI) Response**

**Arizona Public Service Company's Response to Unit 3, Refueling 10,  
Outage (U3R10) Steam Generator Tube Inspection Request for  
Additional Information (RAI)**

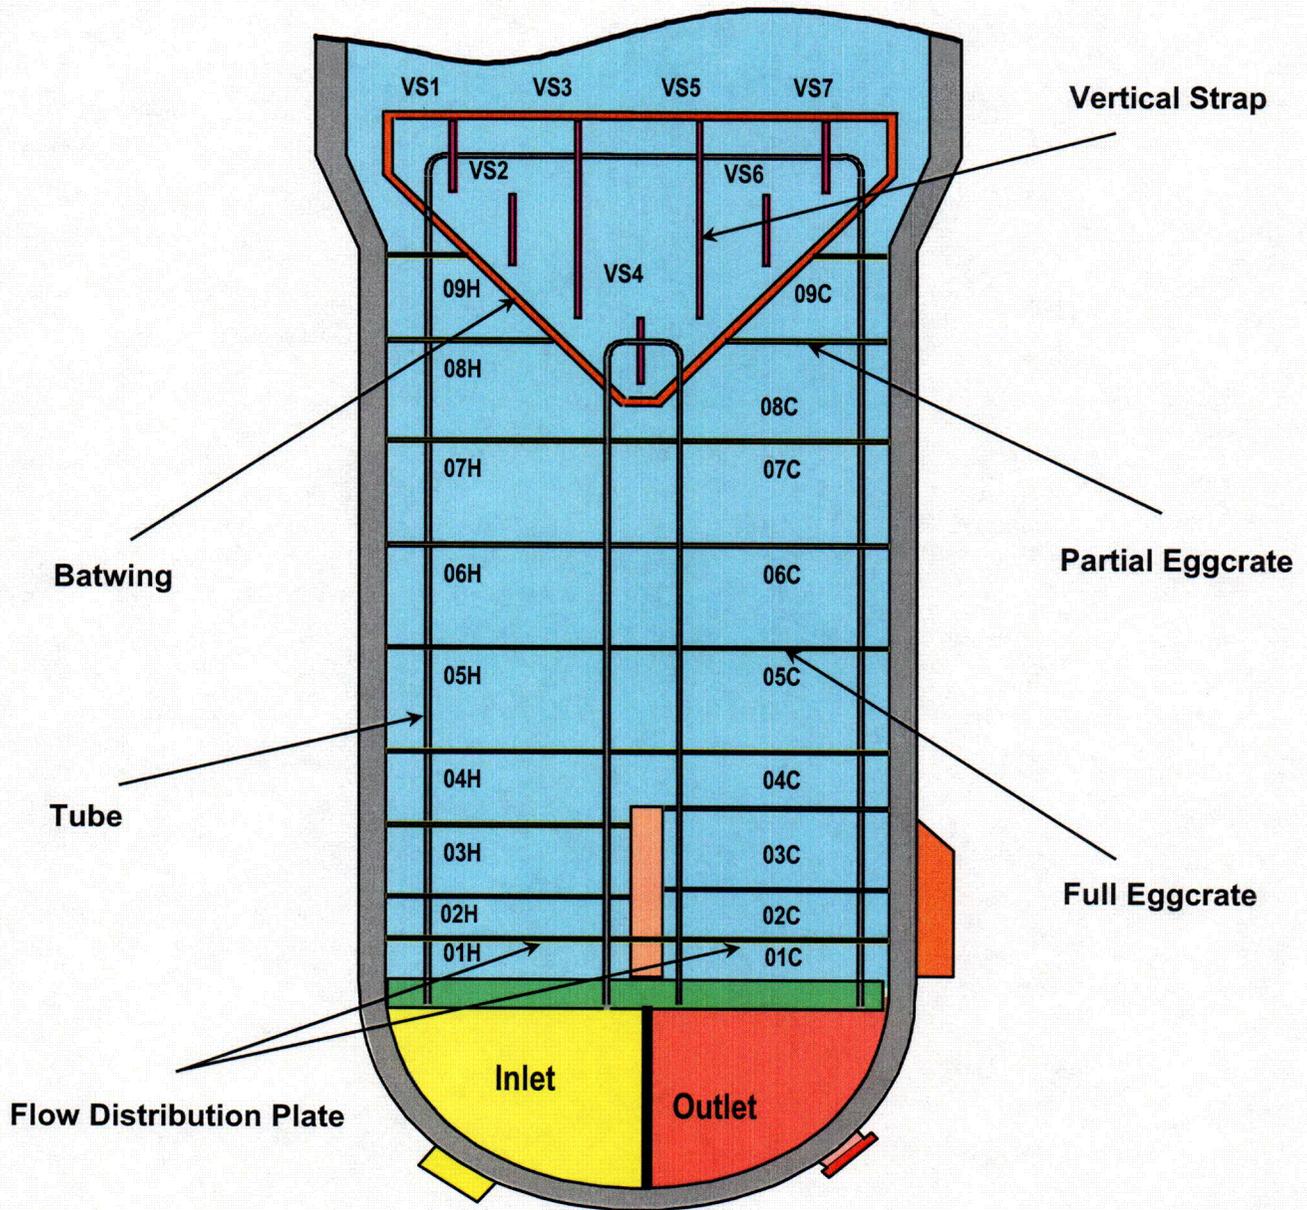
Figure 1

# PVNGS Steam Generator Tube Supports

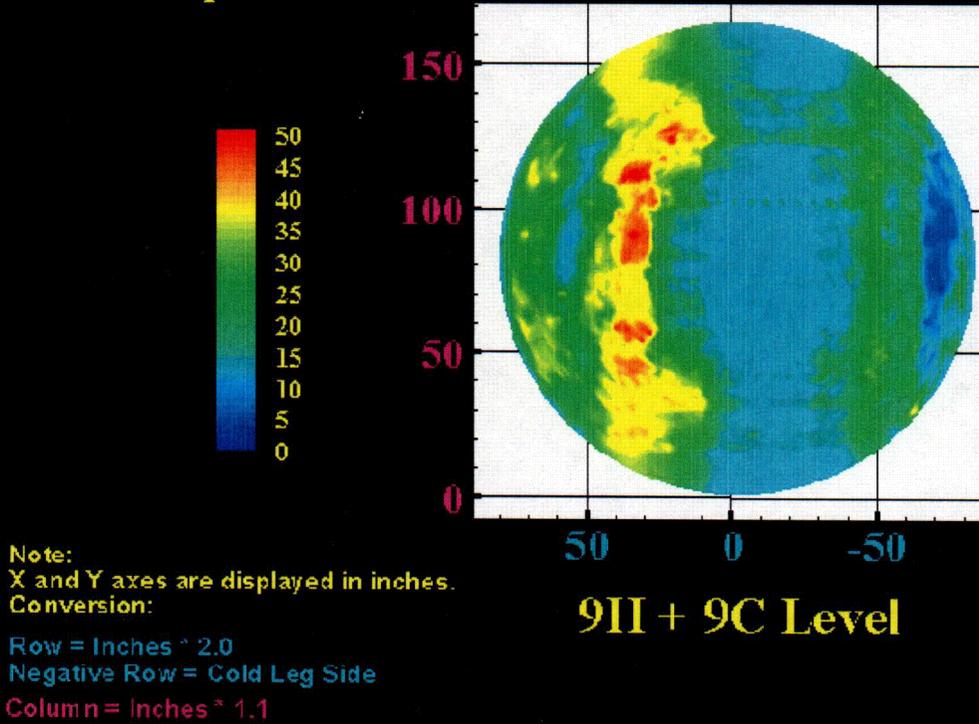
**Figure 2**

The subsequent Unit 3 DA, performed in preparation for U3R10, determined that this first time discovery of Unit 1 axial ODSCC on the cold leg was limited to an area of the steam generator found to contain a higher level of deposits as indicated via a scale profiling technique licensed through Westinghouse (see Figure 2). Although, Unit 3 was not expected to have similar deposition profiles, based on the extent of steam generator modifications designed and implemented in Unit 3 to limit dryout in the upper bundle region of the steam generator, as a conservative measure the U3R10 inspection plan included a freespan upper bundle cold leg exploratory sample program with Plus Point.

**Palo Verde  
Unit 1  
S/G 12  
2001 Inspection**

Note: Plot indicates region of deposition at the 09C support that corresponds radially with tubes with detected cold leg side degradation. Significant deposition on hot leg side corresponds with typical hot leg ARC region
