LICENSEE EVENT REPORT (LER)

FACILITY NAME (1) Donald C. Cook Nuclear Plant Unit 2	DOCKET NUMBER (2) 05000-316	PAGE (3) 1 of 3
--	--------------------------------	--------------------

TITLE (4)
Containment Internal Concrete Structures Do Not Meet Design Load Margins

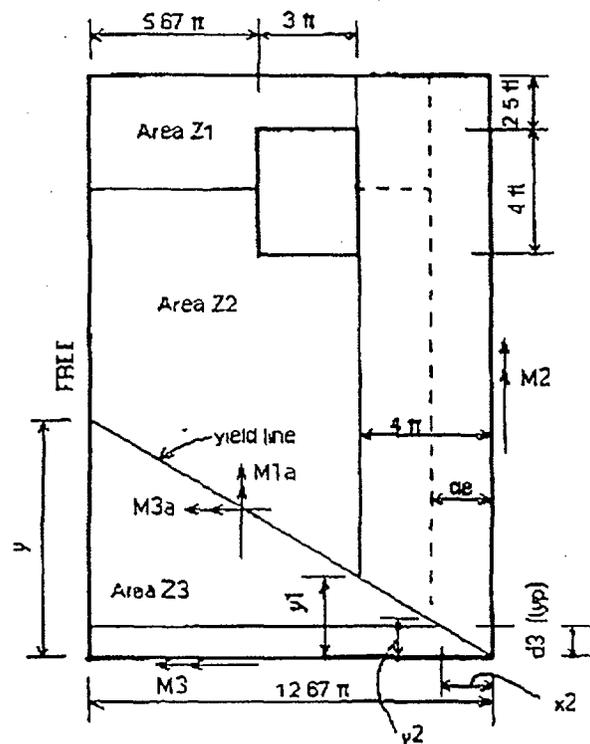
Figure 7.5.2-1

Here the yield line theory will be used to determine the pressure load factor for the wall. Because the only difference between the as-found condition of the wall and the present condition of the wall is the repair/rework of the grout at the top of the wall, the yield line and flexural capacity of the wall will remain unchanged from the values determined in ref. 13. Similarly, only the shear resistance capacity of area Z1 has changed. Therefore, only the load factor for area Z1 will be calculated.

Elevation of wall at azimuth 126 showing yield line

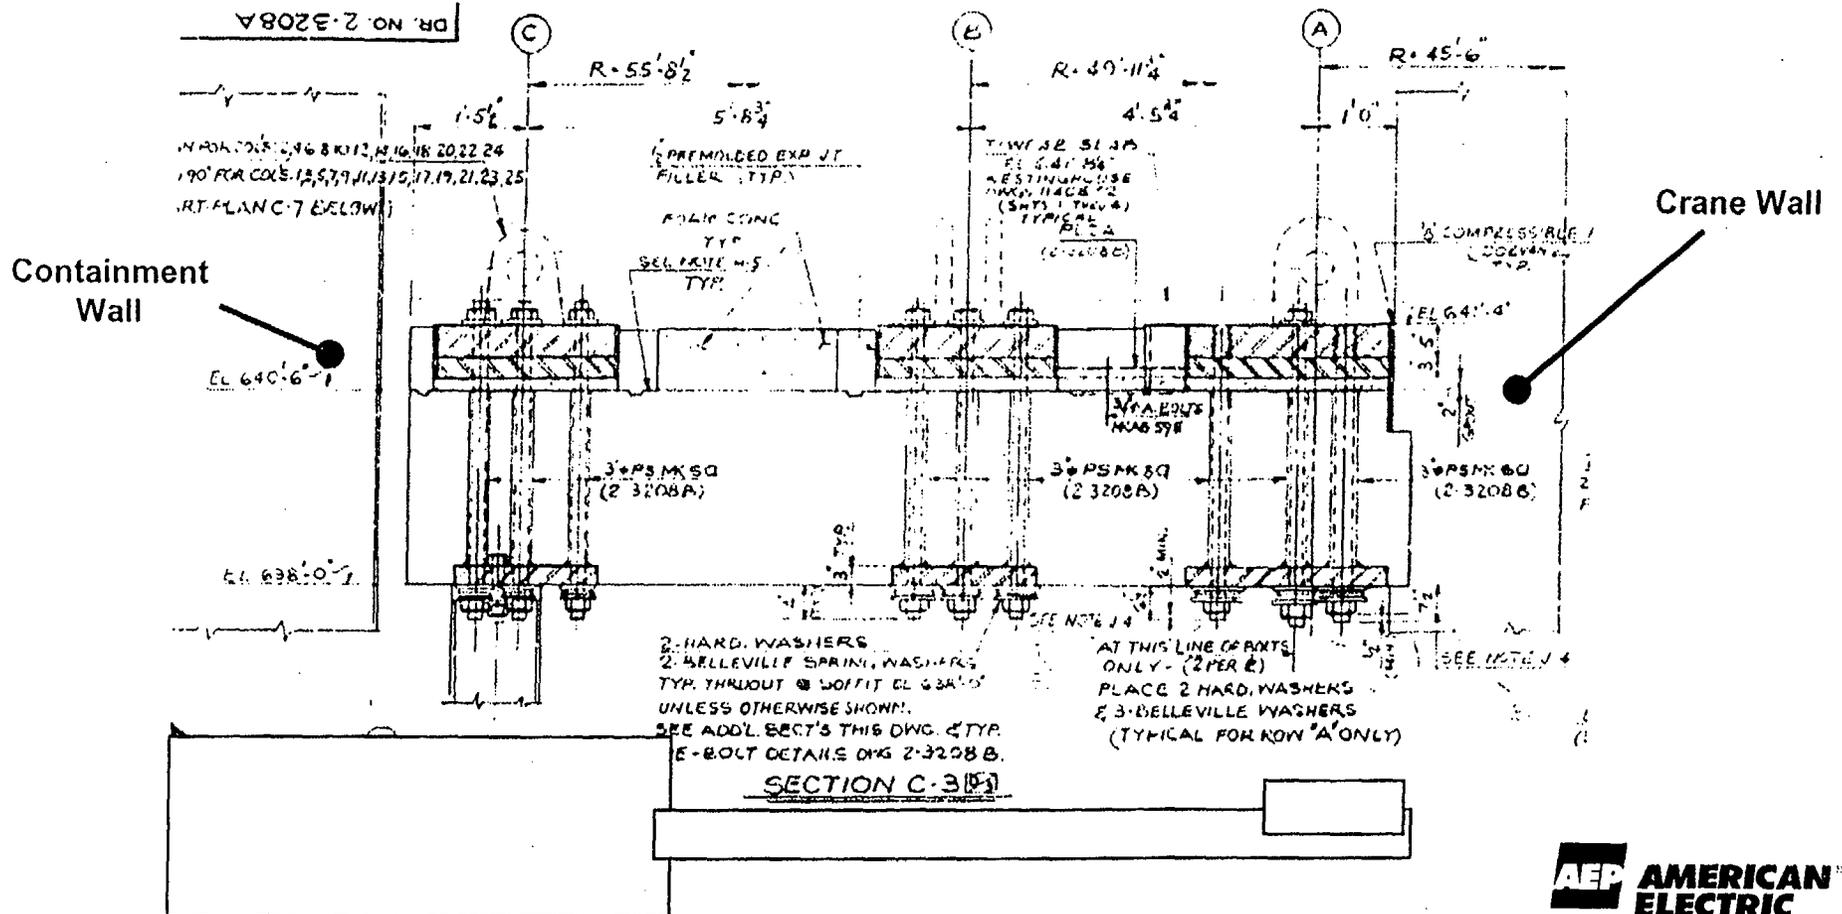
Description of the Issues: Open Pockets - Configuration of Unit 2 Ice Condenser Column Anchorage

■ Typical Slab/Column Connection (Unit 2 Only)

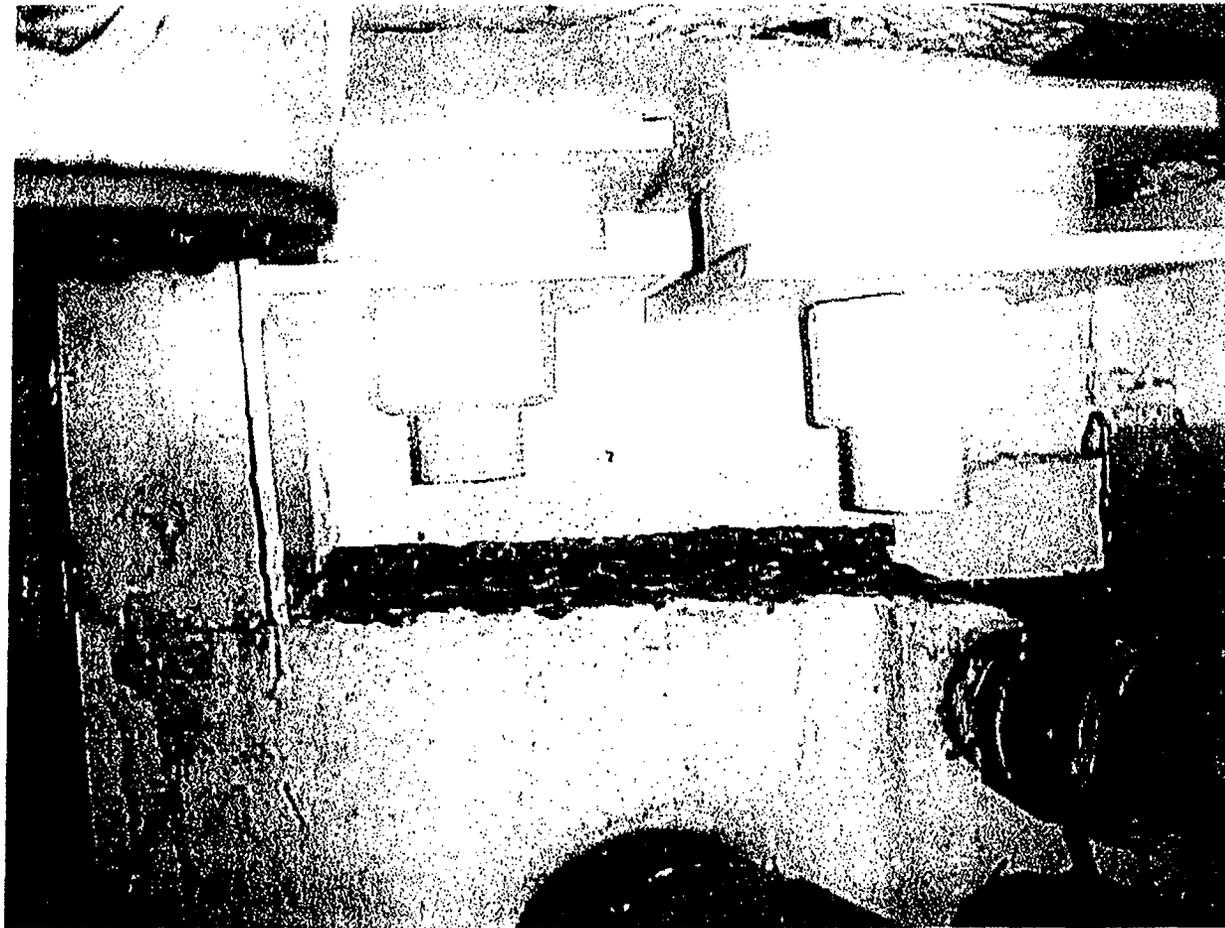
Description of the Issues: Open Pockets - Configuration of Unit 2 Ice Condenser Column Anchorage

■ Detail Showing Pocket for Anchorage Through Bolts

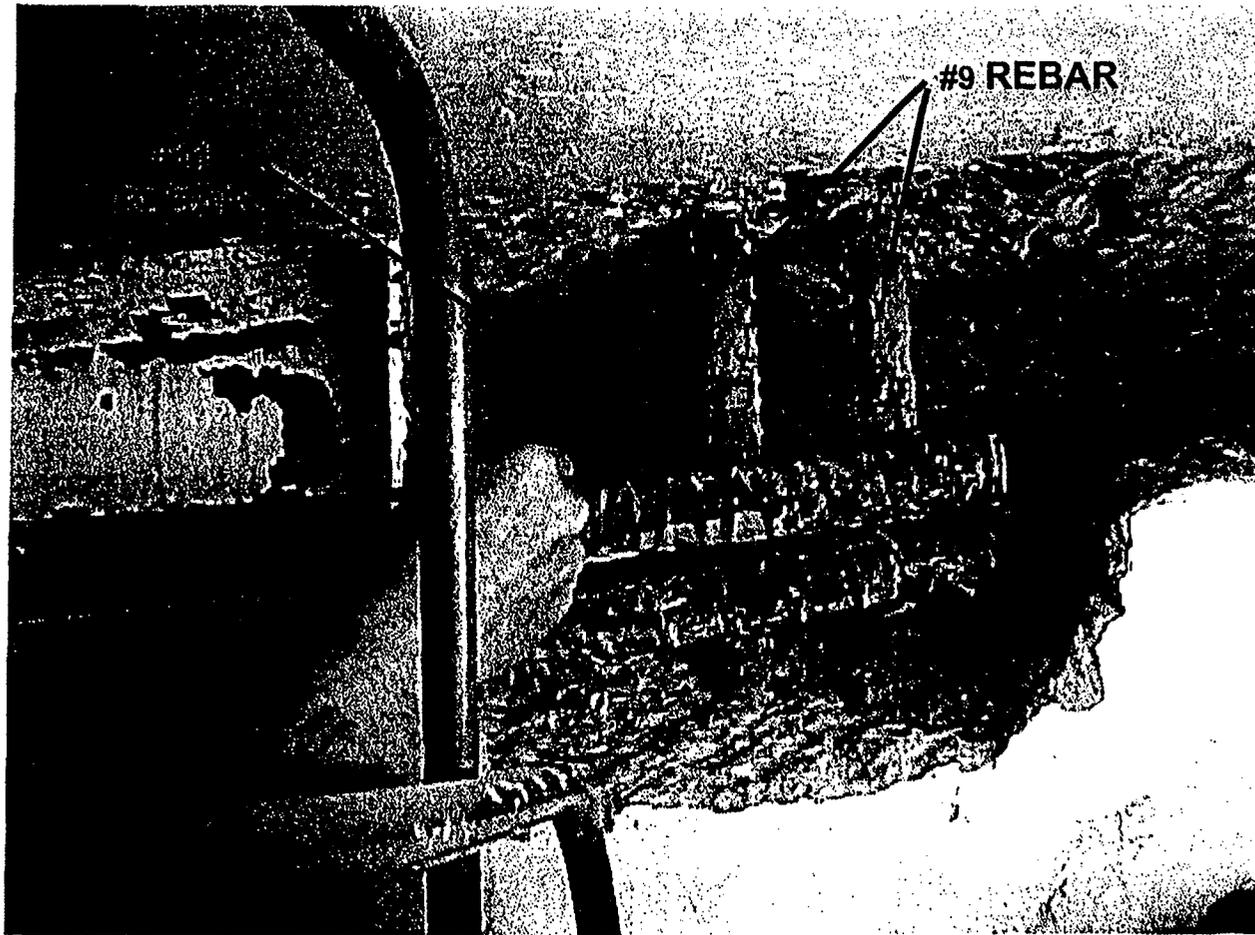
Description of the Issues: Cut Rebar

■ Detail Showing Excavation and Rebar

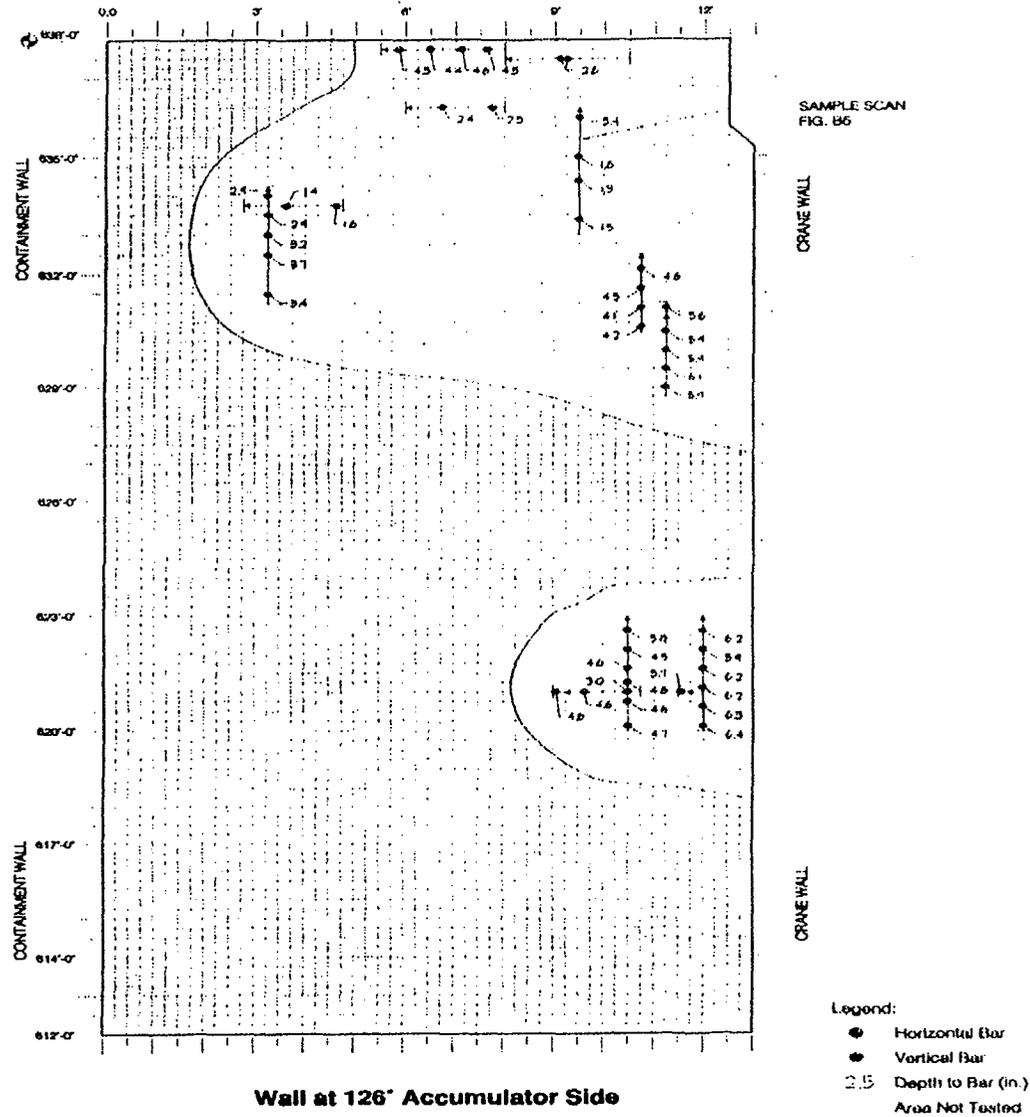
Description of the Issues: Wall Radar Mapping
