From: Melvin Holmberg *MH*
To: Harold Chernoff *HC*
Date: Mon, May 17, 2004 1:52 PM
Subject: Fwd: RE: Talking Points Regarding PBNP U1R28 Reactor Vessel Head Inspection

To: Mark Huting
From: Charles Tomes
Date: May 13, 2004
Subject: U1R28 Extent of Condition Evaluation for Penetration # 26 at PBNP
Copy To: John Paul Cowen, Lyle Bohn, Doug Cooper, Gary Van Middlesworth, James Schweitzer, Craig Lambert, Brian Kemp, Bill Jensen, Kim Bezzant, Gary Sherwood, Jim McCarthy

The primary objective of this evaluation is to document the results of the extent of condition review of indications disclosed in penetration #26 at PBNP-1.

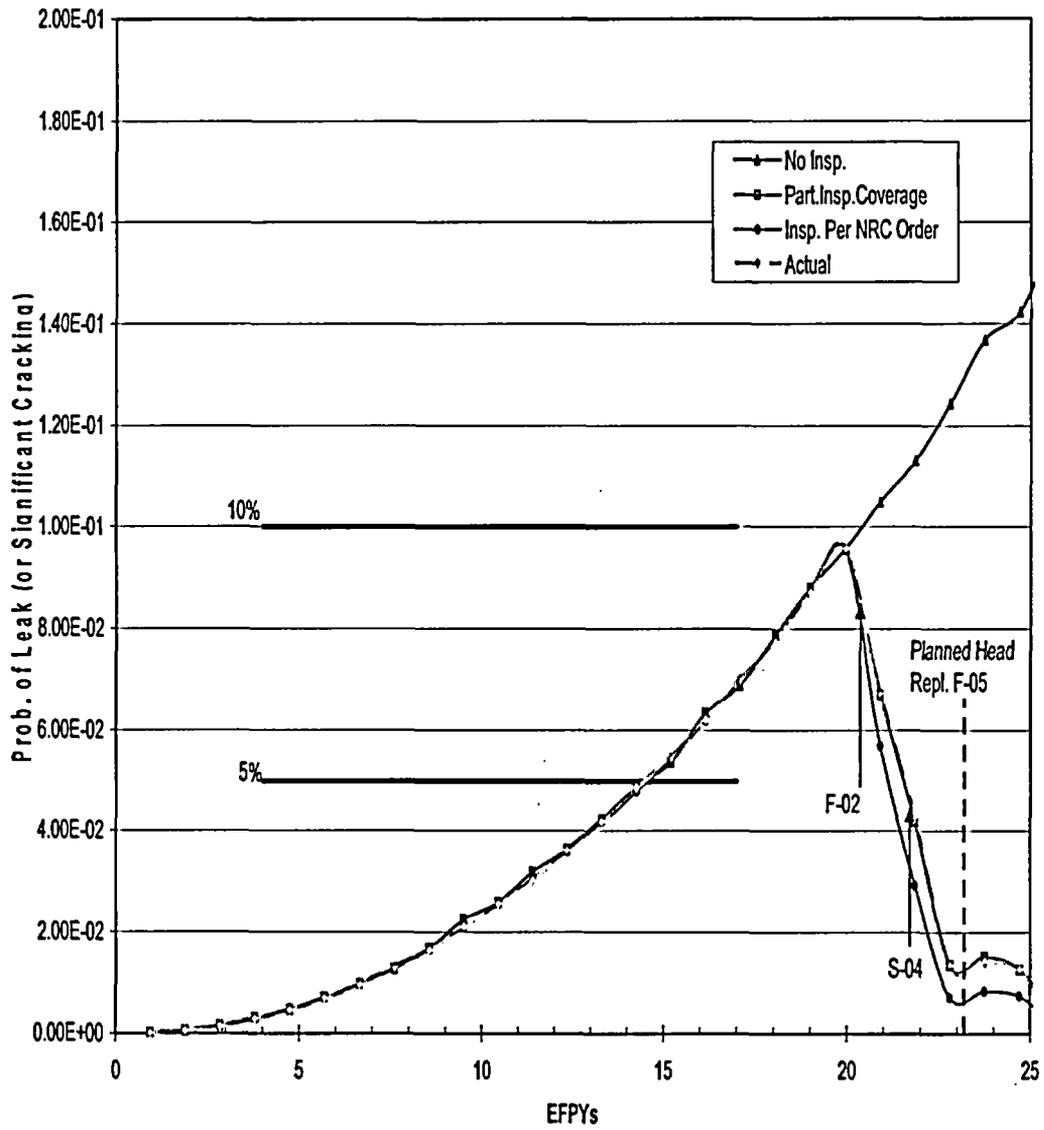
Figure 1
Probability of Leakage at PBNP U1

2. In preparation for the underhead inspection during U1R28, NMC contracted SIA to assess the probability of leakage at PBNP U1 as a precaution in case the site was not able to obtain 100% examination coverage. The model used by SIA has been submitted to NRC, (MRP-105, Probabilistic Fracture Mechanics Analysis of PWR Reactor Pressure Vessel Top Head Nozzle Cracking, March, 2004) and is benchmarked on real data at thirty- (30) plants that have performed nozzle NDE, of which fourteen (14) have experienced leaks or cracks. The results of this work indicate that the probability of leakage over the next operating cycle at PBNP U1 is < 1.5%. This information is illustrated in Figure 1. The NRC has stated that a probability of leakage of <5% would seem appropriate and consistent with other regulatory positions (Letter, Richard Barrett to Alex Marion, "Initial Comments and Questions on MRP-75, PWR Reactor Pressure Vessel Upper Head Penetrations Inspection Plan, Rev. 1", December 9, 2003).

As noted above, the site has confirmed structural integrity by verifying that the absence of axial and circumferential flaws in the alloy 600 CRDM tubing at or above the J-groove weld. Leak integrity is verified by the absence of axial and circumferential flaws in the alloy 600 tubing, absence of corrosion products in the counter bore region adjacent to the alloy 600 tubing above the j-groove weld, and absence of boric acid crystals on the reactor vessel head. Thus, it is known with certainty that leakage through the J-groove welds has not occurred at any time at PBNP U1. While PBNP U1 is not managing PWSCC by leakage (since no leakage has occurred or is allowed by the Technical Specifications) the site has taken steps to quantify and manage the probability of leakage over the next operating cycle when the reactor vessel head will be replaced. The probabilistic analysis by SIA demonstrates that the site is effectively managing the
