From: Patrick Loudon *Bill*  
To: Harold Chernoff *MR*  
Date: Tue, Jun 29, 2004 9:13 AM  
Subject: Fwd: Point Beach AFW Recirc Valve Pneumatic Capacity

**From:** Paul Krohn  
**To:** Burgess, Sonia; Loudon, Patrick > R111  
**Date:** Mon, Jun 28, 2004 6:55 PM  
**Subject:** Point Beach AFW Recirc Valve Pneumatic Capacity

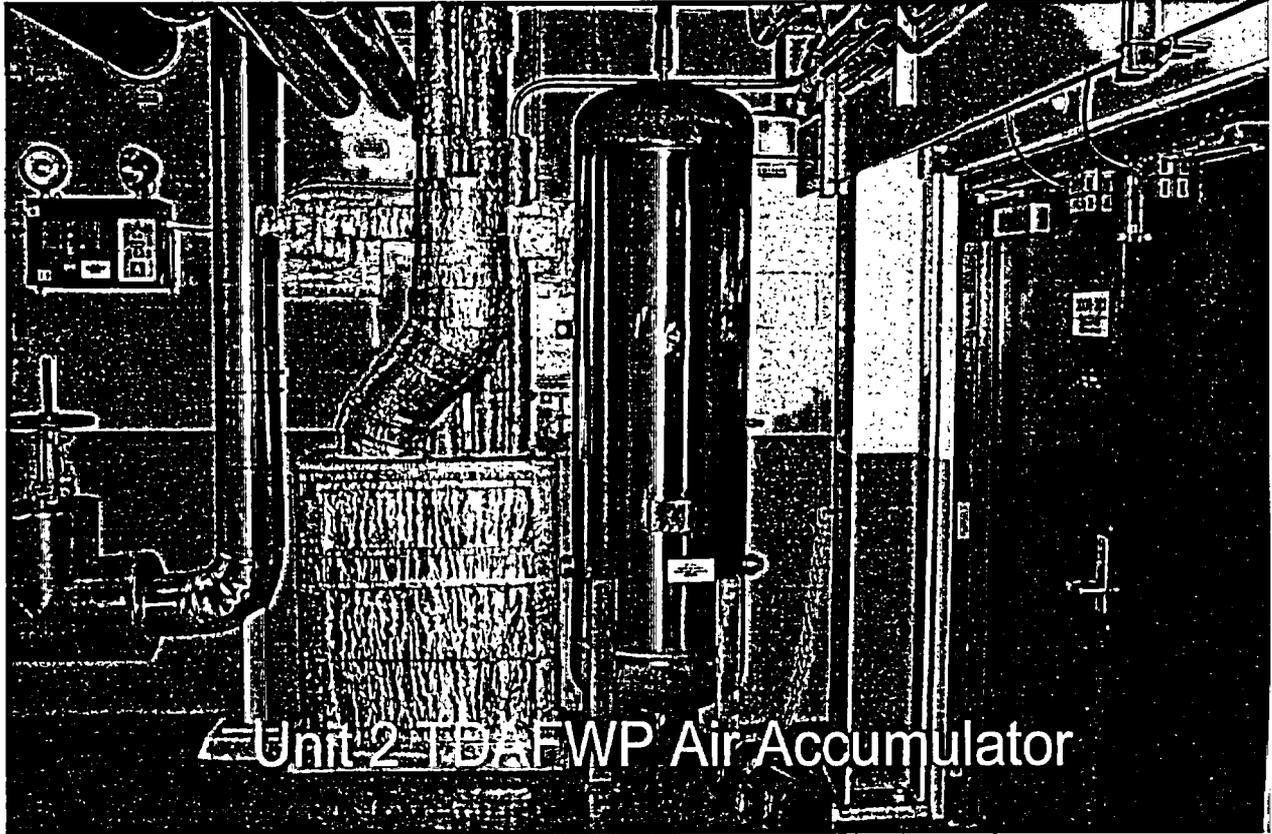
1) the TDAFWP would require a 211 gallon accumulator to provide 10 strokes/hour for 2 hours. The actual accumulator has a volume of 150 gallons.

Unit 2 TBAFWP Air Accumulator

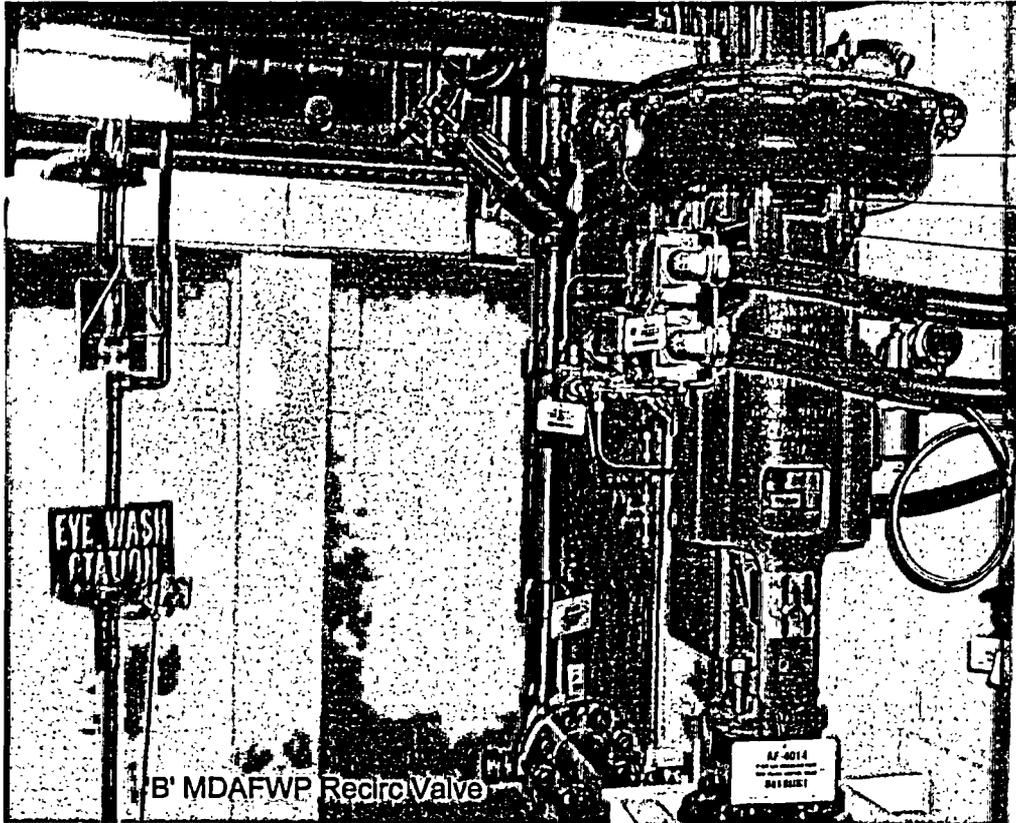
Actual walkdown of the installed configuration in the field has revealed gaps ranging between 7/8" to 1 and 7/8."

Moves  
Gap  
Fixed

'B' MDAFWP Recirc Valve
