RE: St. Lucie Unit 2
Docket No. 50-389
NRC Order EA-03-009 – Reactor Vessel Head and
Vessel Head Penetration Nozzle Inspection Results SL2-15

NRC Order EA-03-009: Reactor Pressure Vessel Head and Vessel Head Penetration Nozzle Post Outage SL2-15 Inspection Results

St. Lucie Unit 2 January/February 2005 (SL2-15) Post Outage Reactor Vessel Upper Head Inspection Results:

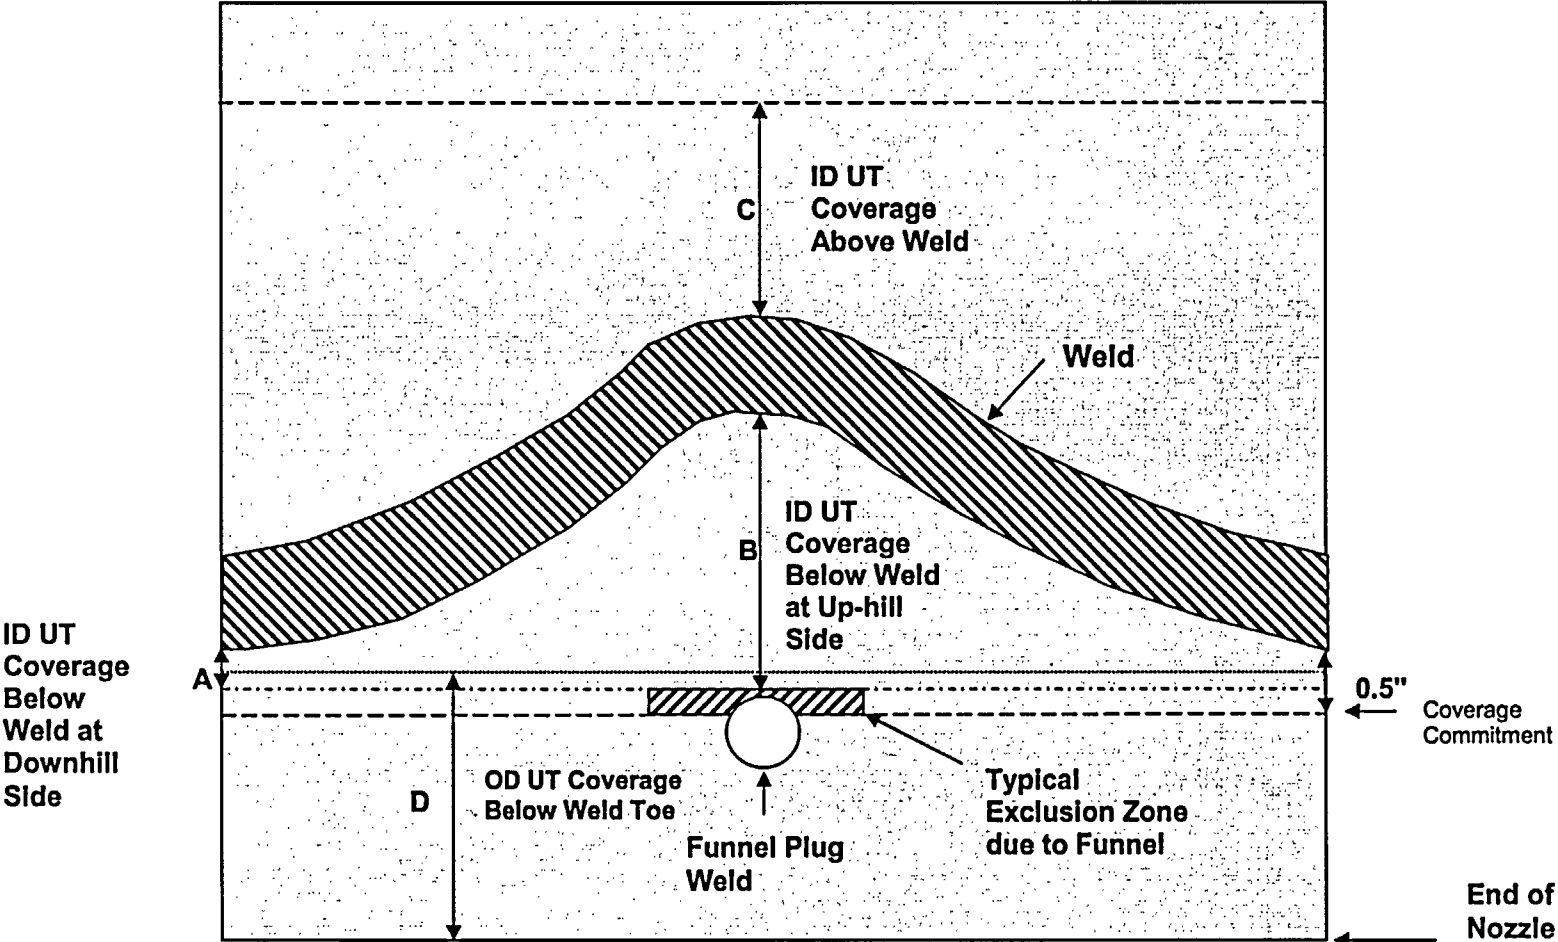
Figure 1: Sketch of St, Lucie Unit 2 Nozzle Coverage Limitations Below the Weld Toe and Funnel Plug Weld

Supplemental OD NDE was required on 17 CEDM nozzles to obtain the required examination area below the weld. The OD NDE method included UT and manual dye penetrant (PT). A limitation was experienced on 14 CEDM nozzles, where the OD UT was utilized to extend the coverage below the weld toe. These limitations were caused by lift off at the funnel plug weld on the high hillside of the nozzle. The small lift off limitations were ≥ 3.80 inches below the weld toe and are described in the attached coverage assessment table. This supplemental OD NDE did not reveal any relevant indications.

Nozzle #	Required Coverage Below Weld (in.)	ID UT COVERAGE					OD UT COVERAGE			OD UT EXCLUSION ZONE (See Figure 1)				
		"A"	ID Coverage shortage below weld on downhill side of weld (in.)	"B"	"C"	Circ. ID Coverage (deg.)	"D"	ID/OD Axial Coverage Overlap (in.)	ID/OD Axial Coverage Gap (in.)	Coverage Impacted ?	Funnel plug weld exclusion zone (deg.)			Axial extent of weld plug exclusion in 1/2" band (in.)
		ID Coverage below weld on downhill side of weld (in.)		ID Coverage below weld on uphill side of weld (in.)	ID Coverage above weld on uphill side of weld (in.)		OD Coverage height from end of nozzle (in.)				Min	Max	Total	
54	0.5	0.43	0.07	3.91	3.90	360	Examined with OD PT			No				
59	0.5	0.32	0.18	3.80	3.90	360	1.10	0.225	None	Yes	165	204	39	0.18
66	0.5	0.44	0.06	4.08	4.30	360	1.10	0.225	None	Yes	154	210	56	0.06
70	0.5	0.43	0.07	4.68	4.55	360	1.25	0.375	None	Yes	153	212	59	0.07
75	0.5	0.43	0.07	4.26	2.80	360	1.20	0.325	None	Yes	154	210	56	0.07

- 1) Nozzle 89 coverage is limited 360 degrees for the axial extent listed as 0.075" and also limited by the funnel weld plug for the dimensions listed.
- 2) The angular coordinate for the OD UT was established visually by placing the transducer at the uphill side and declaring that position 180 degrees.
- 3) Position accuracy is estimated to be ± 20 degrees.
- 4) Nozzles 54, 85, and 89 were supplemented by PT examination on the nozzle OD to provide coverage of a band extending 0.5" below the weld toe.
