FAX CONTROL SHEETDATE: April 18, 2005Number of pages including this sheet 7

COMMENTS: **Part 21 Initial Notification and Preliminary Report - Cutler-Hammer A200 NEMA Size 1 Starters**

Equipment Identification: Starter, Non-Reversing, Size 1, 600VAC, 3 Pole, W/125VDC coil, Westinghouse/Cutler-Hammer P/N A200M1CS, Type B Thermal Overloads, Ambient Compensated, Manual Reset Only

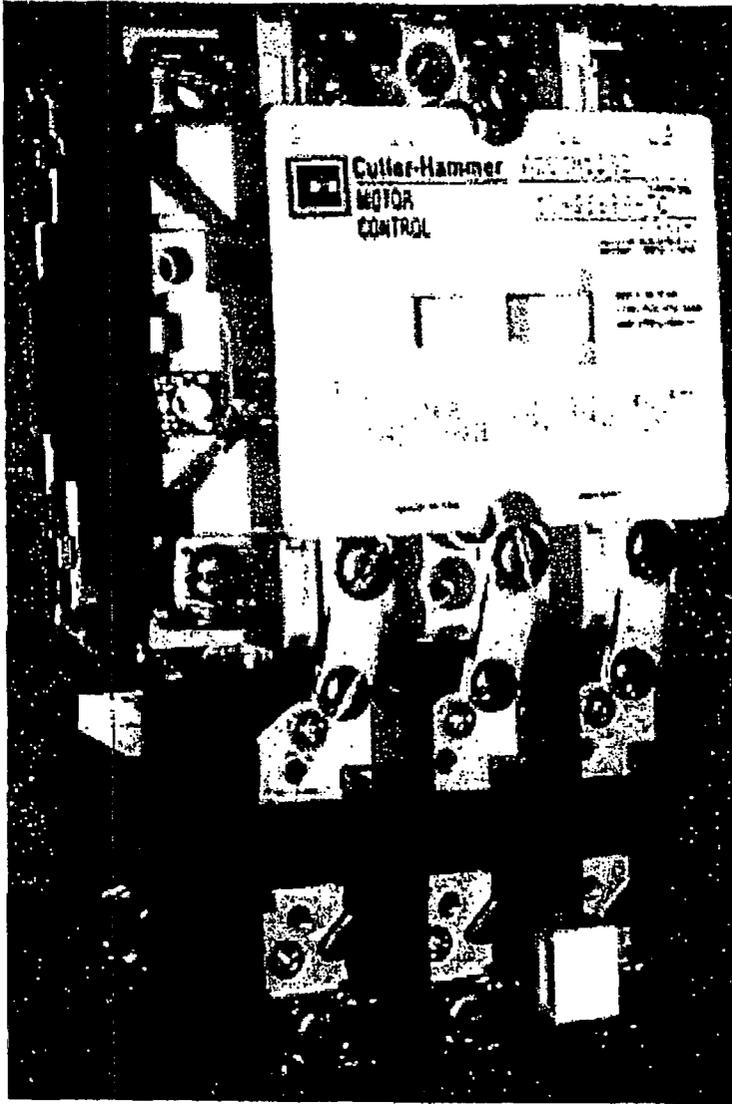
Figure 1. Contactor

Figure 1 (attached) shows the starter as received and the coil after removal from the starter. No other defects were seen in the starter assembly except for in the failed coil.

Cutler Hammer Motor Control

Motor Control Coil

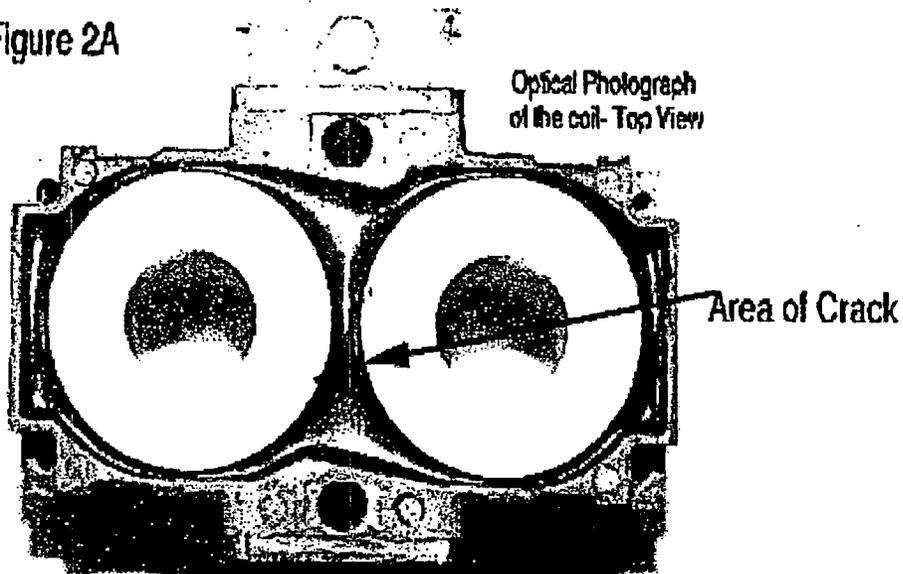
Figure 2A

Figure 2 (attached) shows: (A) an optical photograph of the coil before disassembly and sectioning, (B) a radiograph which identifies the crack location, and (C) an enlargement of the radiograph showing where the wire failed.

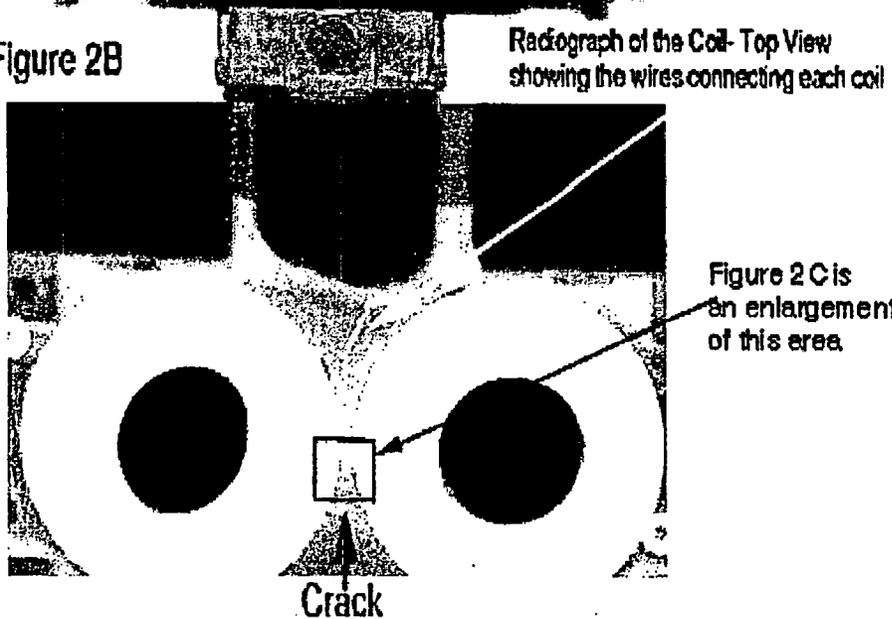
Figure 2B

It was determined that the failure is the result of a manufacturing defect in the epoxy surrounding the coil. The open circuit was caused when the epoxy cracked at the defect and broke a wire running through the epoxy. This wire connected the two coils and this failure caused the open circuit. The defect in the epoxy was caused by the tape surrounding the coils. A piece of the tape protruded into the area between the coils where the epoxy is poured. This created a weak area which resulted in the failure during service.

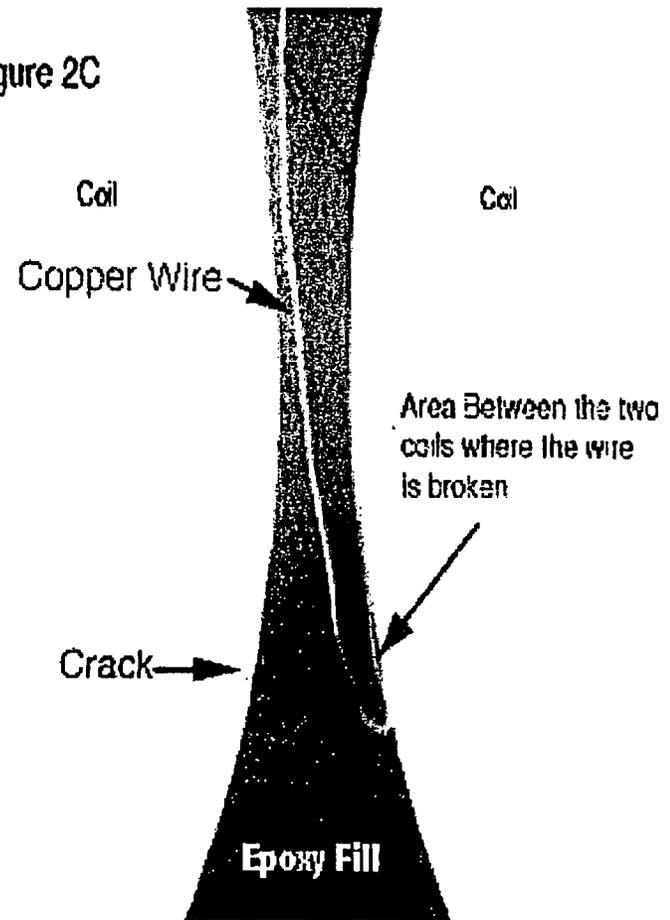
Figure 2C

Enlargement of Figure 2B Area between the two coils

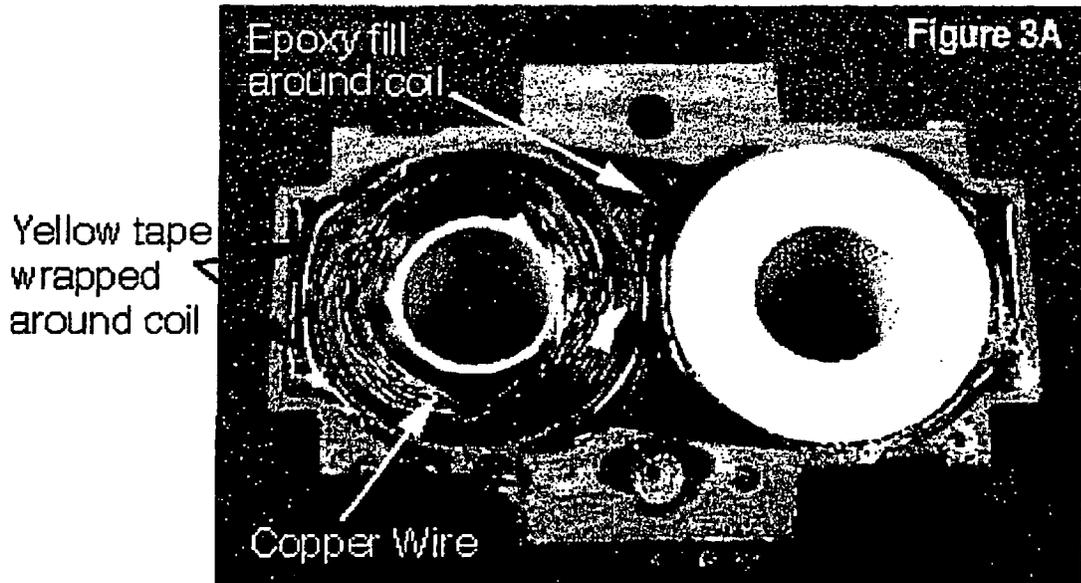
Figure 3 (attached) shows: (A) an optical photograph of the coil with one plastic cover removed. (B) the coil cross section. The coil was constructed by inserting the copper wire (wrapped in yellow tape) into the housing. Epoxy was then poured into the housing and hardened in stages. (C) shows the epoxy surface with the crack. Some of the copper wire and yellow tape has been removed to show the crack. Figure 3C shows the epoxy surface with the crack.

Top view of coil with plastic cover removed

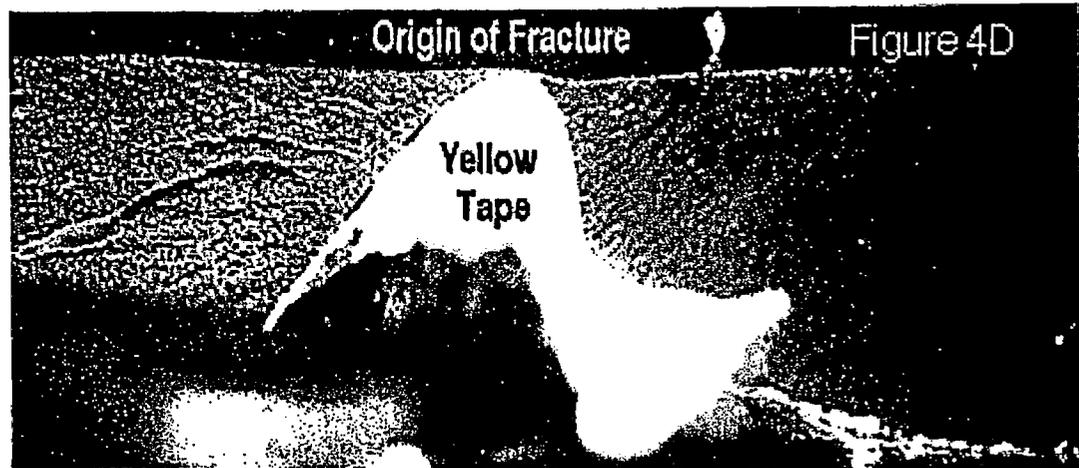
The epoxy also separates the two coils except for the copper wire running between them. The yellow areas seen in Figures 4A and 4C are where the yellow tape is sticking out into the epoxy. Figure 4A shows the cracked epoxy surface. The yellow area on the surface is where the tape protrudes into the epoxy. Figure 4B shows the surface of the fracture where the copper wire broke. Figure 4C is a scanning electron microscope photograph of the fracture surface showing the yellow tape. This is the area where the fracture originated. Figure 4D shows an optical photograph of the fracture origin. The fracture surface appears brittle and lines radiating away from the origin can be seen.

It is likely that the epoxy did not crack until the part was placed in service. Since the epoxy between the two coils was 90% penetrated by the tape, any normal vibration or heat cycling may have been enough to cause the crack.

Fracture surface where the incursion of tape caused a weak area in the epoxy

Ginna plans to examine any additional pre-mature failures for presence of cracks. They are also radiographing selected starters from the same lot for the presence of defects and will take additional actions based upon their findings or based upon the manufacturer's recommendations.
