COMMENTS: **Part 21 Initial Notification and Preliminary Report - Cutler-Hammer A200 NEMA Size 1 Starters**

Equipment Identification: Starter, Non-Reversing, Size 1, 600VAC, 3 Pole, W/125VDC coil, Westinghouse/Cutler-Hammer P/N A200M1CS, Type B Thermal Overloads, Ambient Compensated, Manual Reset Only

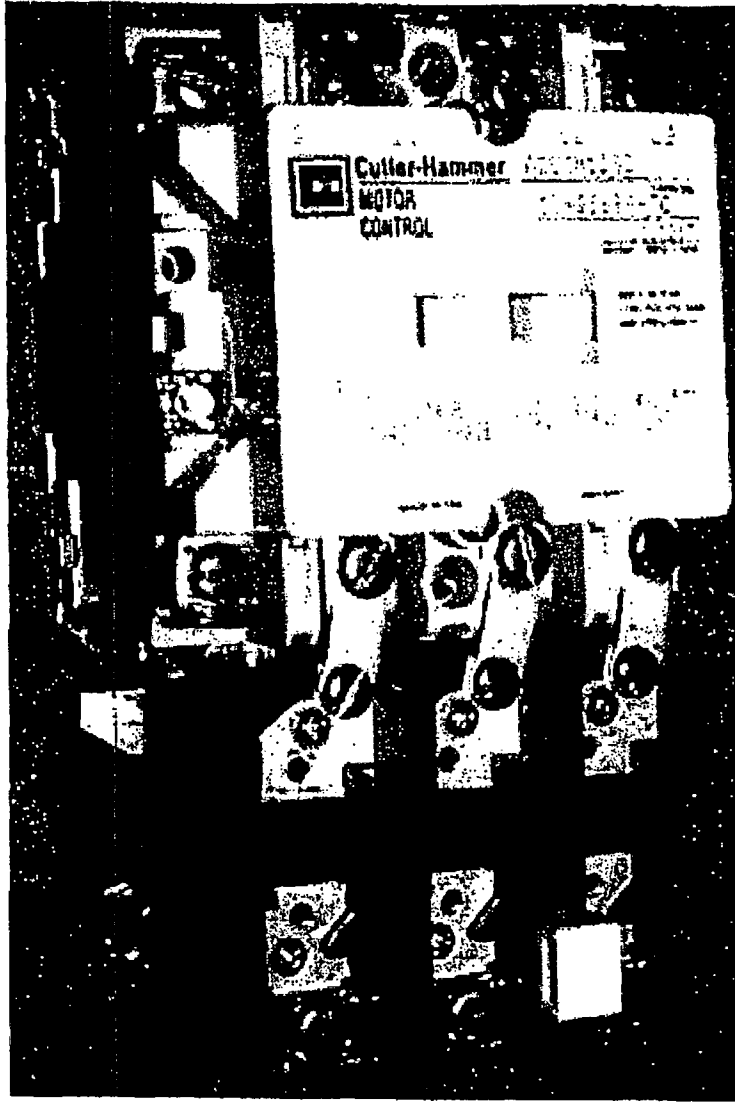
Figure 1. Contactor

Figure 1 (attached) shows the starter as received and the coil after removal from the starter. No other defects were seen in the starter assembly except for in the failed coil.

Cutler Hammer Motor Control

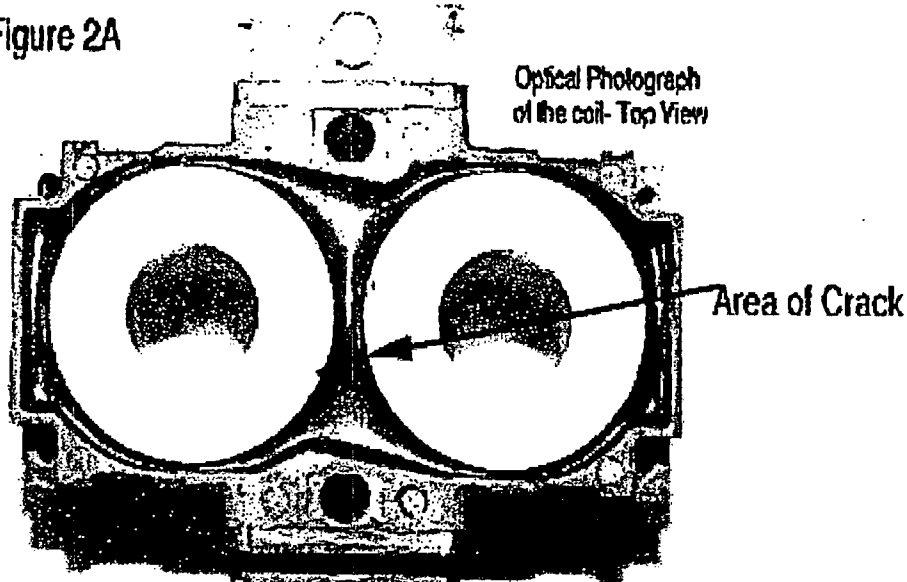
Figure 2A

Figure 2 (attached) shows: (A) an optical photograph of the coil before disassembly and sectioning, (B) a radiograph which identifies the crack location, and (C) an enlargement of the radiograph showing where the wire failed.

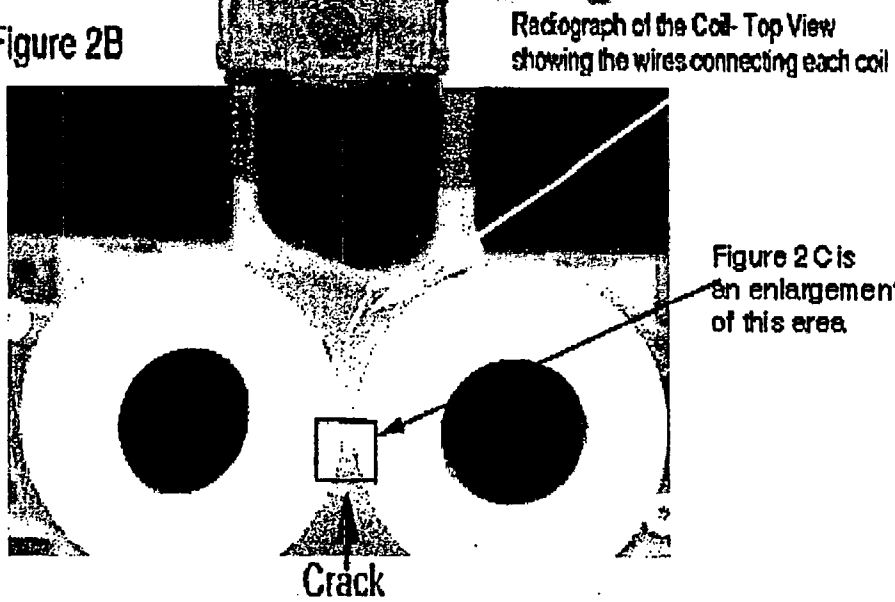
Enlargement of Figure 2B Area between the two coils

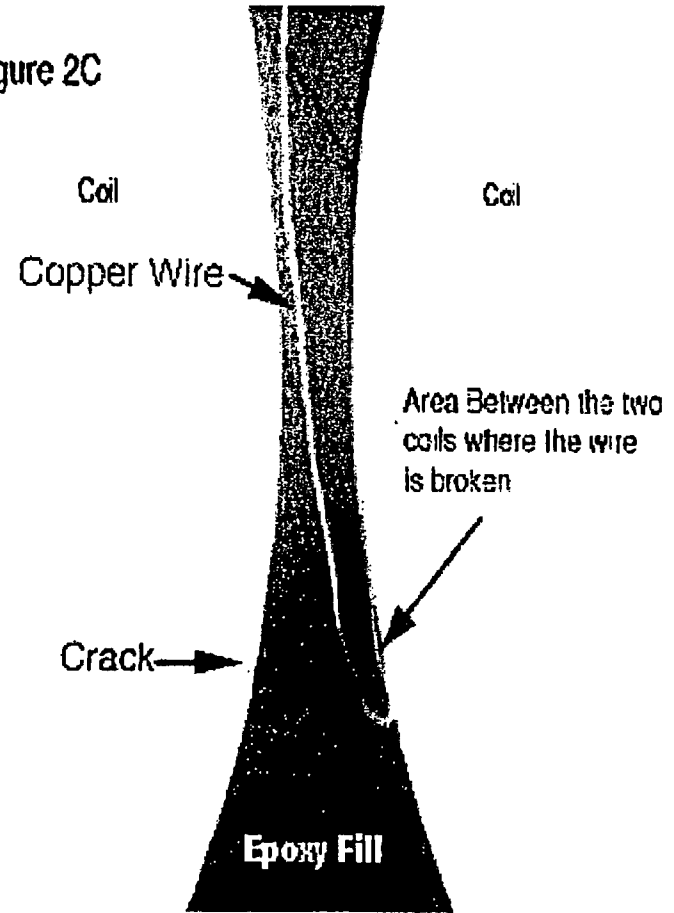
Figure 2C

It was determined that the failure is the result of a manufacturing defect in the epoxy surrounding the coil. The open circuit was caused when the epoxy cracked at the defect and broke a wire running through the epoxy. This wire connected the two coils and this failure caused the open circuit. The defect in the epoxy was caused by the tape surrounding the coils. A piece of the tape protruded into the area between the coils where the epoxy is poured. This created a weak area which resulted in the failure during service.

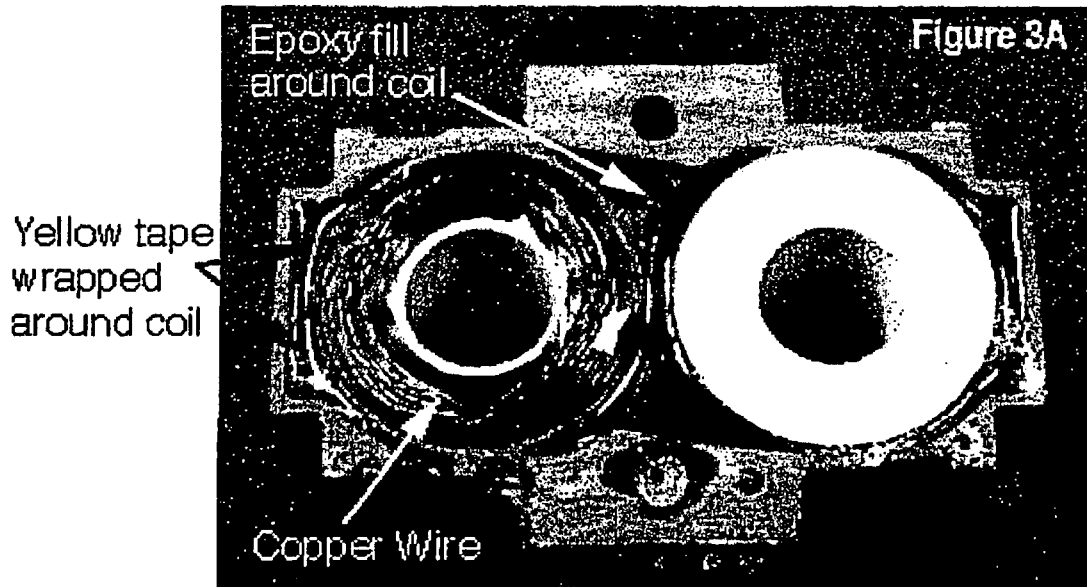
Figure 3 (attached) shows: (A) an optical photograph of the coil with one plastic cover removed. (B) the coil cross section. The coil was constructed by inserting the copper wire (wrapped in yellow tape) into the housing. Epoxy was then poured into the housing and hardened in stages. (C) shows the epoxy surface with the crack. Some of the copper wire and yellow tape has been removed to show the crack. Figure 3C shows the epoxy surface with the crack.

Top view of coil with plastic cover removed

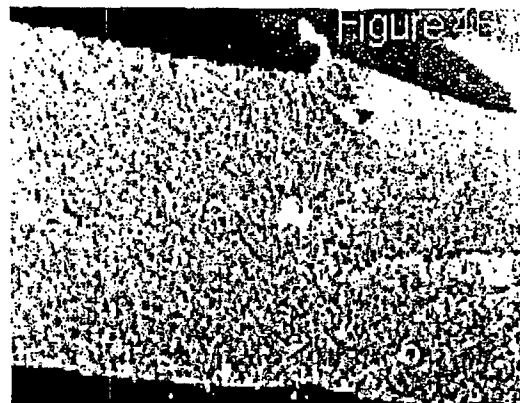
The epoxy also separates the two coils except for the copper wire running between them. The yellow areas seen in Figures 4A and 4C are where the yellow tape is sticking out into the epoxy. Figure 4A shows the cracked epoxy surface. The yellow area on the surface is where the tape protrudes into the epoxy. Figure 4B shows the surface of the fracture where the copper wire broke. Figure 4C is a scanning electron microscope photograph of the fracture surface showing the yellow tape. This is the area where the fracture originated. Figure 4D shows an optical photograph of the fracture origin. The fracture surface appears brittle and lines radiating away from the origin can be seen.

SEM Photo of the tape defect Magnification ~25x

Fracture Surface with broken wire

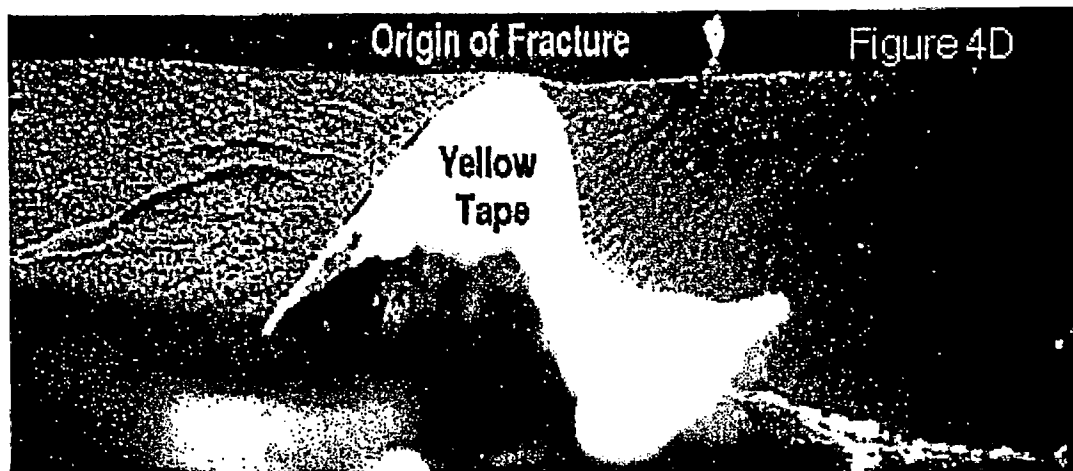
Figure 4D

It is likely that the epoxy did not crack until the part was placed in service. Since the epoxy between the two coils was 90% penetrated by the tape, any normal vibration or heat cycling may have been enough to cause the crack.

Origin of Fracture

Yellow Tape

Fracture surface where the incursion of tape caused a weak area in the epoxy
