# OEM Unqualified Coatings Testing

Washington D.C. / Rockville  
April 12-13, 2005

*Timothy Eckert*  
*PSE Project Manager*  
*eckertt@epri.com*  
*704 547-6058*

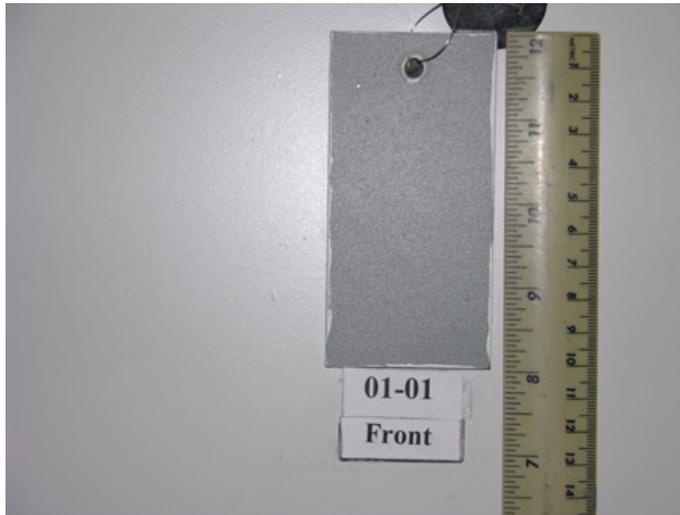
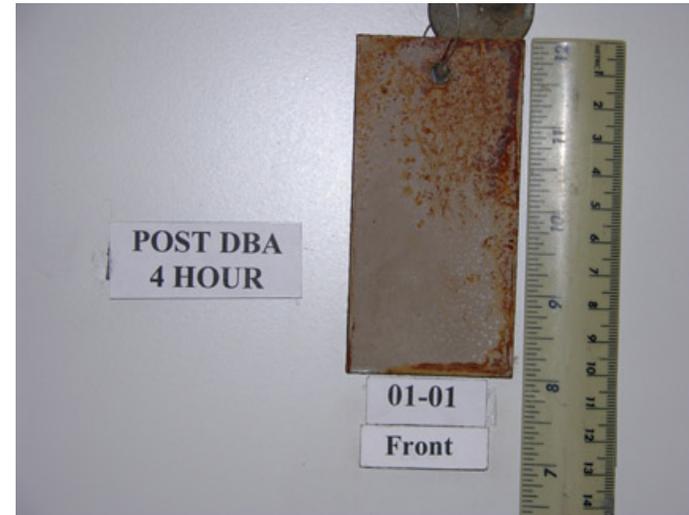
# OEM Unqualified Coating Sample# 01

- OEM Coats # 01; Panel from a transformer; Alkyd; No. 8 medium dense blistering on upper half with some broken and rust/rust stain Lower right half has some flaking Approximately 5% Delamination of Coating

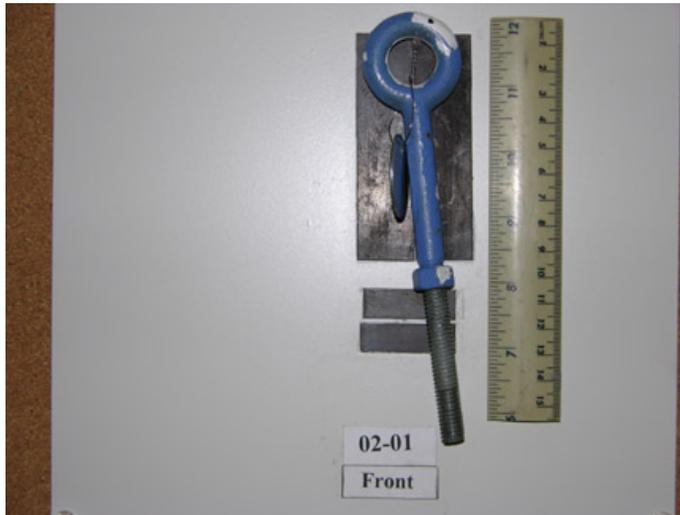
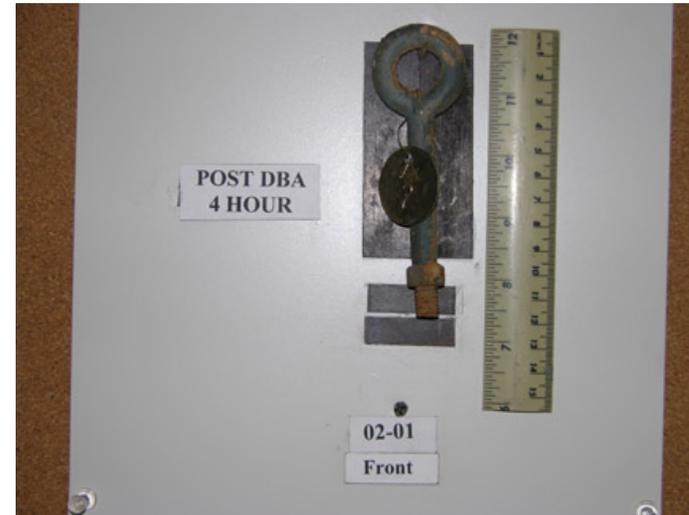
## OEM Unqualified Coating Sample# 02

- OEM Coats # 02; Blue eye bolt from Limitorque operator; Coating type not available; Coating bubbled and delaminated from substrate What remains is loosely attached Approximately 60% Delamination of Coating

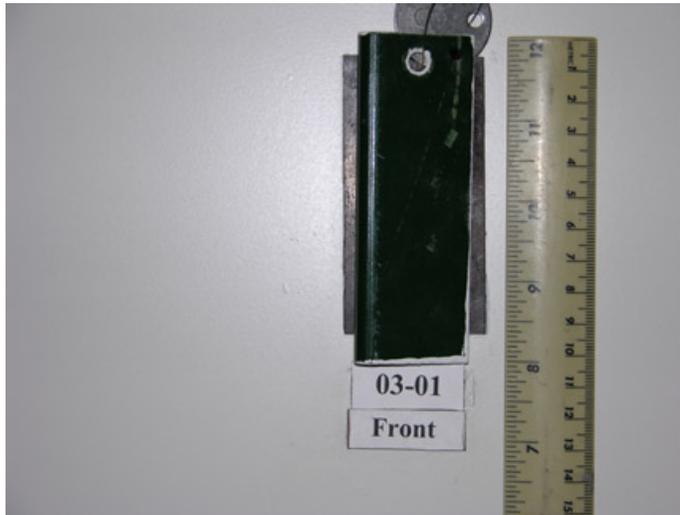
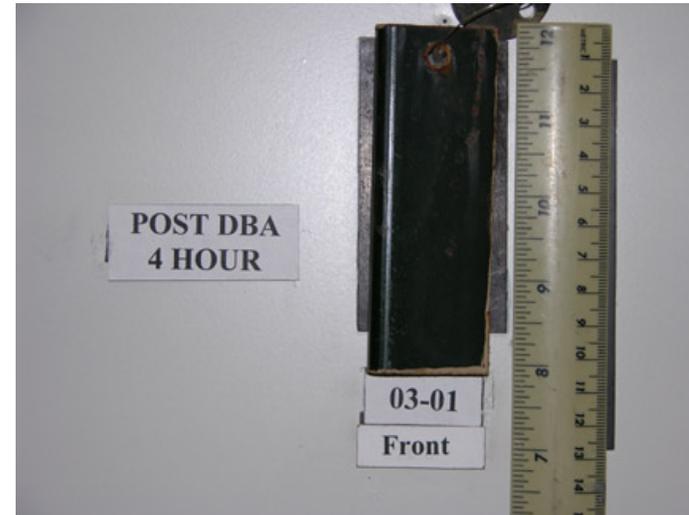
## OEM Unqualified Coating Sample# 03

- OEM Coats # 03; Piece of green unistrut; Styrenated acrylic; Minor rust upper right corner, from mechanical damage. Coating intact, no other defects 0% Delamination of Coating

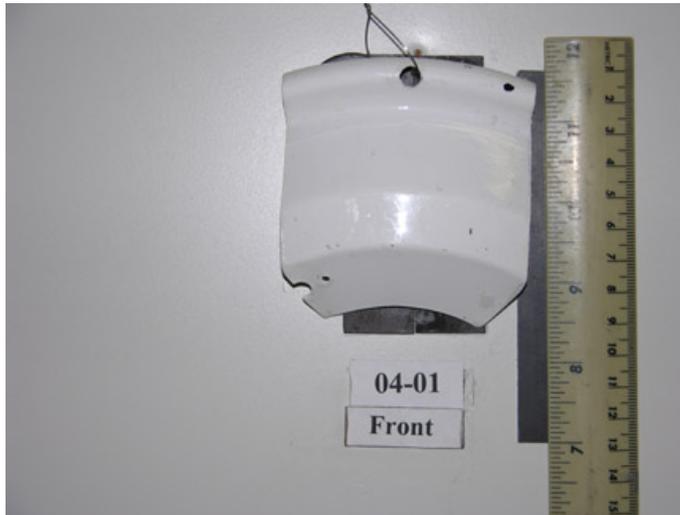
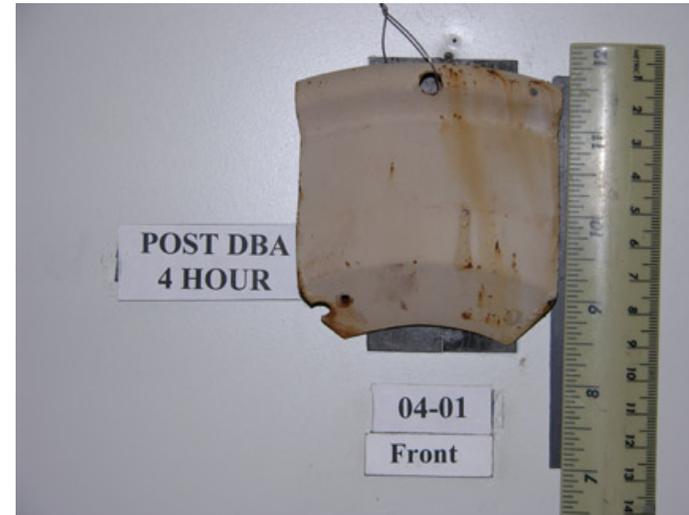
## OEM Unqualified Coating Sample# 04

- OEM Coats # 04; White light fixture; Urethane; Localized areas of No. 6-8 medium dense to dense blisters. Several blisters have broken and delaminated, causing rust to form <5% Delamination of Coating

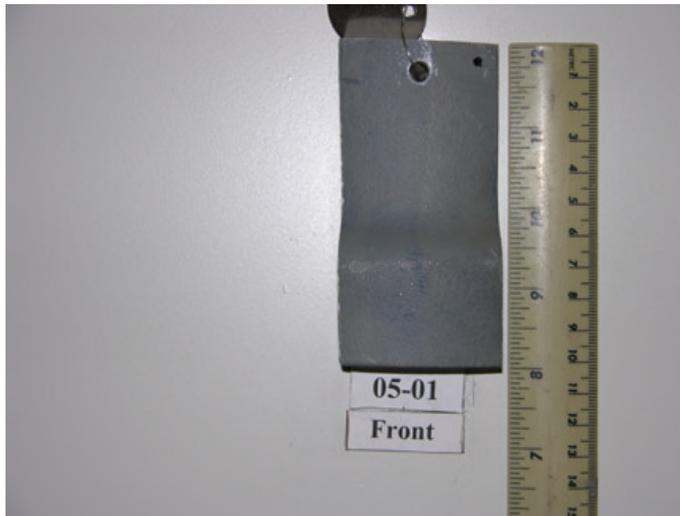
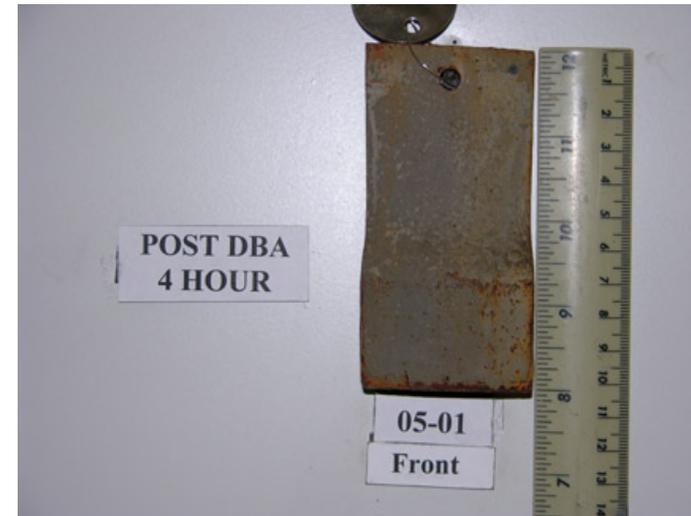
## OEM Unqualified Coating Sample# 05

- OEM Coats # 05; Cap from a Foxboro transmitter; Epoxy; No. 6-8 medium dense intact blistering over entire panel. Curved surface has >#2 dense. Some pinpoint rusting from broken blisters <5% Delamination of Coating

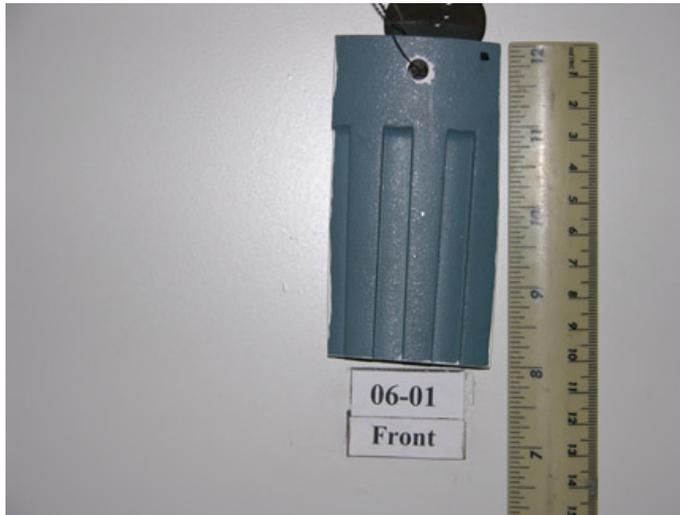
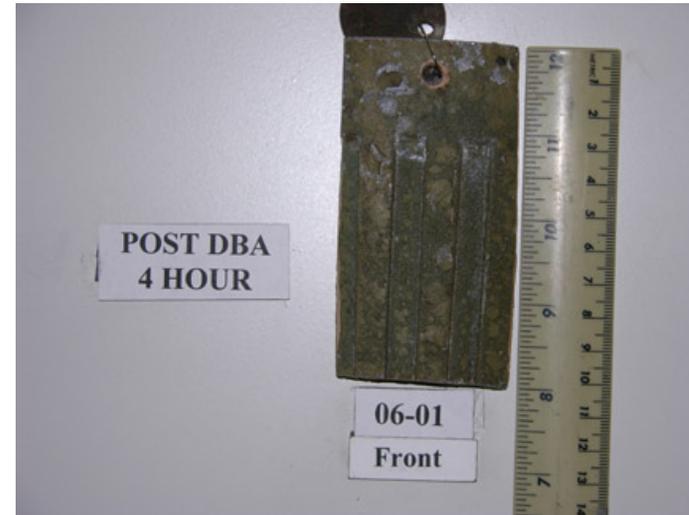
## OEM Unqualified Coating Sample# 06

- OEM Coats # 06; Cap from a Foxboro transmitter; Epoxy Ester; No. 4-8 dense blistering entire panel. > No. 2 medium, some broken and delaminated. Oxide formation on exposed surface. Approximately 5% Delamination of Coating

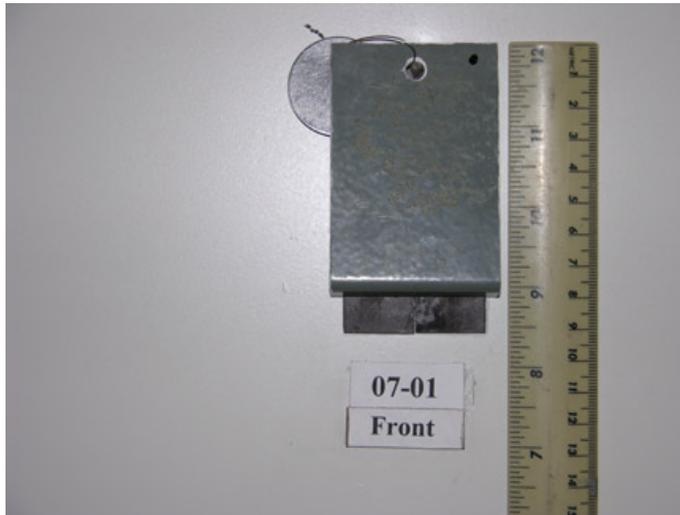
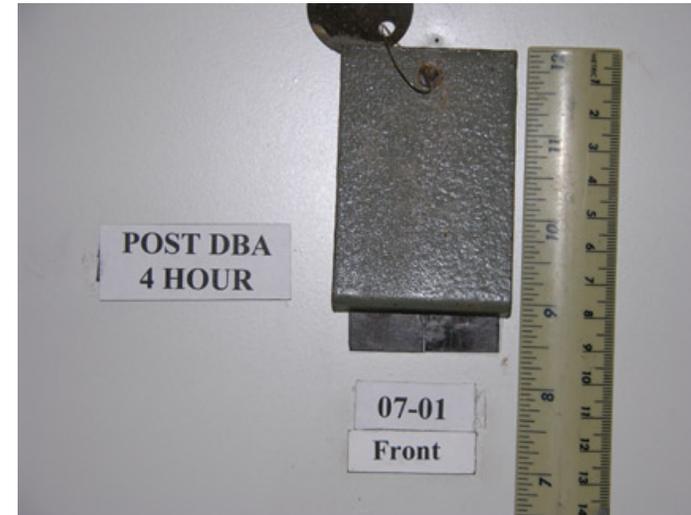
## OEM Unqualified Coating Sample# 07

- OEM Coats # 07; Cover from an electrical j-box; Epoxy; No. 4 dense blistering entire panel. When viewed under magnification blisters have a spotted black appearance. 3 rust spots located on bottom curved surface. Coating intact, no other defects. <5% Delamination of Coating

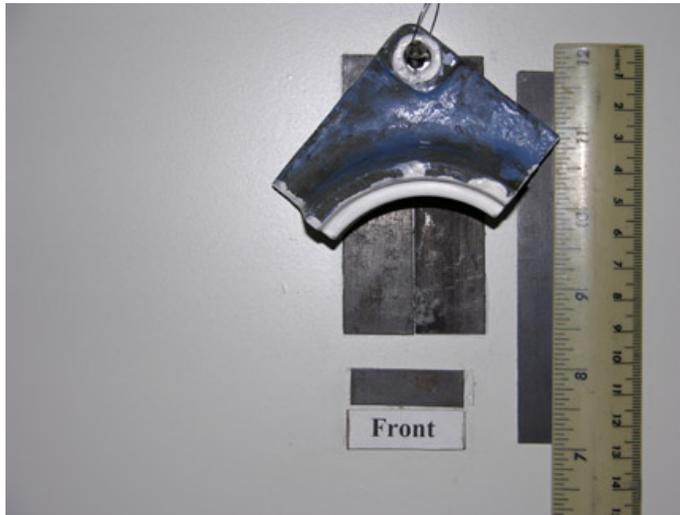
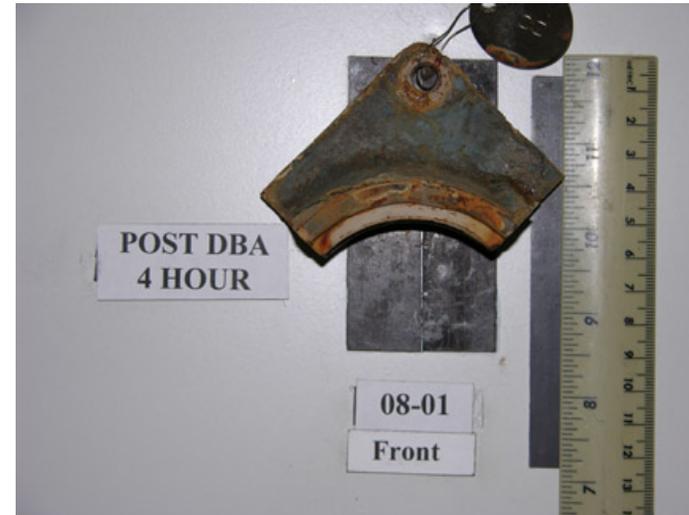
## OEM Unqualified Coating Sample# 08

- OEM Coats # 08; Blue/purple (damaged) bearing housing from a Limitorque operator; Epoxy; No. 2-8 dense blistering entire surface. Coating is attached but dis-bonded. Approximately 10% Delamination of Coating

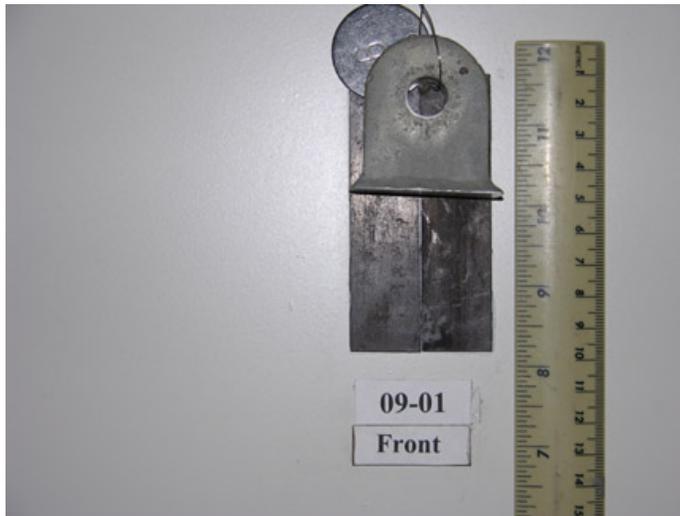
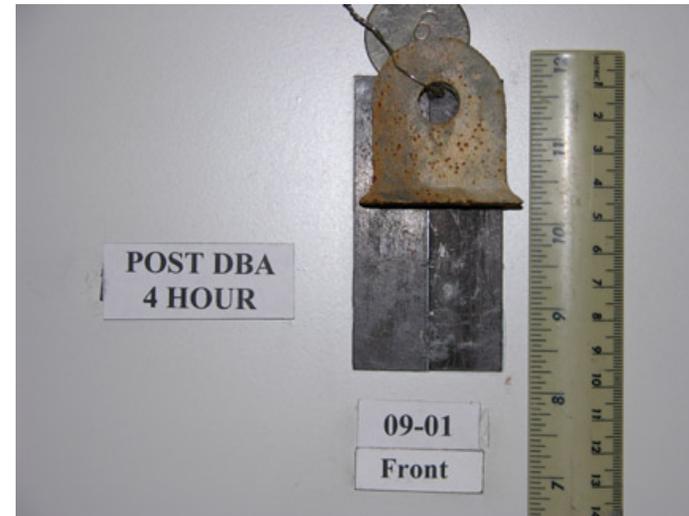
## OEM Unqualified Coating Sample# 09

- OEM Coats # 09; Piece of gray zinc primed strut body; Appears to be a residue, not a coating – possibly rusted galvanizing; Oxide formation on surface, some pinpoint rusting. No other defects. 0% Delamination of Coating

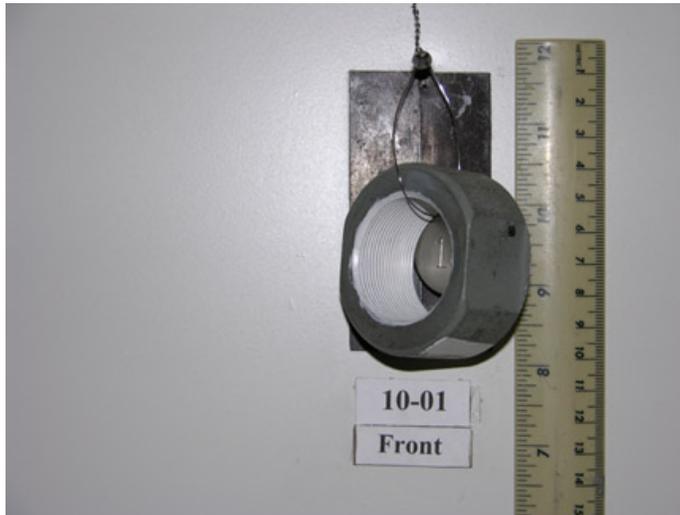
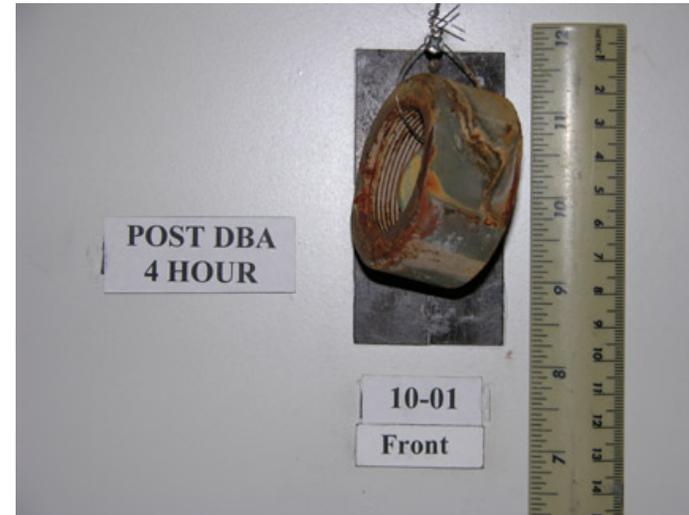
# OEM Unqualified Coating Sample# 10

- OEM Coats # 10; Piece of gray strut body; Inorganic zinc rich; Some rusting. Coating intact, no other defects. <1% Delamination of Coating

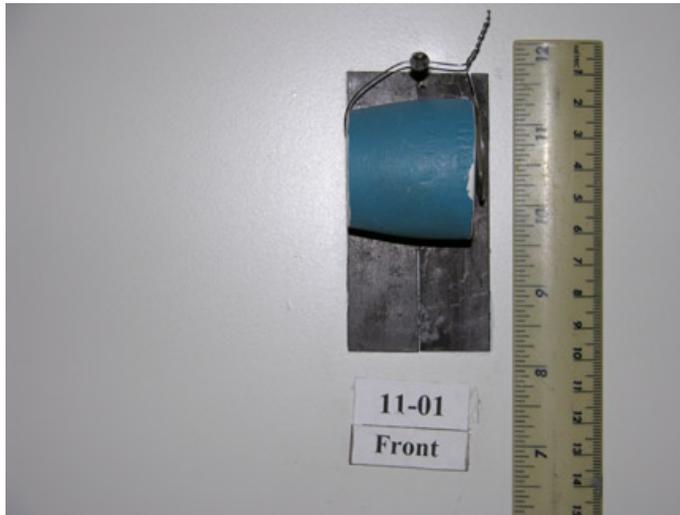
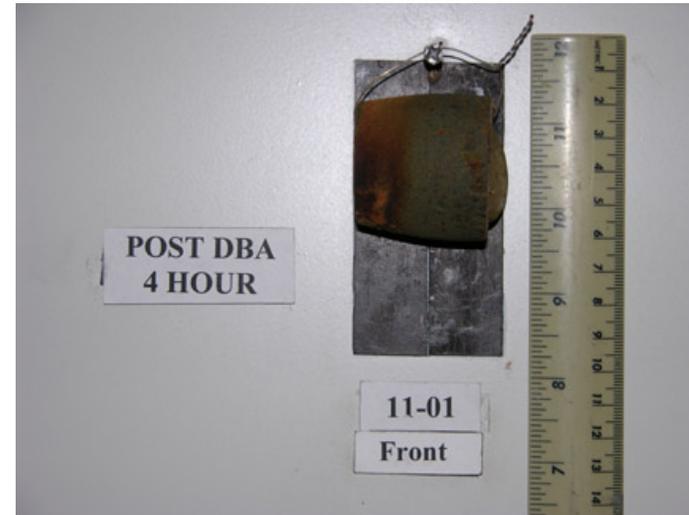
# OEM Unqualified Coating Sample# 11

- OEM Coats # 11; Piece of blue strut body; Moisture-cured urethane; 1 rust spot from delaminated coating. Coating intact, no other defects. <5% Delamination of Coating.

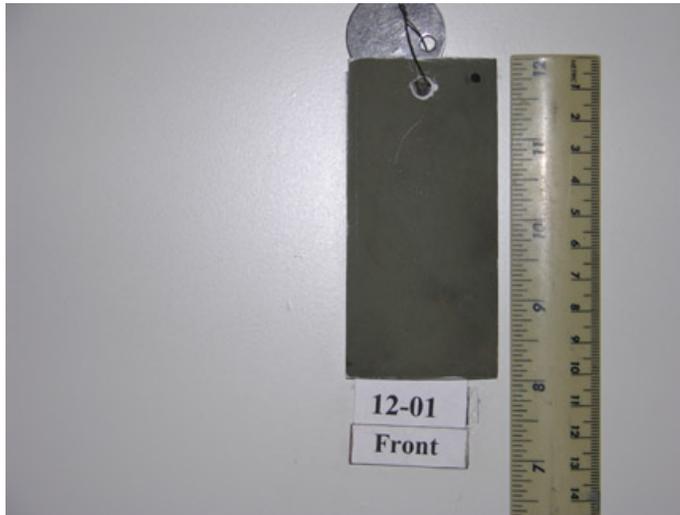
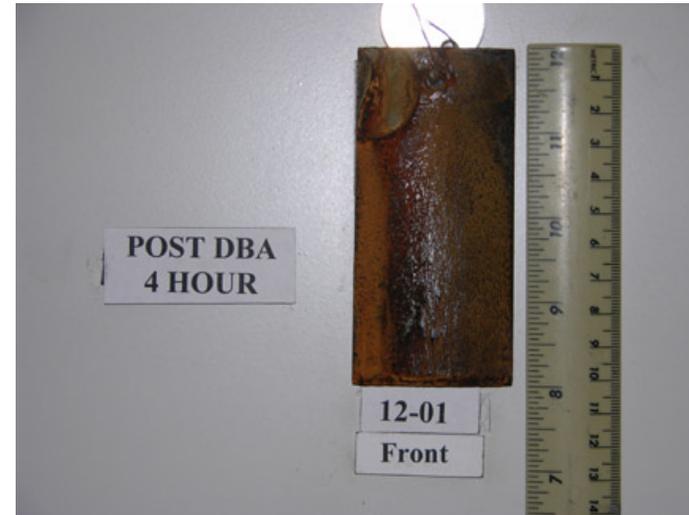
## OEM Unqualified Coating Sample# 12

- OEM Coats # 12; Limitorque motor; Inorganic zinc rich; Near complete coating failure, heavy rust. 95% Delamination of Coating.

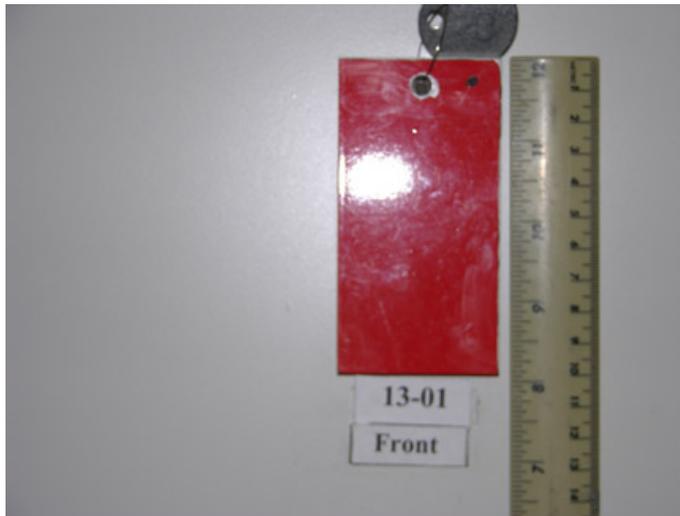
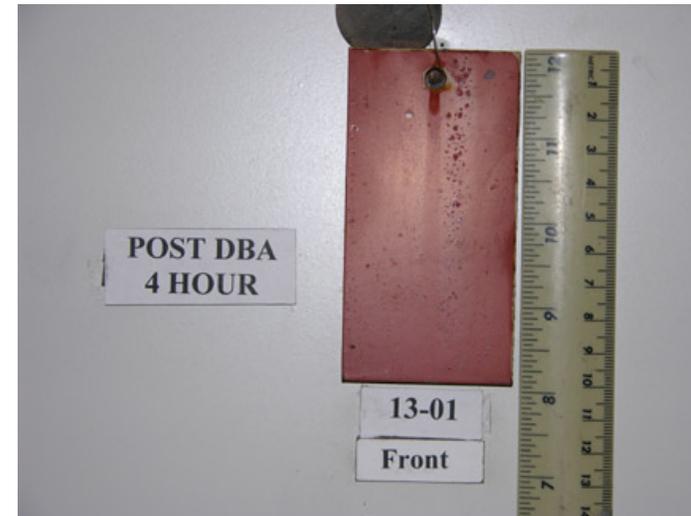
## OEM Unqualified Coating Sample# 13

- OEM Coats # 13; Piece of orange plate from a crane; Urethane; No. 6-8 few blisters. Coating intact, no other defects. 0% Delamination of Coating.

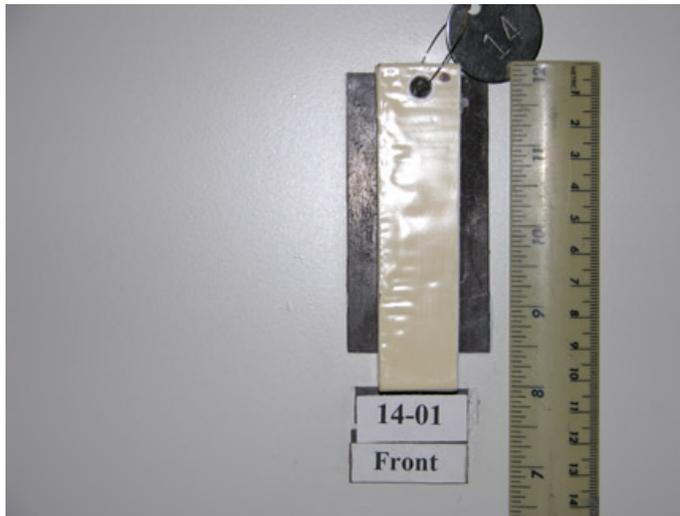
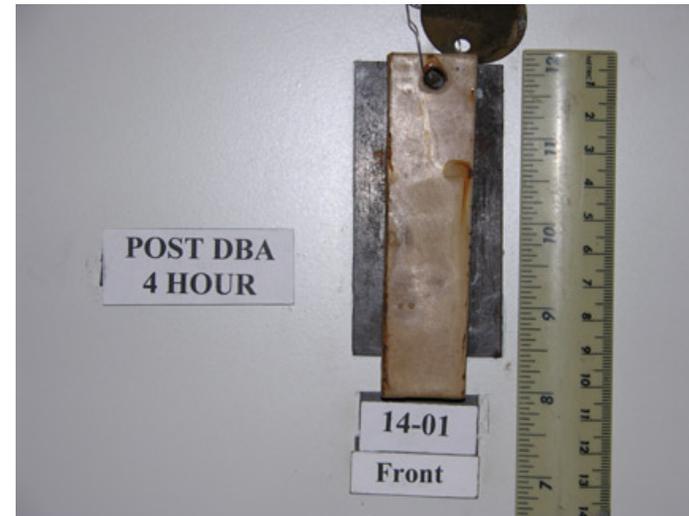
## OEM Unqualified Coating Sample# 14

- OEM Coats # 14; Piece of yellow steel. Repair paint from W RCP motor shop; Epoxy ester; No. 6 few blisters, 1 crack right side with rusting Coating intact, no other defects. 0% Delamination of Coating.

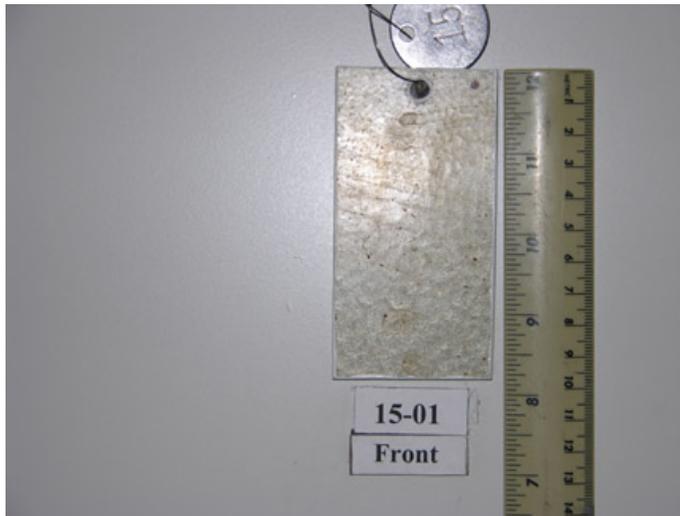
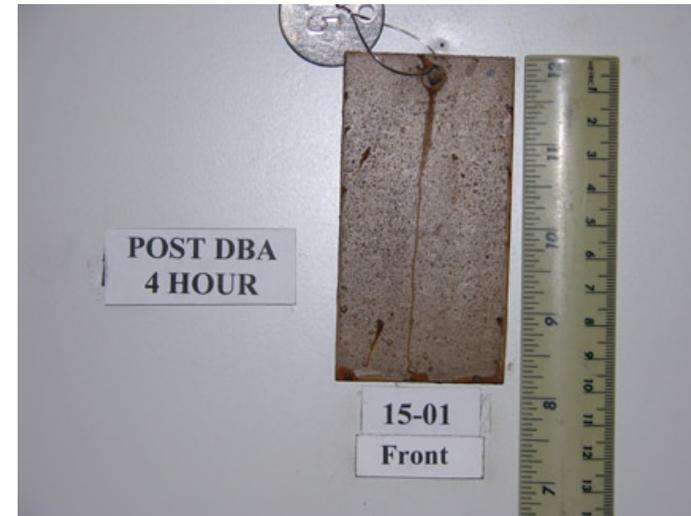
# OEM Unqualified Coating Sample# 15

- OEM Coats # 15; “Austin brand” electrical junction box, gray; Vinyl toluene modified alkyd; No. 8 dense blisters entire panel, localized #2-4 medium dense, few rust spots Coating intact, no other defects. <1% Delamination of Coating.

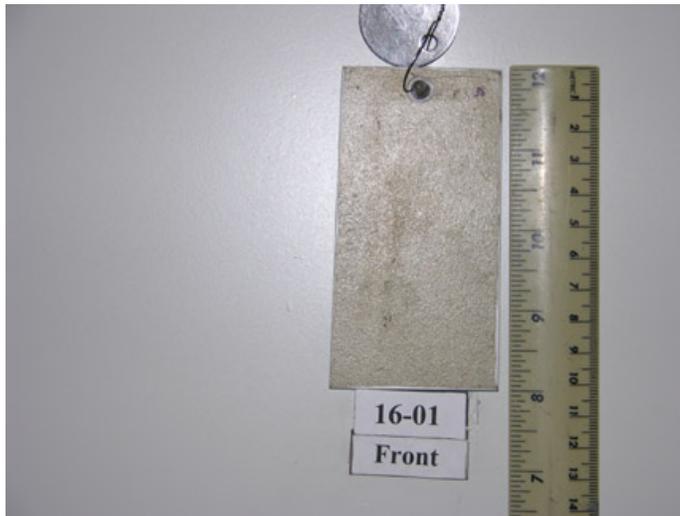
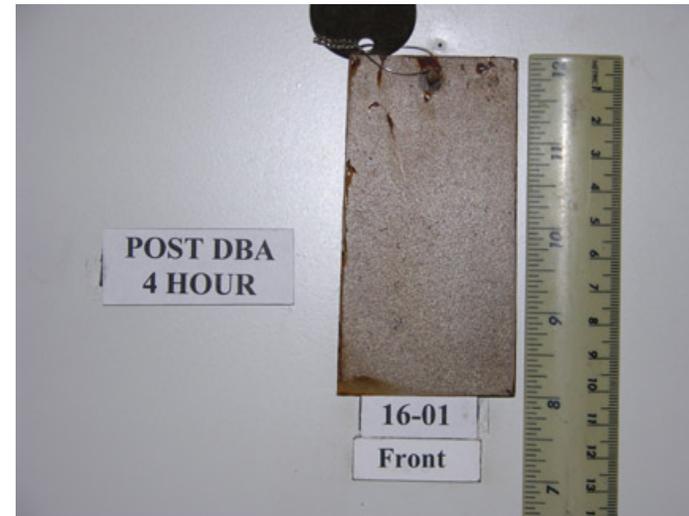
## OEM Unqualified Coating Sample# 16

- OEM Coats # 16; “Austin brand” electrical junction box, gray Vinyl toluene modified alkyd; Coating cracked, few rust spots, some flaking <5% Delamination of Coating.

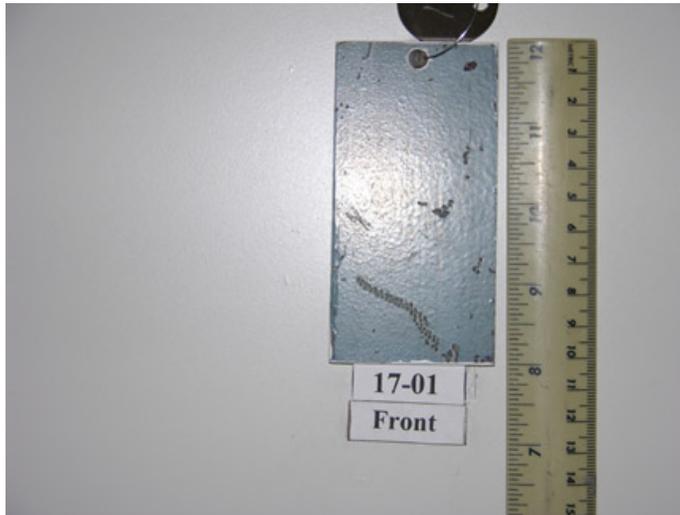
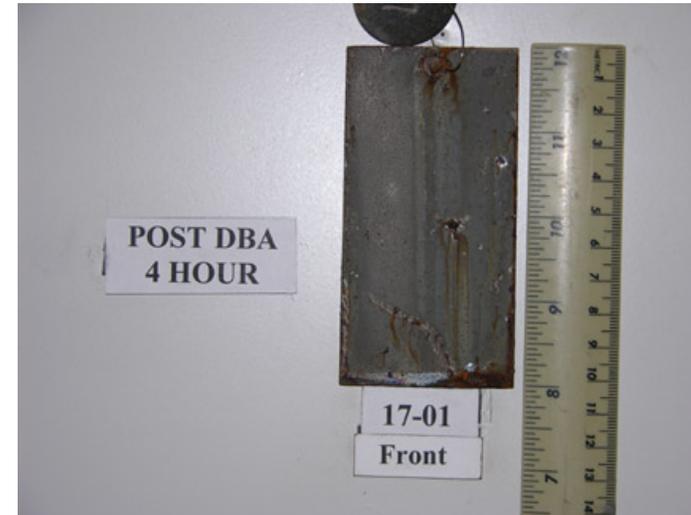
# OEM Unqualified Coating Sample# 17

- OEM Coats # 17; “Austin brand” electrical junction box, gray; Vinyl toluene modified alkyd; No. 8 dense, few rust spots Coating intact, no other defects <1% Delamination of Coating.

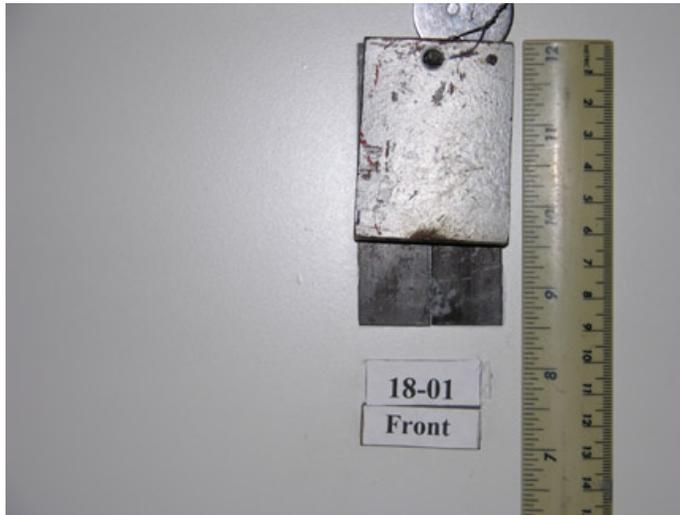
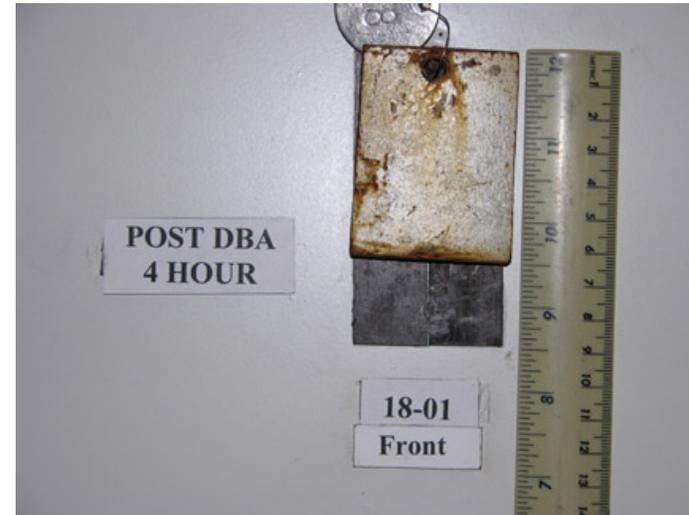
## OEM Unqualified Coating Sample# 18

- OEM Coats # 18; Pipe hanger, silver; Alkyd; Few rust spots <1% Delamination of Coating.

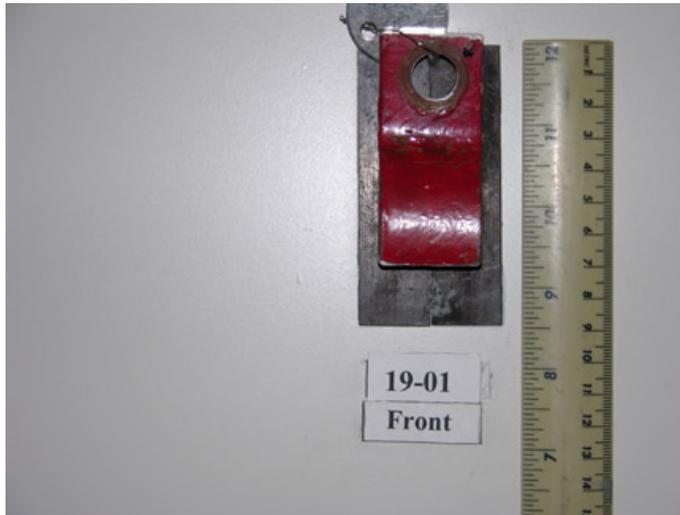
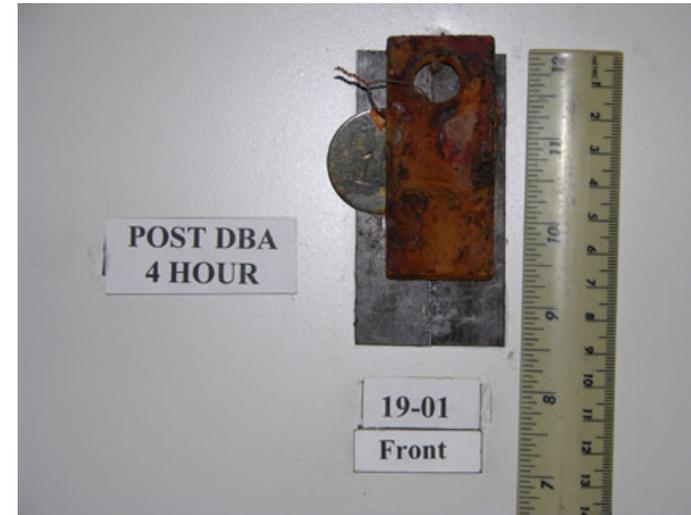
## OEM Unqualified Coating Sample# 19

- OEM Coats # 19; Small pipe hanger, red; Alkyd; Heavy rust, delamination. Approximately 95% Delamination of Coating.

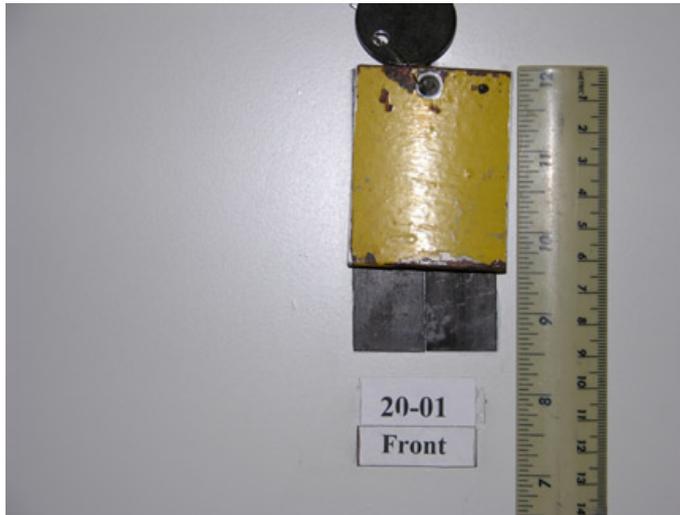
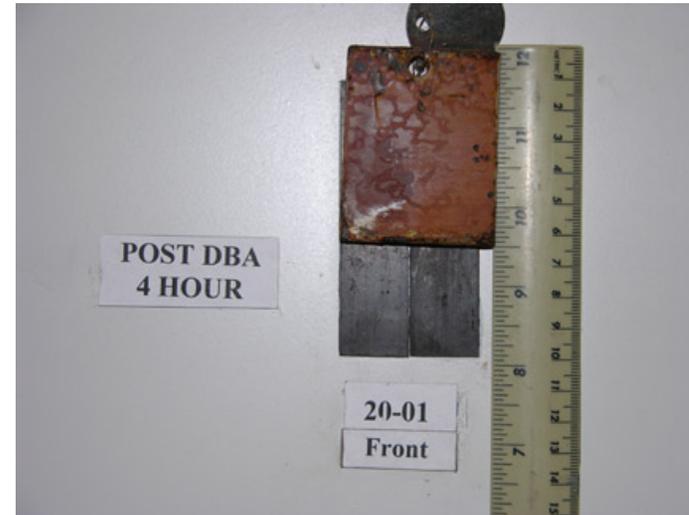
## OEM Unqualified Coating Sample# 20

- OEM Coats # 20; Pipe hanger, yellow; Alkyd; 100% of topcoat delaminated, primer intact. 5% of panel rusted. Approximately 55% Delamination of Coating 50% topcoat, 5% primer.

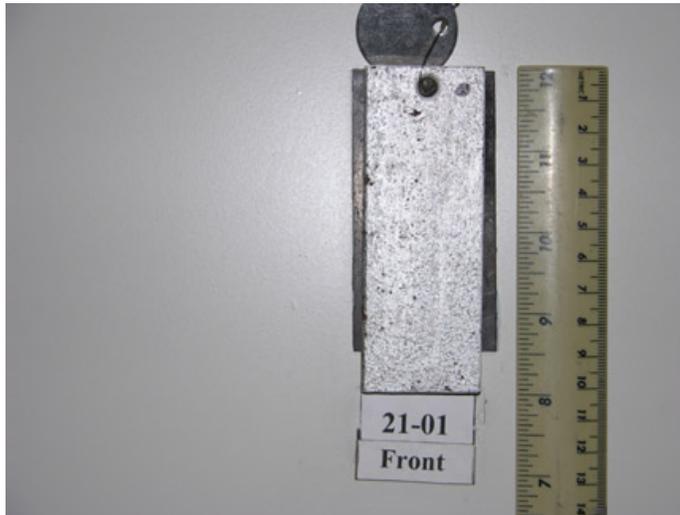
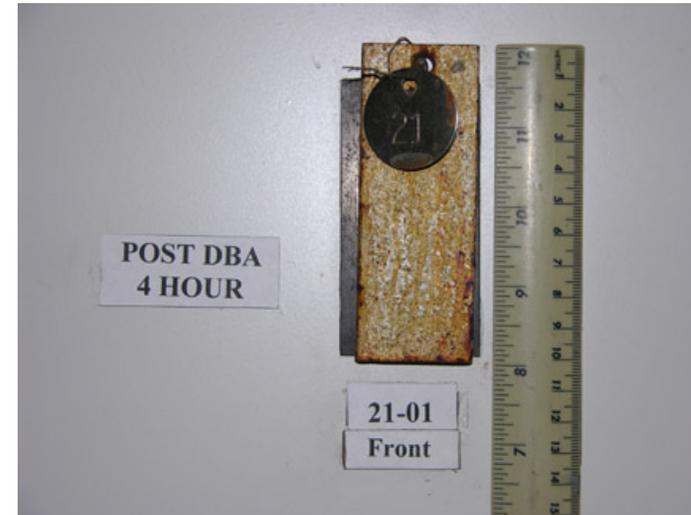
# OEM Unqualified Coating Sample# 21

- OEM Coats # 21; Piece of angle iron, silver; Alkyd; No. 6-8 medium blisters, some broken with rust. Rust stain on 100% of panel. <5% Delamination of topcoat.

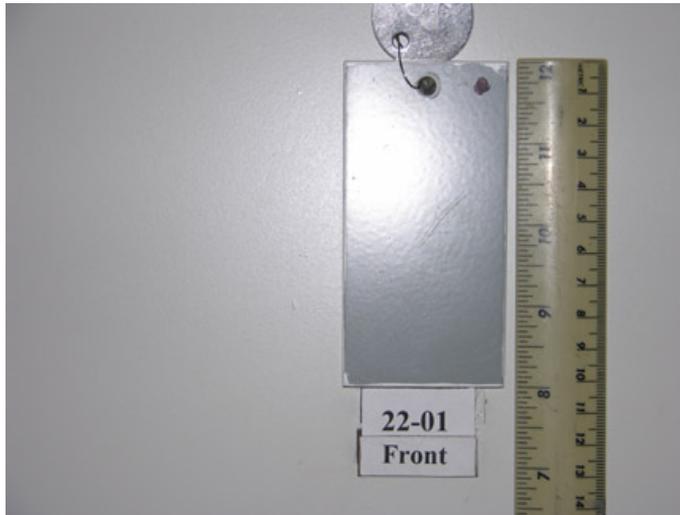
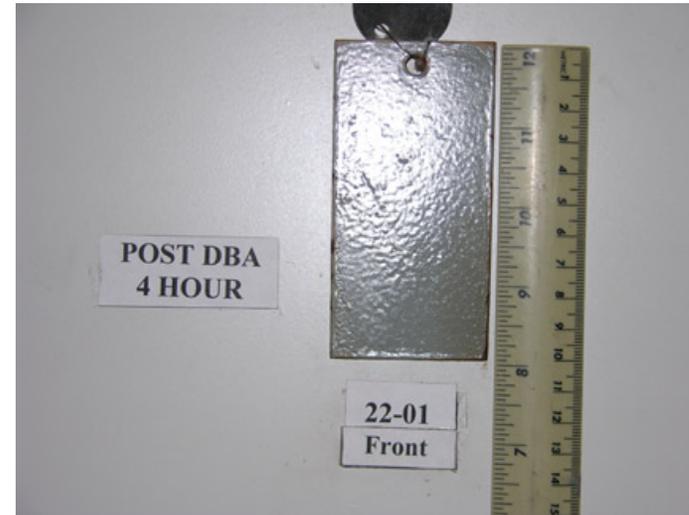
## OEM Unqualified Coating Sample# 22

- OEM Coats # 22; “Hoffman brand” electrical j-box, gray; Alkyd; No. 6-8 few blisters, some broken Coating intact, no other defects <1% Delamination of coating.

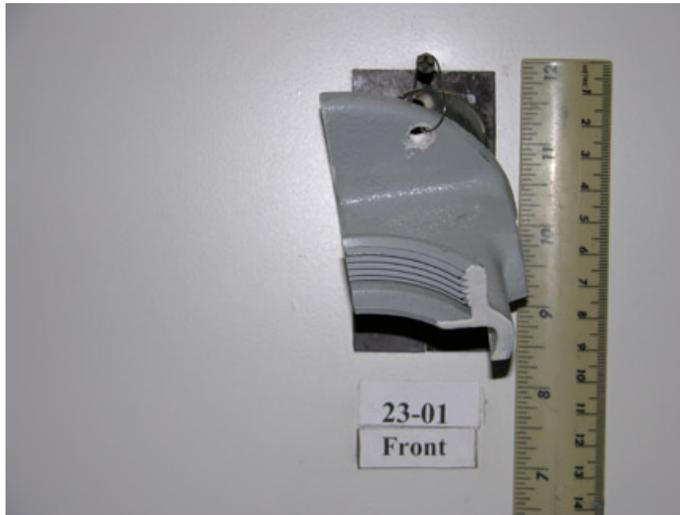
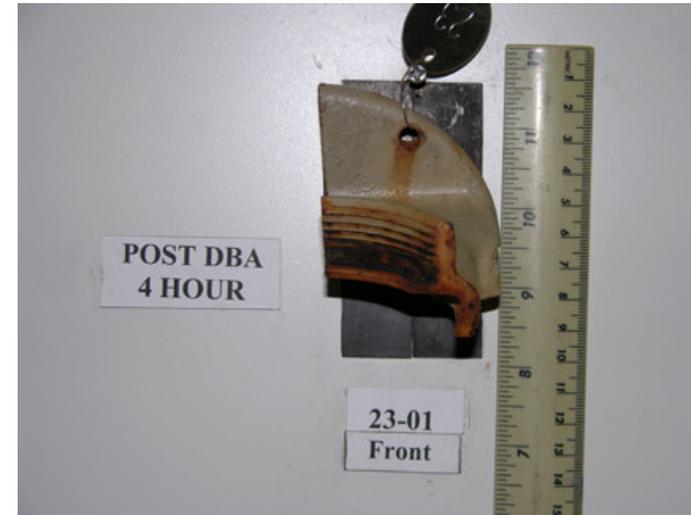
## OEM Unqualified Coating Sample# 23

- OEM Coats # 23; Electrical lamp fixture, gray; Epoxy; Several rust spots causing. Approximately 1% delamination. Coating intact, no other defects.

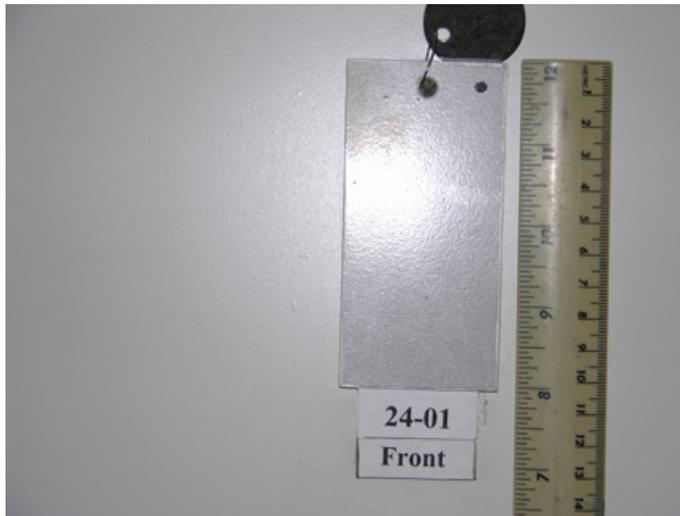
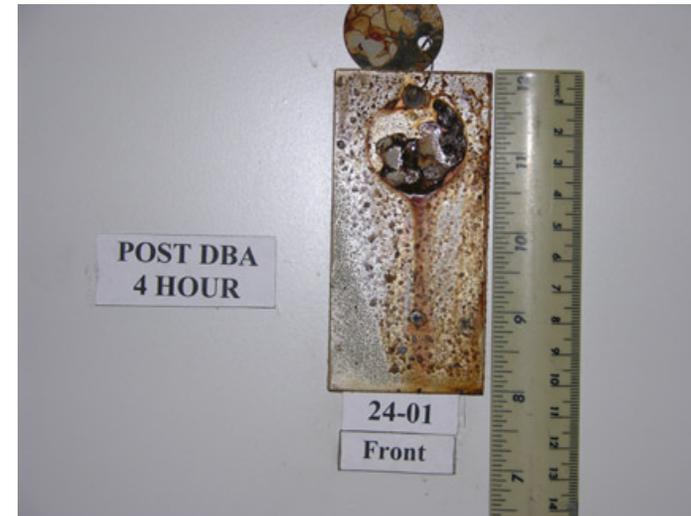
## OEM Unqualified Coating Sample# 24

- OEM Coats # 24; Electrical j-box cover, gray; Moisture cured urethane; #8 dense blisters entire panel, >#2 Few blisters. Approximately 5% delamination from broken blisters. Note: Tag stuck to top of panel causing heavy rust.

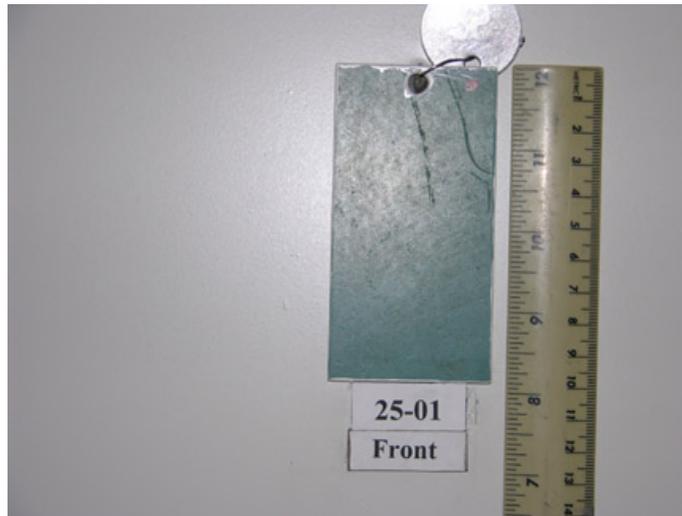
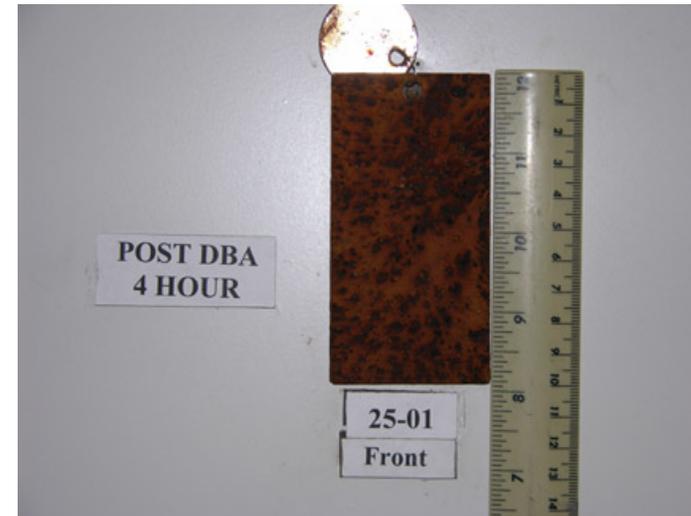
## OEM Unqualified Coating Sample# 25

- OEM Coats # 25; Shaft coupling guard, blue-green; Alkyd; Heavy rust on entire panel. Approximately 80% delamination.

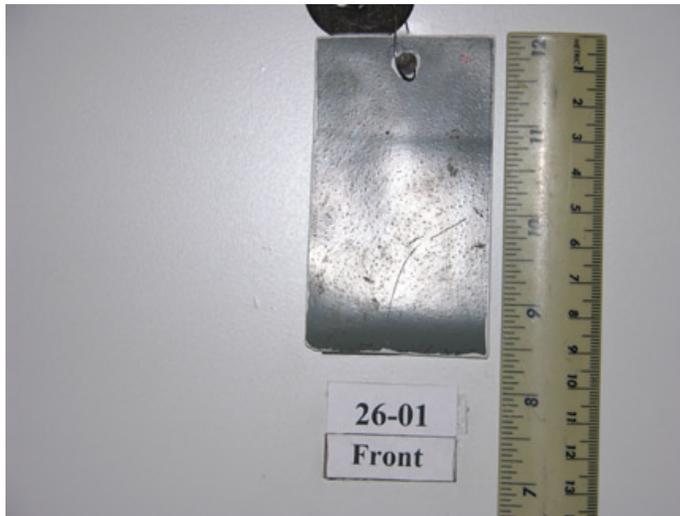
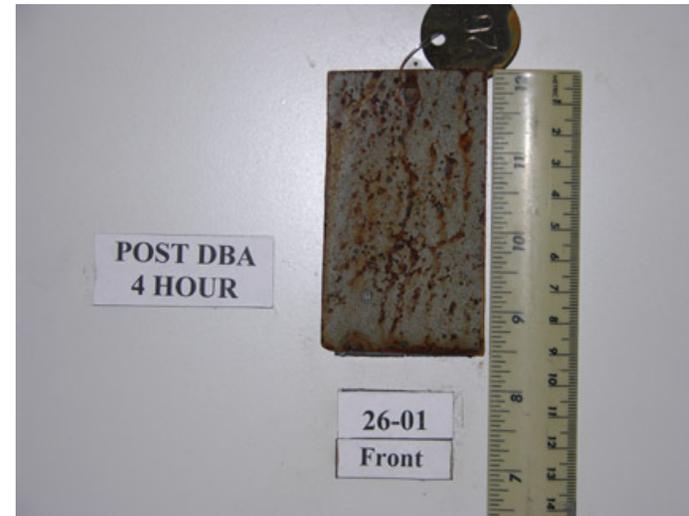
## OEM Unqualified Coating Sample# 26

- OEM Coats # 26; “Westinghouse brand” conduit box cover, gray; Styrenated alkyd; No.2-8 dense blistering, some broken. Approximately 20% delamination.

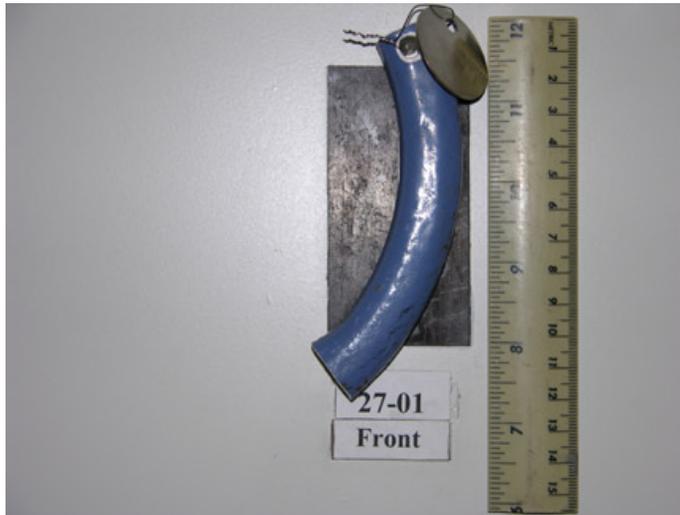
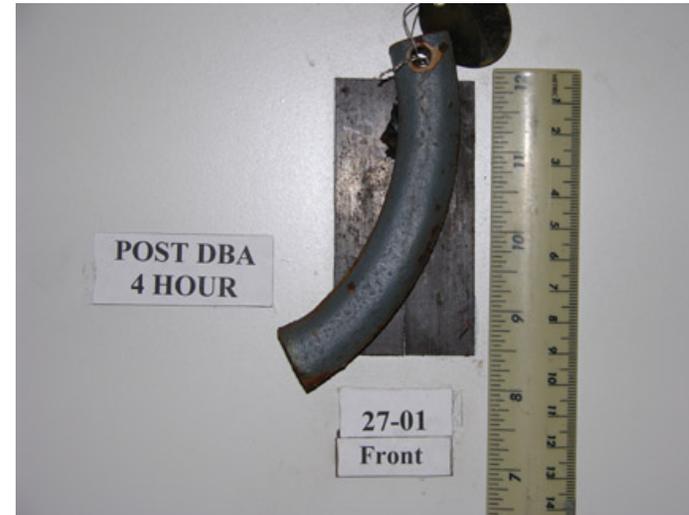
## OEM Unqualified Coating Sample# 27

- OEM Coats # 27; “Grinnel brand” hand wheel, light blue; Epoxy; No. 8 medium dense blistering, some broken. Approximately 20% delamination.

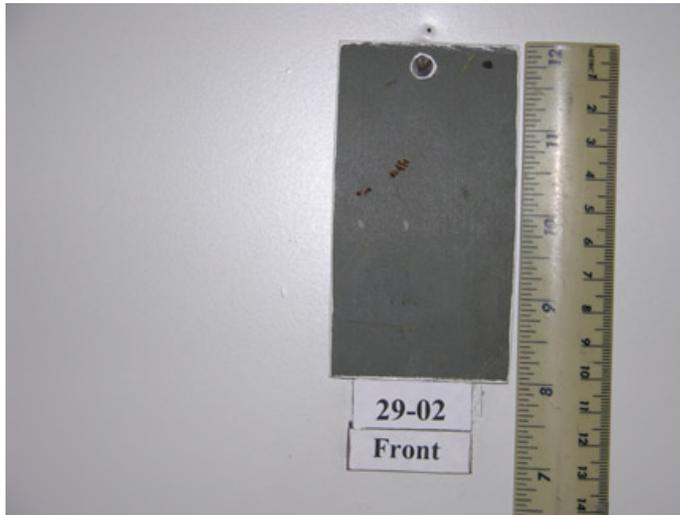
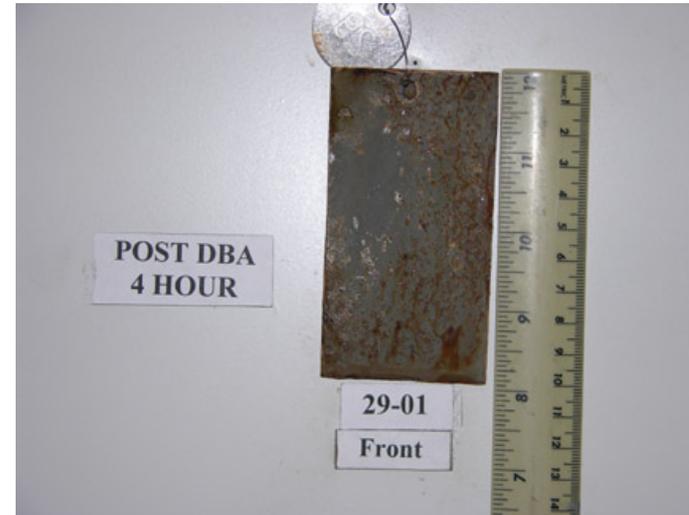
## OEM Unqualified Coating Sample# 29

- OEM Coats # 29; “Victoreen brand” instrument cover, gray; Epoxy; No. 8 dense blistering, some broken causing rust. When viewed under magnification there is a possibility of intracoat delamination. Approximately 50% intracoat delamination.

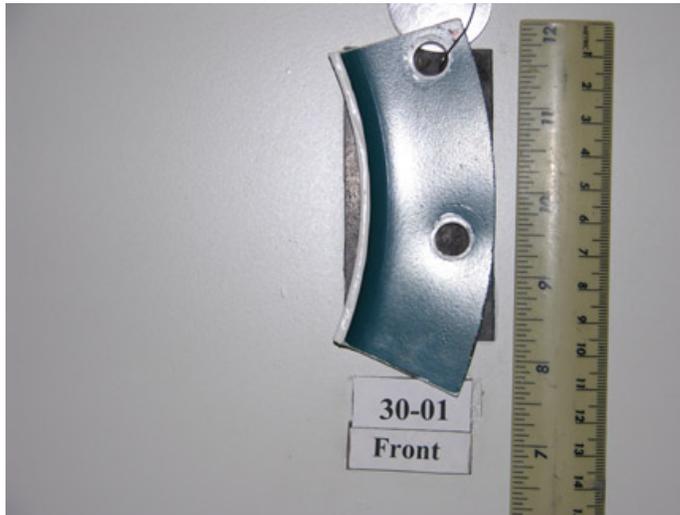
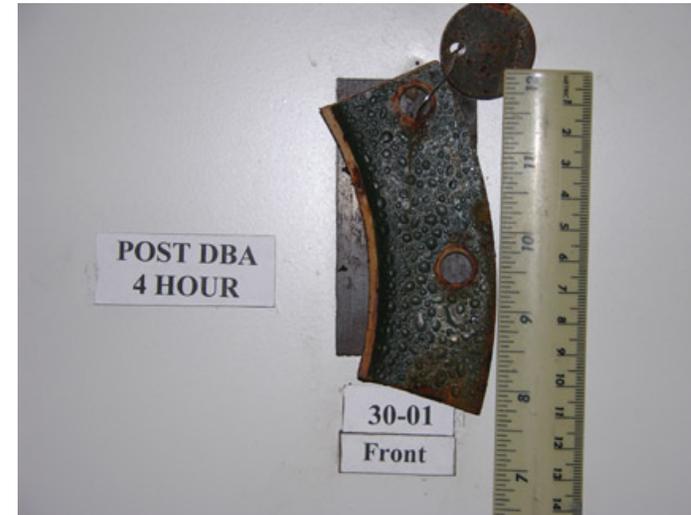
## OEM Unqualified Coating Sample# 30

- OEM Coats # 30; Top of diaphragm operator, blue-green; Moisture cured urethane; No. 2 dense blistering, all intact with the exception of a single blister located bottom center of panel. <1% delamination.

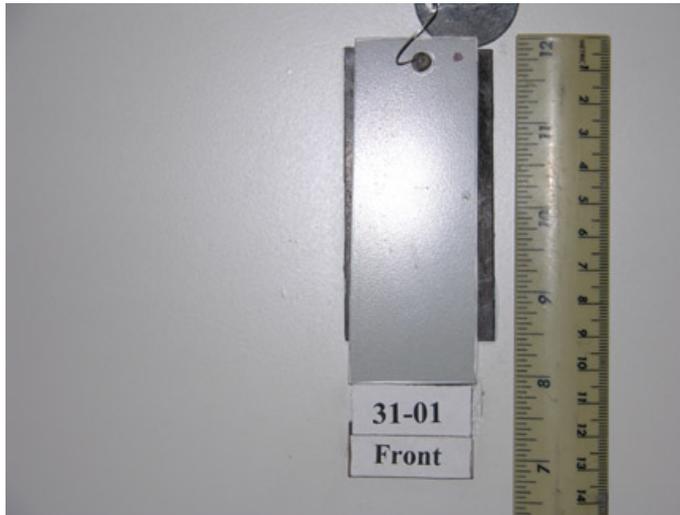
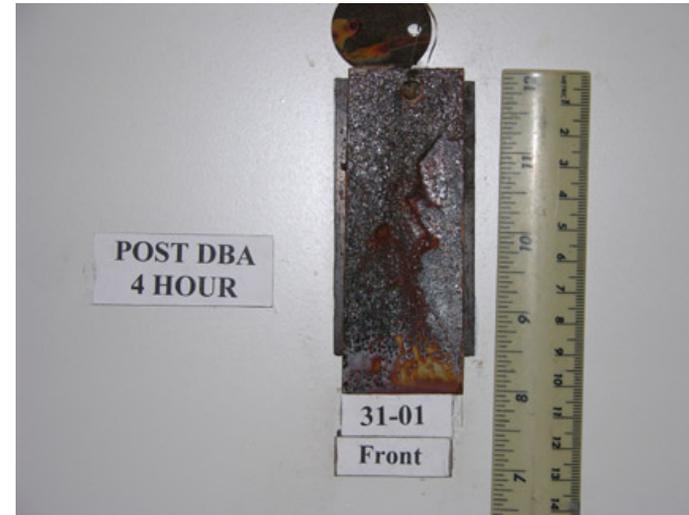
# OEM Unqualified Coating Sample# 31

- OEM Coats # 31; Gaitronics j-box, gray; Alkyd; Heavy rust and deterioration of coating. Approximately 98% delamination.
