# OEM Unqualified Coatings Testing

Washington D.C. / Rockville  
April 12-13, 2005

*Timothy Eckert*  
*PSE Project Manager*  
*eckertt@epri.com*  
*704 547-6058*

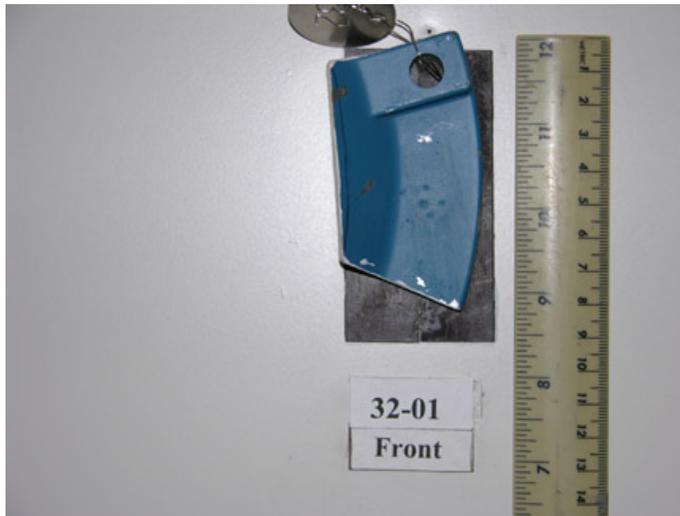
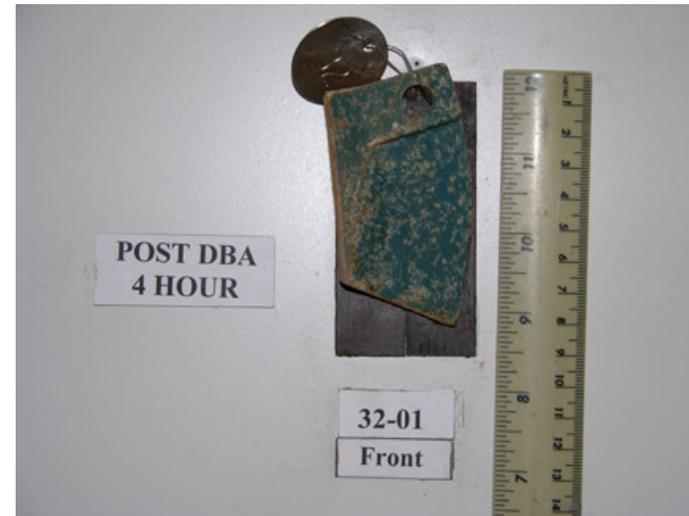
## OEM Unqualified Coating Sample# 32

- OEM Coats # 32; Top of an ITT diaphragm operator, blue-green; Alkyd; No. 8 dense blistering with oxidation in powder form coming through broken blisters. Approximately 40% delamination.

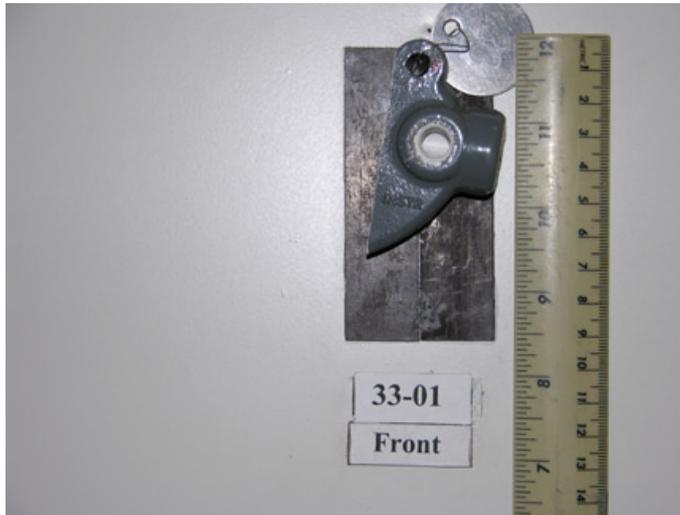
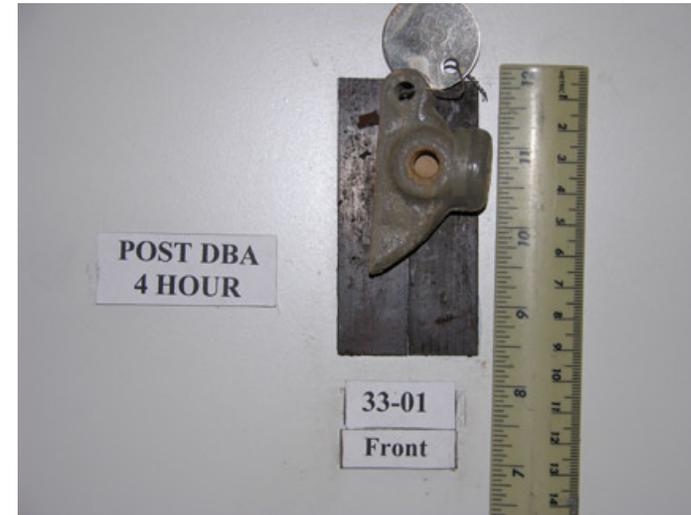
## OEM Unqualified Coating Sample# 33

- OEM Coats # 33; Manifold for air lines, gray; Epoxy ester; No. 4-6 medium dense blistering with oxidation in powder form coming through broken blisters. Approximately 5% delamination.

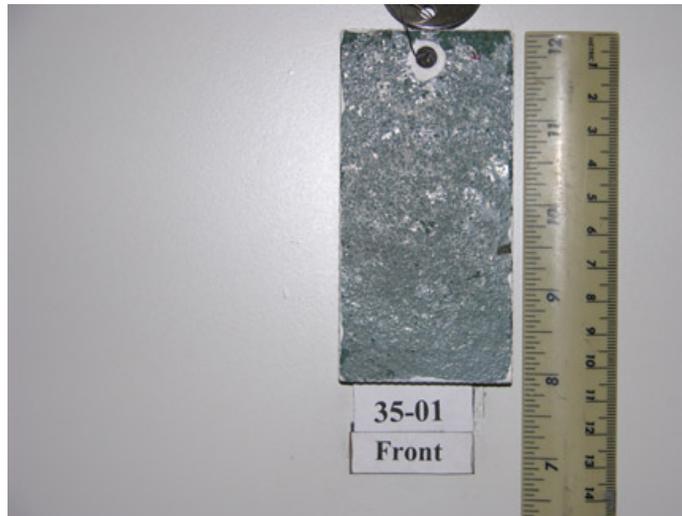
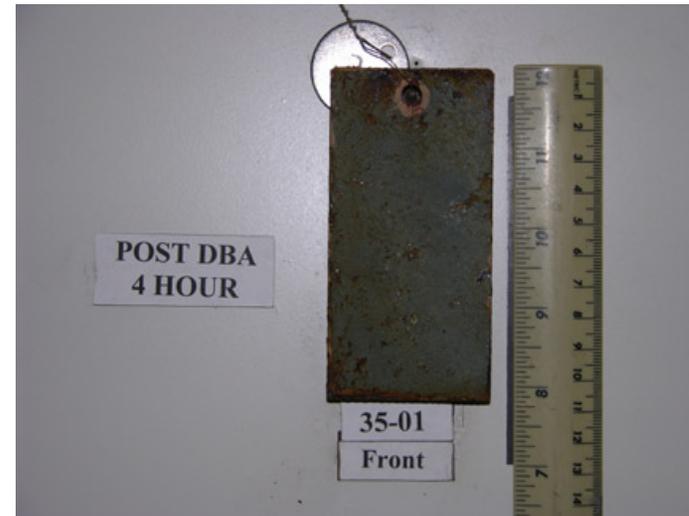
## OEM Unqualified Coating Sample# 35

- OEM Coats # 35; Limitorque cover, blue; Alkyd; No. 6-8 dense blistering, some rust from broken blisters. Approximately 5% delamination

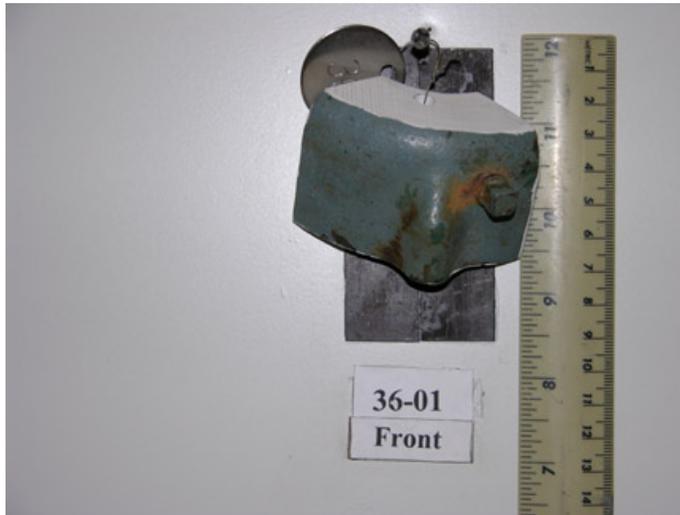
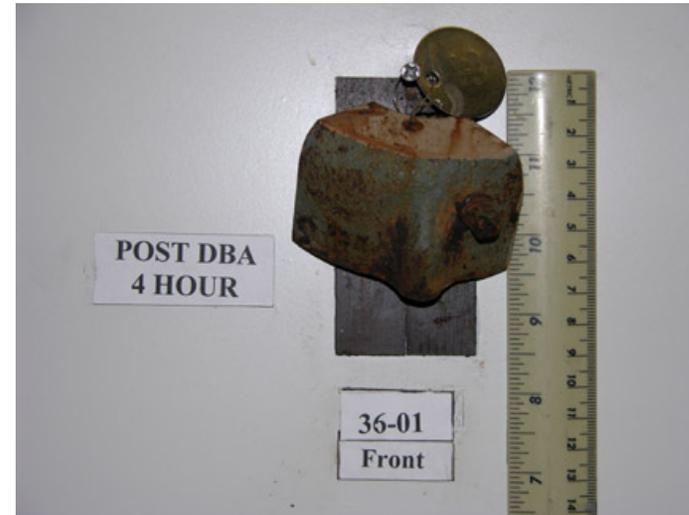
## OEM Unqualified Coating Sample# 36

- OEM Coats # 36; Motor/pump end piece, blue; Alkyd; No. 2-8 dense blistering, some broken. Approximately 5% delamination
