Subject: 10CFR21 Reporting of Defects and Non-Compliance -
Engine Systems, Inc. Report No. 10CFR21-0089, Rev. 0

Woodward Governor "Compensating" EG Series Actuators

Report No. 10CFR21-0089
Rev. 0: 04/12/05

10CFR21 REPORTING OF DEFECTS AND NON-COMPLIANCE

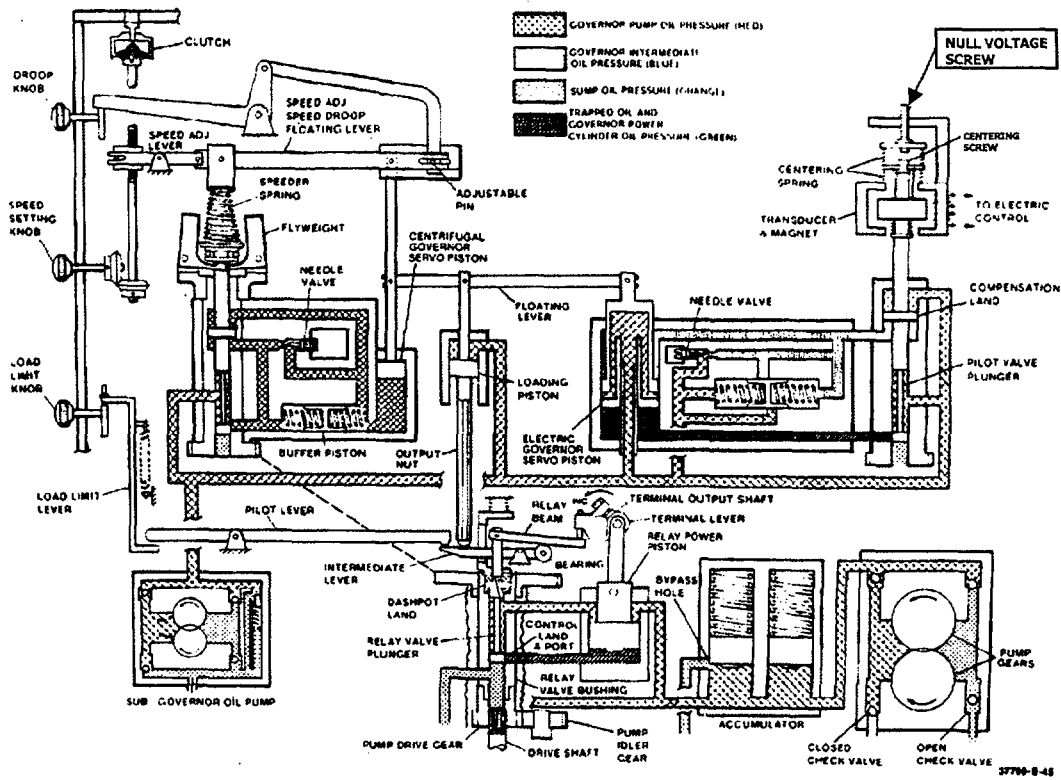
FIGURE 1: TYPICAL EGB-C "COMPENSATING" GOVERNOR

Null voltage is used with "compensating" Woodward EG series actuators. The actuators use the Woodward EGA and EGM electronic controls. The EGA controls obtain input power from generator output voltage and sense prime mover speed by monitoring generator output frequency. EGM controls usually are powered from a DC power source and sense prime mover speed via a magnetic pickup monitoring a toothed wheel or gear. The systems are at steady state (rated speed) when operating at the null voltage. The control's output voltage signal will increase or decrease from the null value when it senses a speed change (such as during load transients) to return the prime mover to rated speed. The output voltage will return to the null value once rated speed is obtained. Since the EGA cannot sense speed until the generator builds output voltage, the actuator must go to maximum fuel when a control signal is not present to enable starting of the prime mover; this is known as "fail to maximum fuel". This is not required for starting of EGM systems, since the control will sense speed from the magnetic pickup during cranking of the prime mover. "Fail to maximum fuel" response however is desirable for nuclear safety related applications of both controls since it provides a failsafe mode; that is, the prime mover will go to the high speed setpoint upon loss of the electronic control signal. With "fail to minimum fuel" response, the actuator goes to minimum fuel upon loss of control signal and therefore there is no failsafe mode.

Ideally, the null value would be zero volts to provide equivalent response time in the increase and decrease fuel directions. At zero volts however, the actuator does not recognize the difference between a zero voltage signal (null point) and a loss of control signal. A small offset voltage must therefore be set into the actuator to provide "fail to maximum fuel" or "fail to minimum fuel" response. A negative null voltage results in "fail to maximum fuel" response and a positive null voltage results in "fail to minimum fuel" response. A small offset voltage is utilized to minimize the imbalance between increase fuel and decrease fuel response times. Typically, the null voltage is set at -0.9 to -0.7 volts; however some applications use up to -1.5 volts.

Proportional actuators (EGB-13P, 35P, etc.) have an internal feedback (a mechanical link) between the electrical power piston and electrical section pilot valve. This feedback, which is not provided on the compensating actuators, eliminates the concern of drift because any deviations within the centering restoring spring, pilot valve, etc. are overcome as the power piston and pilot valve come to equilibrium. Reference Figures 1 and 2.
