ENGINE SYSTEMS, INC.

Subject: 10CFR21 Reporting of Defects and Non-Compliance -
Engine Systems, Inc. Report No. 10CFR21-0089, Rev. 0

Woodward Governor "Compensating" EG Series Actuators

10CFR21 REPORTING OF DEFECTS AND NON-COMPLIANCE

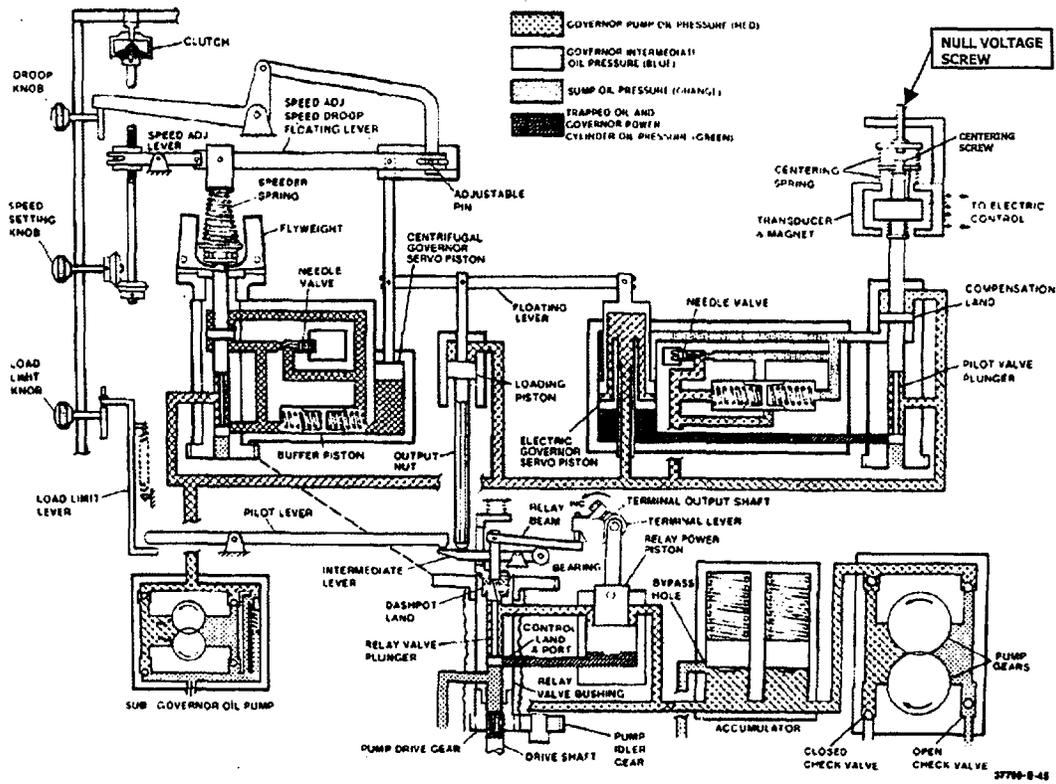
FIGURE 1: TYPICAL EGB-C "COMPENSATING" GOVERNOR

Proportional actuators (EGB-13P, 35P, etc.) have an internal feedback (a mechanical link) between the electrical power piston and electrical section pilot valve. This feedback, which is not provided on the compensating actuators, eliminates the concern of drift because any deviations within the centering restoring spring, pilot valve, etc. are overcome as the power piston and pilot valve come to equilibrium. Reference Figures 1 and 2.
