SUBJECT: BYRON STATION, UNIT 1 - SUMMARY OF CONFERENCE TELEPHONE
CALL REGARDING STEAM GENERATOR INSPECTIONS FROM THE SPRING
2005 OUTAGE (TAC NO. MC6415)

CONFERENCE CALL SUMMARY

2005 STEAM GENERATOR TUBE INSPECTIONS

BYRON STATION, UNIT 1

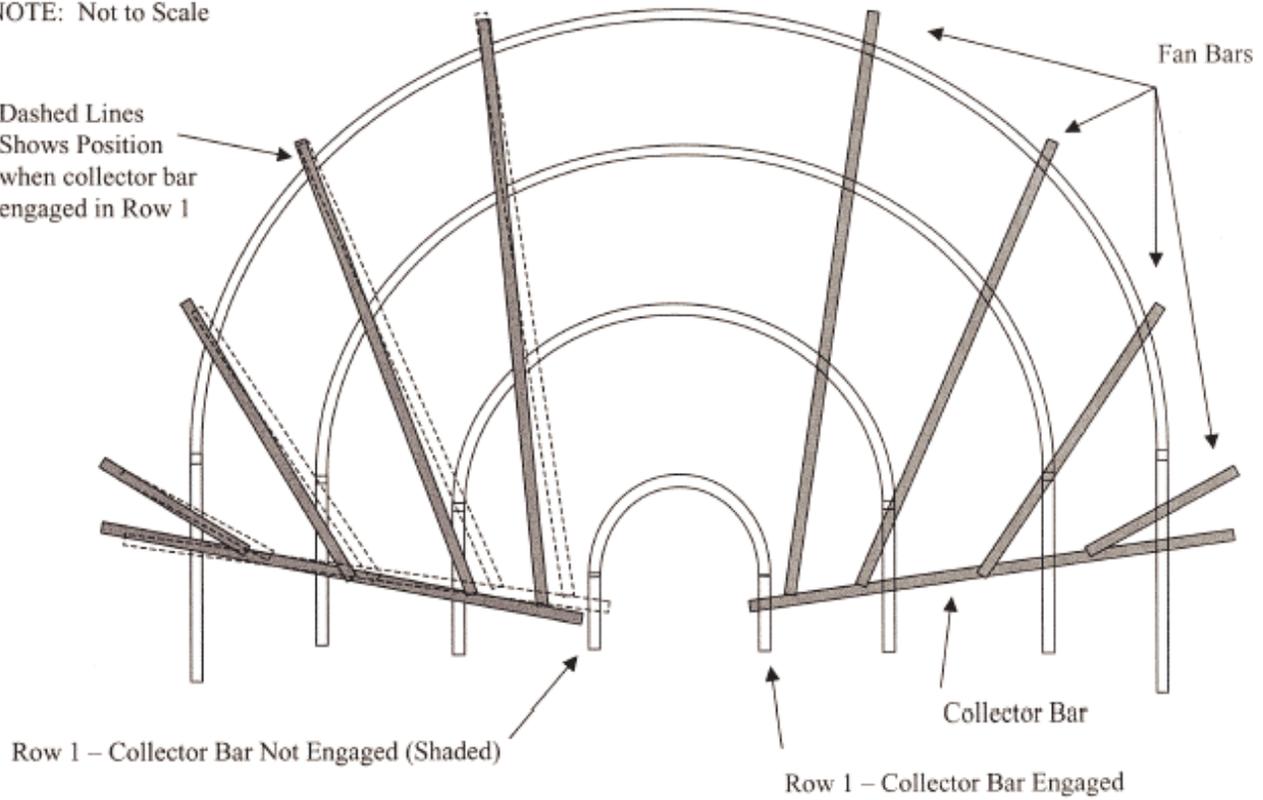
Fan Bar Configuration

In steam generator B, 57 of the 67 row 1 tubes on the hot-leg side of the bundle were found to be disengaged from the collector bar (see attached figure). The ten row 1 tubes on the hot-leg side that remained engaged with the collector bar were in close proximity to one another and were located near the edge of the tube bundle. The collector bar remained engaged for all row 1 tubes on the cold-leg side. There were no indications of tube wear in the affected row 1 tubes. All other steam generators had fully engaged collector bars, as confirmed by eddy current.

The condition of the disengaged collector bar is believed to have originated during fabrication of the steam generator. In order to correct the potential for tubes to come into contact (or close proximity) with each other, the fan bar support mechanisms (J-tabs) were repositioned during the fabrication process. The curvature of the tube bundle is believed to have interacted with the J-tabs in a way that caused the collector bar to shift out of contact with the row 1 tubes on the hot-leg side. The ten row 1 tubes that remain in contact with the collector bar are located at the end of the tube bundle where the outermost tubes have a smaller U-bend radius. The licensee believes that the smaller radius tubes caused less rotation of the fan bar assembly during the J-tab repositioning process, and therefore, allowed the collector bar to remain engaged at those locations. The licensee's analysis predicts no additional stress has been added to the fan bar assemblies as a result of the shift in position. The assembly rotated approximately one half of a degree. The fan bar assembly can tolerate movements of this magnitude without adding strain to fan bars or the tubes.

Dashed Lines Shows Position when collector bar engaged in Row 1
