SUBJECT: FORT CALHOUN STATION, UNIT NO. 1 - 2005 STEAM GENERATOR  
INSPECTION CONFERENCE CALL SUMMARY (TAC NO. MC5776)

**MARCH 14, 2005 CONFERENCE CALL SUMMARY**

**2005 STEAM GENERATOR TUBE INSPECTIONS**

**FORT CALHOUN STATION, UNIT 1**

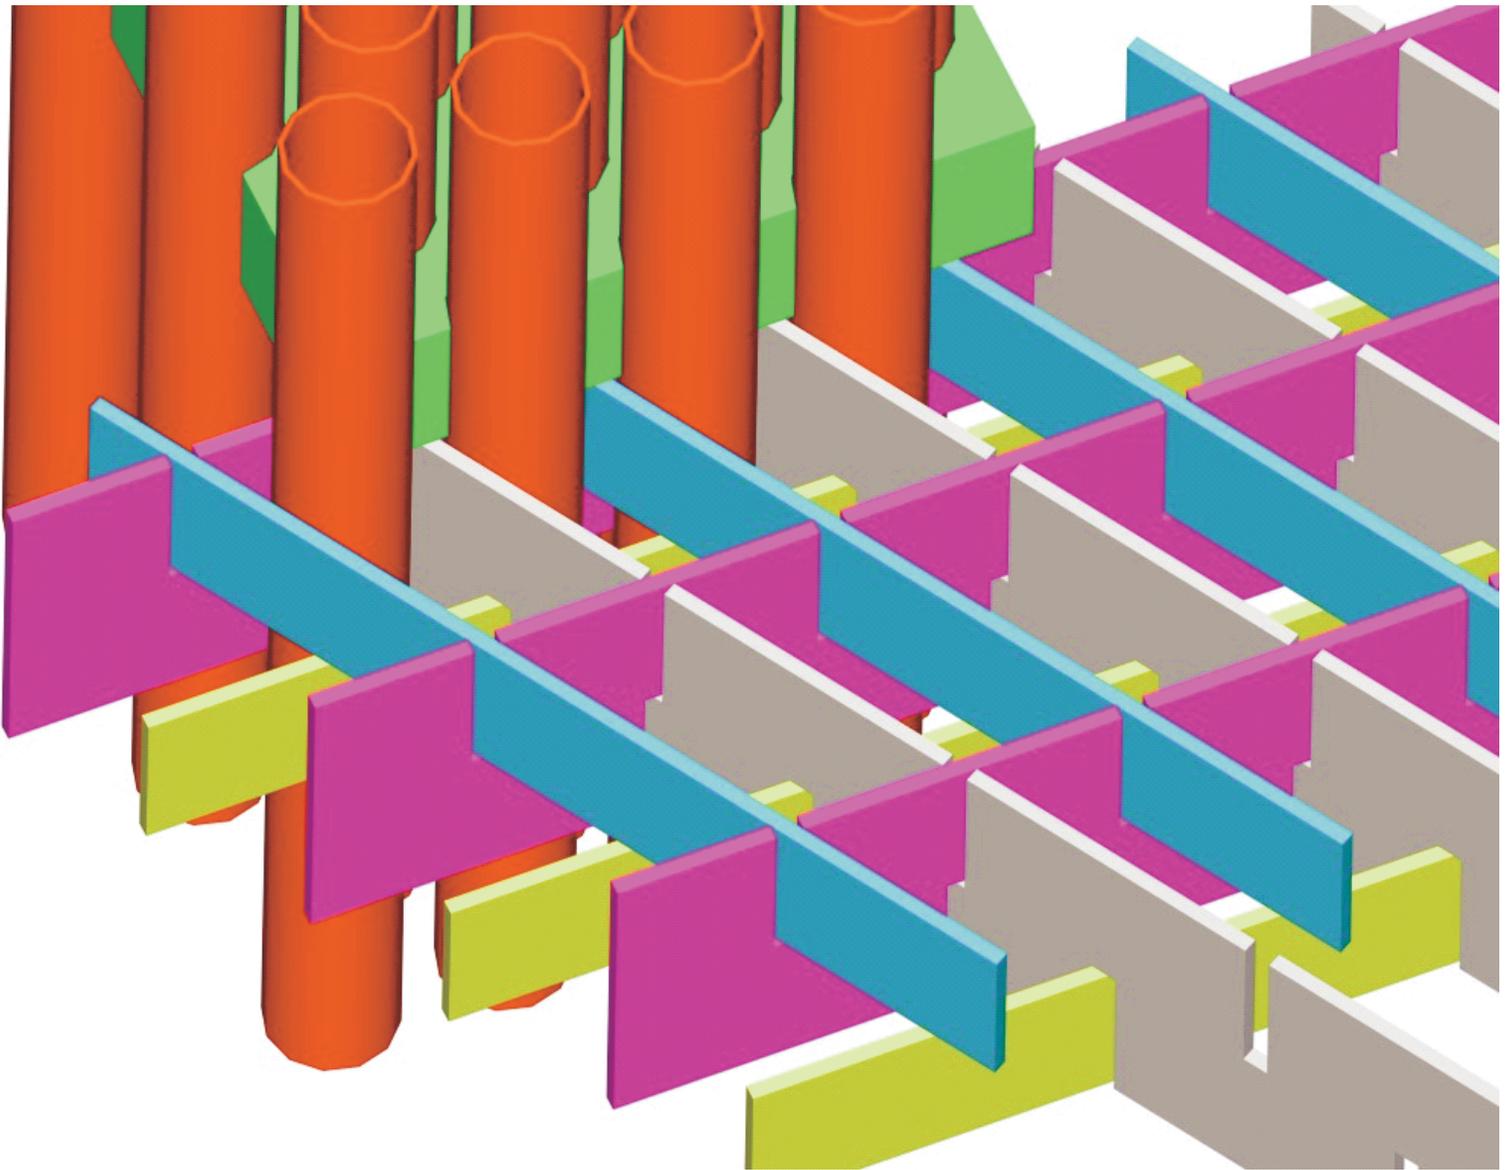
Figure 1  
Eggcrate and Tube Support Plate Intersection – Top View

The area defined as the "Circumferential Critical Area +2 to -6 inches", is the area where the drilled hole portion of a support (i.e., the patch plate) meets the eggcrate portion of the support. In this region, two lines of tubes are supported by both supports (eggcrate and drilled hole). The drilled support plate is positioned directly above the eggcrate support. The edge of the drilled plate is scalloped, having the shape of a series of semi-circles when viewed from above. One of the lines of tubes is in contact with the scalloped edge of the drilled support plate (i.e. it is only supported on one side by the drilled hole support) and is fully supported by the eggcrate support directly below it. The other line of tubes is fully supported by the drilled support and is only supported on one side by the eggcrate support directly below the drilled plate. Growth of the drilled plate from denting could result in a bending strain at and below the eggcrate where the tube is restrained by movement in the lateral plane. This area is inspected 100 percent with a rotating probe from 2 inches above the supports to 6 inches below to identify any cracks that may occur in the freespan as a result of strain caused by the interaction of

the supports. Figures depicting the Circumferential Critical Area were supplied by the licensee and are attached to this summary.

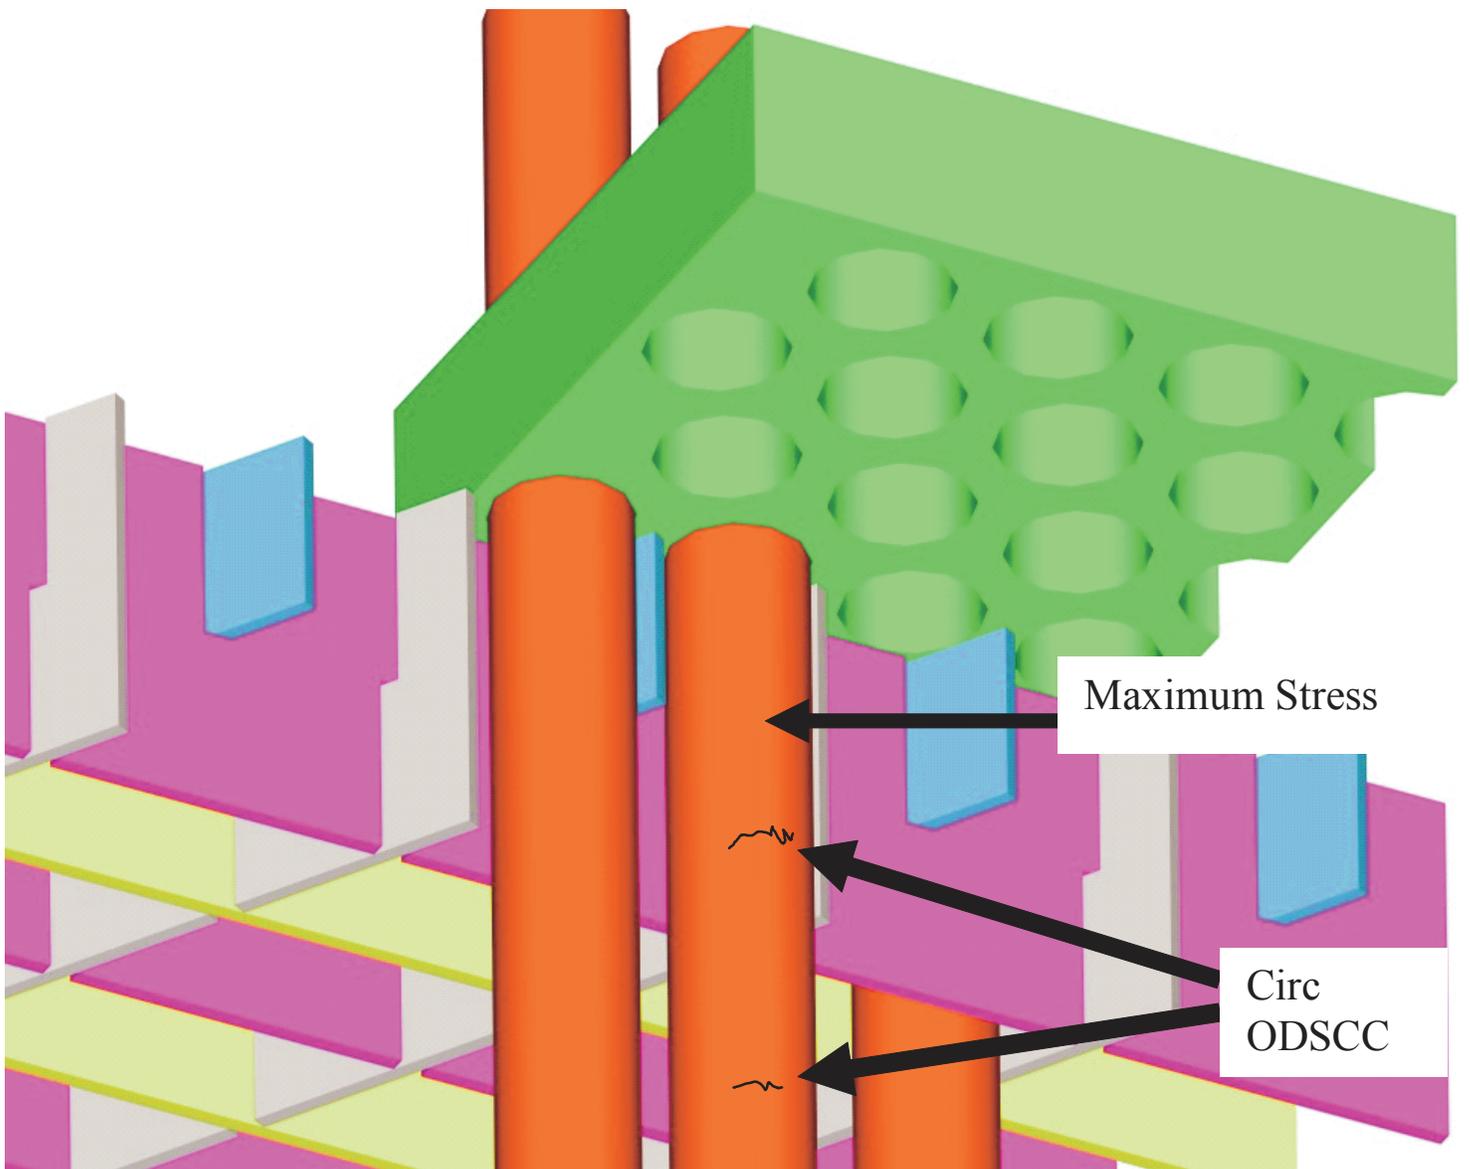
Figure 3

Two tubes in steam generator A had circumferential flaws in the Circumferential Critical Area. The flaws are located in the line of tubes that is fully supported by the drilled plate and partially supported by the eggcrate support. The flaws were located within the drilled hole support and were fully enveloped by the support (360 degrees). Both flaws were facing away from the drilled support and towards the eggcrate support structure. The first flaw, located at the H1 support, was 62 percent throughwall with a circumferential extent of 27 degrees. The second flaw, located at H6, was 36 percent throughwall with a circumferential extent of 90 degrees.

*For the 2005 examination a critical area was defined for freespan circumferential outer diameter stress corrosion cracking (ODSCC). This is comprised of the two lines of tubes surrounding the partial drilled support plates where the relative displacement of the drilled support and eggcrate structure resulted in a bending strain below the eggcrate. The bending strain dissipates with increasing distance below the structure. The tubes in this critical area were tested to a distance of 6 inches below the centerline of the eggcrate (2 inches thick). This distance is based on engineering judgment as well as the results from the 2003 examination which showed that the flaw furthest away from the support was 2.38 inches below the lower edge of the eggcrate.*

Eggcrate and Tube Support Plate Intersection –  
Bottom View with Maximum Stress and Crack Locations  
Detected During the 2003 Inspection
