Union of Concerned Scientists
Citizens and Scientists for Environmental Solutions

issue brief

THE MILLSTONE UNIT 3 EVENT – REV. 0

Prepared by: David Lochbaum April 18, 2005 – Rev. 0

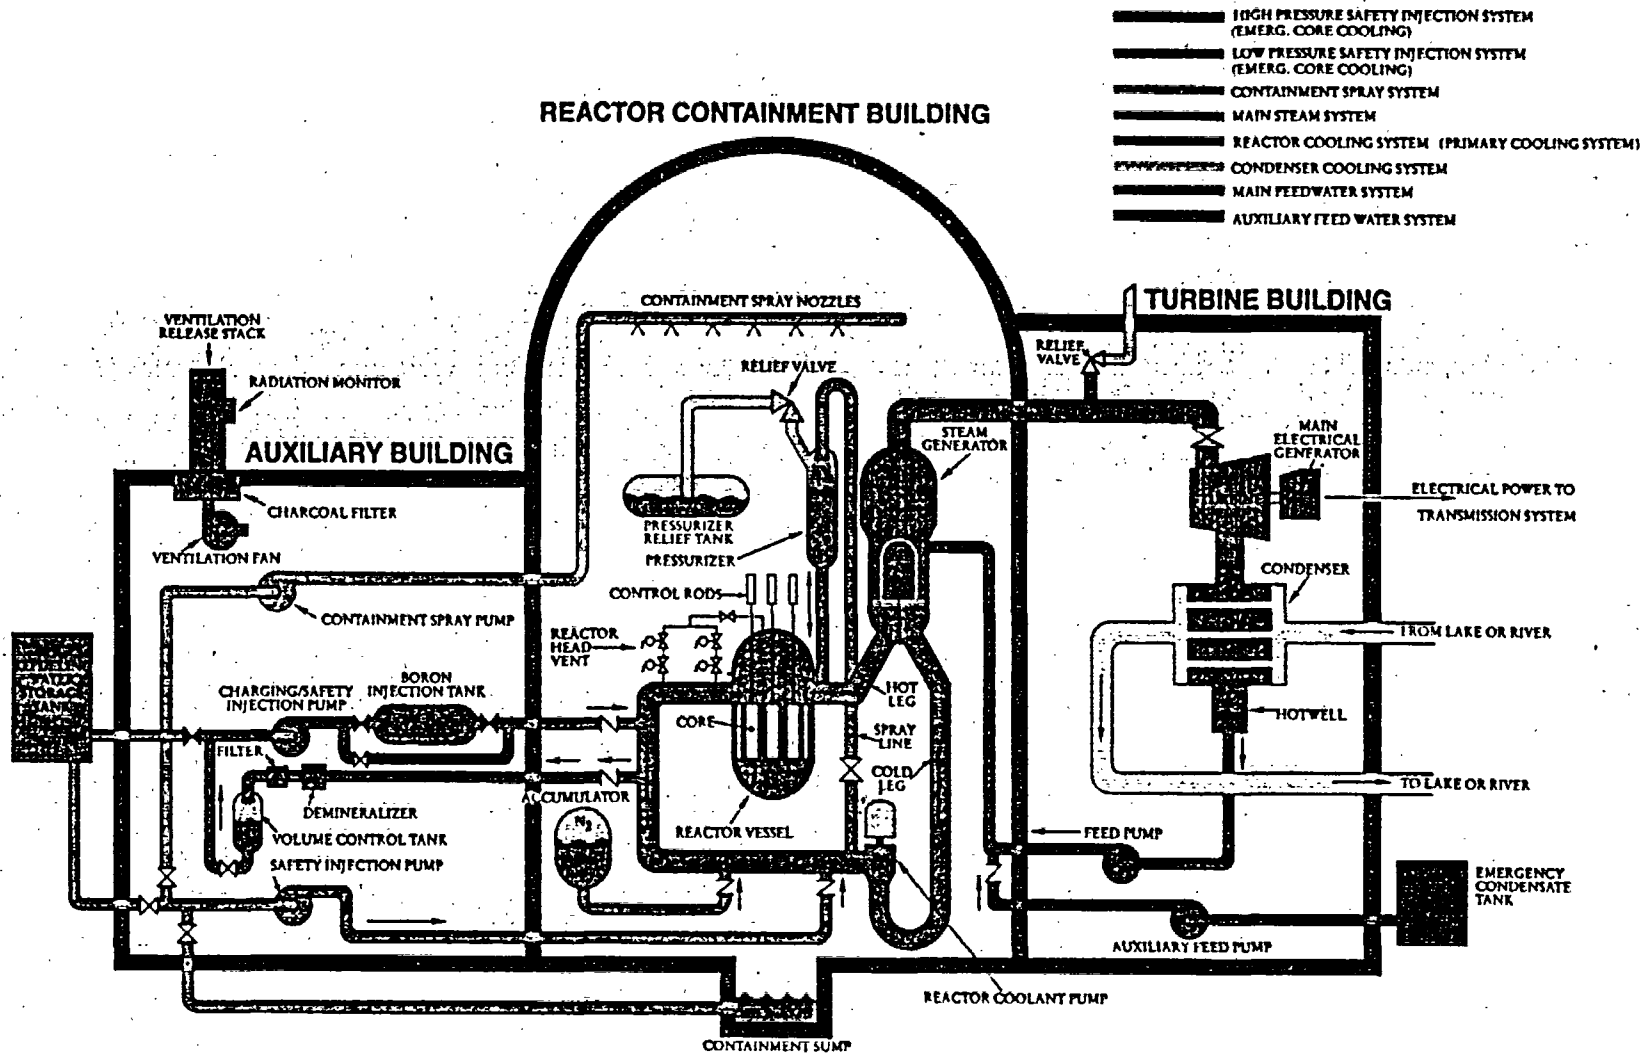
It appears – although the initial reports are very fuzzy on this point – the problem started when several main steam relief valves opened with the reactor operating at full power. These valves are located on the pipes that carry steam from the steam generators to the main turbine. (In the figure, these valves are represented by a single “Relief Valve” located in the upper left corner of the Turbine Building.) Steam flowed through these opened valves and to the turbine. This high rate of steam flow apparently triggered automatic sensors that monitor for ruptures of the steam piping. These sensors caused a safety injection signal and an automatic trip of the reactor.

It appears that the automatic safety injection signal was not successful in causing the safety injection system to start. The report suggests that the operators had to manually complete the initiation sequence. The safety injection system (which appears in the lower left corner of the figure) takes water from a large tank outside the plant and supplies it to the loop of water circulating through the reactor core. Because this loop of water – termed the reactor coolant system and the primary loop – was intact, the flow from the safety injection system filled the pressurizer (shown slightly above dead center in the figure) and caused one primary system safety valve to open. (The primary system safety valve is loosely represented by the “Relief Valve” shown above and to the left of the pressurizer.)

The operators also manually assisted another automatic safety action that had only halfway initiated. They took steps to close the main steam isolation valves (represented by the vertical ‘bow-tie’ just above the turbine at the upper right portion of the figure.) The heat produced by the nuclear fuel is normally routed to the main condenser during normal operation and during shutdown and transferred to water drawn from the sound. Closure of the main steam isolation valves eliminated this pathway for decay heat removal. Instead, the atmospheric steam dump valves (not shown on the figure, but located on the steam pipes between the “Relief Valve” and the main steam isolation valves) opened to discharge the heat in the form of steam directly to the atmosphere.

The auxiliary feedwater system automatically initiated. The auxiliary feedwater pumps are the backup to the feedwater pumps that normally supply makeup water to the steam generators. (The auxiliary feedwater pump appears in the lower right portion of the figure.)

Operators turned off the safety injection system and relied on the charging system to periodically makeup water to the reactor coolant system. (The charging/safety injection pump appears on the left side of the figure.) The initial reports indicate that a couple of valves in the charging system leaked water into the auxiliary building, but that those leaks have now been found and fixed.
