THE MILLSTONE UNIT 3 EVENT - REV. 0

N clear Regulatory Commission (NRC) Daily Event Report No. 41607 provided sketchy and incomplete information about an emergency declared on Sunday April 17, 2005 at Millstone Unit 3. This Issue Brief attempts to explain the event from the sparse details publicly available. It is anticipated that this Issue Brief will be revised as the full story emerges.

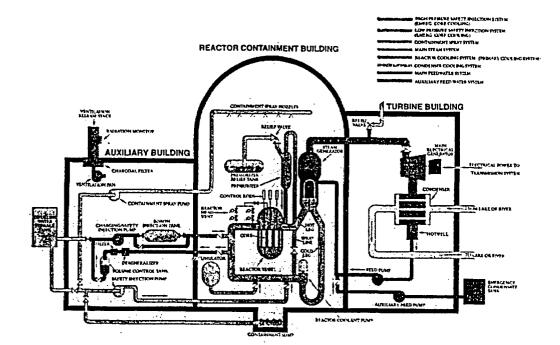
I appears – although the initial reports are very fuzzy on this point – the problem started when several main steam relief valves opened with the reactor operating at full power. These valves are located on the pipes that carry steam from the steam generators to the main turbine. (In the figure, these valves are represented by a single "Relief Valve" located in the upper left corner of the Turbine Building.) Steam flowed through these opened valves and to the turbine. This high rate of steam flow apparently triggered automatic sensors that monitor for ruptures of the steam piping. These sensors caused a safety injection signal and an automatic trip of the reactor.

I appears that the automatic safety injection signal was not successful in causing the safety injection system to start. The report suggests that the operators had to manually complete the initiation sequence. The safety injection system (which appears in the lower left corner of the figure) takes water from a large tank outside the plant and supplies it to the loop of water circulating through the reactor core. Because this loop of water — termed the reactor coolant system and the primary loop — was intact, the flow from the safety injection system filled the pressurizer (shown slightly above dead center in the figure) and caused one primary system safety valve to open. (The primary system safety valve is loosely represented by the "Relief Valve" shown above and to the left of the pressurizer.)

T e operators also manually assisted another automatic safety action that had only halfway initiated. They took steps to close the main steam isolation valves (represented by the vertical 'bow-tie' just above the turbine at the upper right portion of the figure.) The heat produced by the nuclear fuel is normally routed to the main condenser during normal operation and during shutdown and transferred to water drawn from the sound. Closure of the main steam isolation valves eliminated this pathway for decay heat removal. Instead, the atmospheric steam dump valves (not shown on the figure, but located on the steam pipes between the "Relief Valve" and the main steam isolation valves) opened to discharge the heat in the form of steam directly to the atmosphere.

T e auxiliary feedwater system automatically initiated. The auxiliary feedwater pumps are the backup to the feedwater pumps that normally supply makeup water to the steam generators. (The auxiliary feedwater pump appears in the lower right portion of the figure.)

O erators turned off the safety injection system and relied on the charging system to periodically makeup water to the reactor coolant system. (The charging/safety injection pump appears on the left side of the figure.) The initial reports indicate that a couple of valves in the charging system leaked water into the auxiliary building, but that those leaks have now been found and fixed.
