W3F1-2005-0037

Waterford 3 SES Docket No. 50-382 License No. NPF-38 Combined Category C-3 and 15-Day Special Report SR-05-001-00 on the 13th Refueling Outage Steam Generator Tube Inservice Inspection

RF13 Combined Category C-3 and 15-Day Special Report

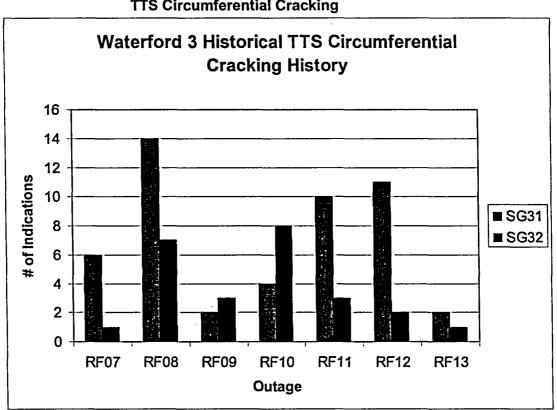
Figure 3.1.1 TTS Circumferential Cracking

The number of circumferential indications found per SG in each inspection is shown in Figure 3.1.1.

Screening of the indications was performed for in-situ testing. None of the indications met the minimum criteria for testing.

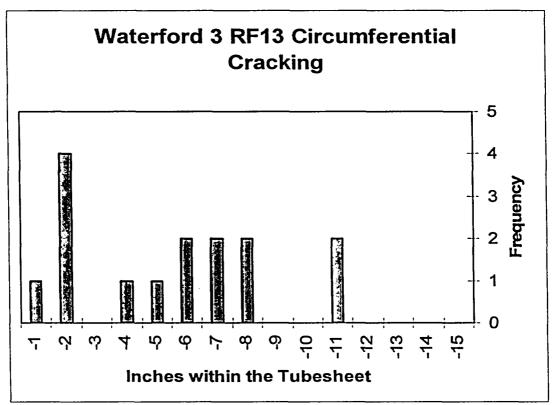
to 11 inches to be consistent with C*. A breakdown by location of the cracking within the tubesheet is provided in Figure 3.2.1:

Based on WCAP 16208, stabilization was performed on all circumferential indications above -3 inches. None of the indications exceed the in-situ selection criteria.

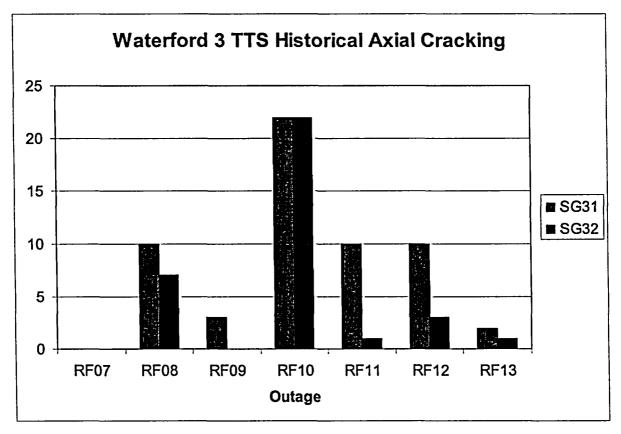
Figure 3.3.1 TTS Axial Cracking

This is displayed graphically below in Figure 3.3.1:

None of the TTS axial cracks exceeded the in-situ screening criteria for burst or leakage.

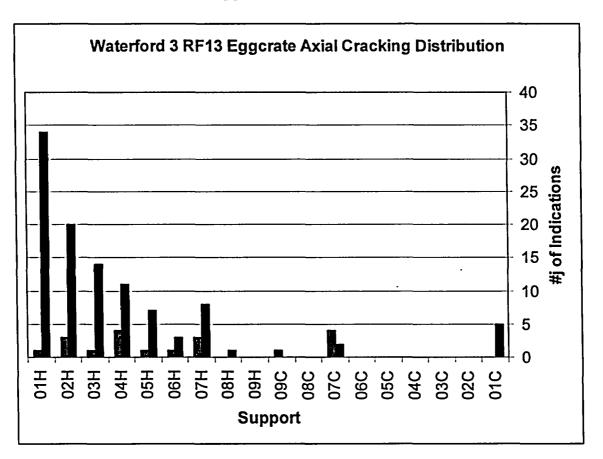
Figure 3.5.1 Eggcrate Flaw Distribution

Cracking at eggcrates was first detected at Waterford 3 in 1999 (RF09). The eggcrate support flaws at Waterford 3 are classified as axially oriented outside diameter stress corrosion cracking. The cracking can be a single crack or multiple cracks interconnected in the tube within the eggcrate support. As noted in Figure 3.5.1, SG31 has the largest number of flaws occurring at the hottest support plate (01 Hot) and generally decreases as the temperature decreases. SG32 does not have a statistically large enough number to determine the exact distribution. Figure 3.5.2 depicts the number of indications by outage.

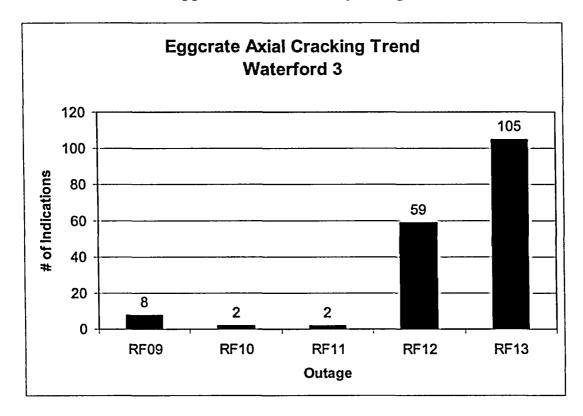
Figure 3.5.2 Eggcrate Axial Flaws by Outage

None of the eggcrate flaws detected during RF13 inspection met the in-situ pressure test criteria.

The increased number of indications at the eggcrates is consistent with industry experience. The RF12 value was 59 while the RF13 value was 105 in the bounding generator. This was bound by the operational assessment for the previous operating cycle.
