SUBJECT: WATTS BAR NUCLEAR PLANT, UNIT 1 — SUMMARY OF CONFERENCE  
CALLS WITH TENNESSEE VALLEY AUTHORITY REGARDING THE CYCLE 6  
REFUELING OUTAGE STEAM GENERATOR TUBE INSPECTIONS (TAC NO.  
MC5629)

SUMMARY OF CONFERENCE CALLS  
TENNESSEE VALLEY AUTHORITY  
STEAM GENERATOR TUBE INSPECTION RESULTS  
FOR THE CYCLE 6 REFUELING OUTAGE  
WATTS BAR NUCLEAR PLANT, UNIT 1

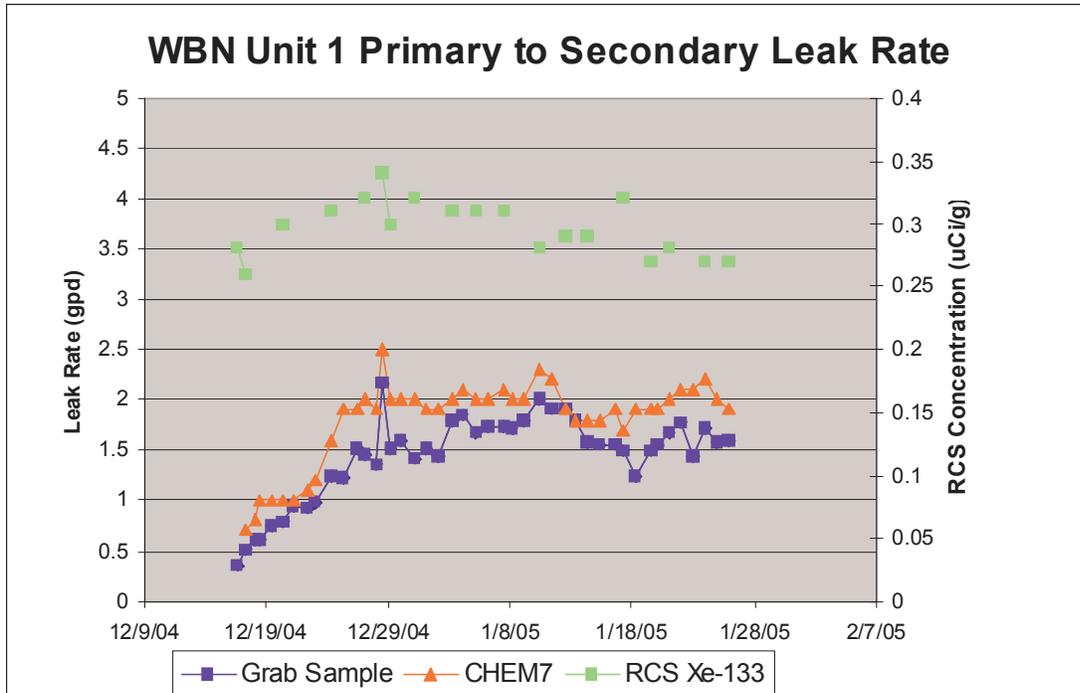
Response: There has been a very small amount of primary-to-secondary leakage for most of the cycle. It peaked at approximately 2.6 gallons per day. By the time the unit was shut down at the end of February the leakage had decreased to around 1 gallon per day. Chemistry identified the leaking SG as SG#2. The outage was moved one month sooner than planned to address this leakage concern.
