VIRGINIA ELECTRIC AND POWER COMPANY
SURRY POWER STATION UNIT 2
ASME SECTION XI INSERVICE INSPECTION (ISI) RELIEF REQUEST
MAIN STEAM LINE BRANCH CONNECTION WELDOLETS

Relief Request SPT-008 (Unit 2)
Surry Power Station Fourth Ten Year Interval

Alternative Ultrasonic Examination Method in Lieu of the Radiography Required
by ASME Section III

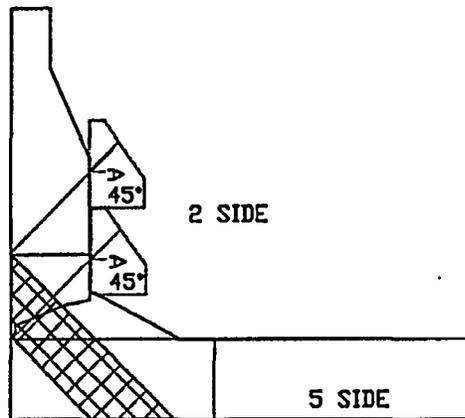
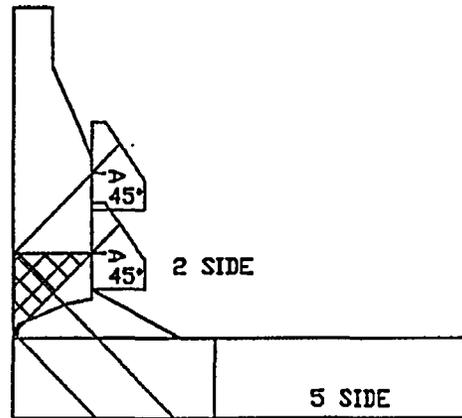
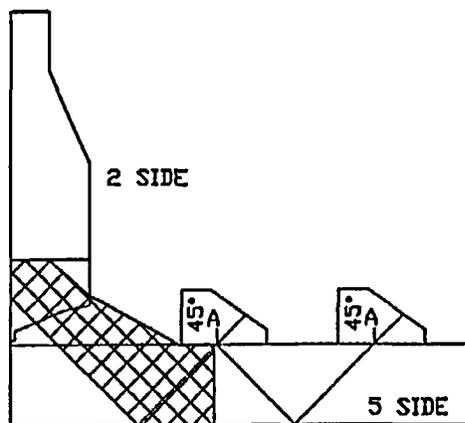
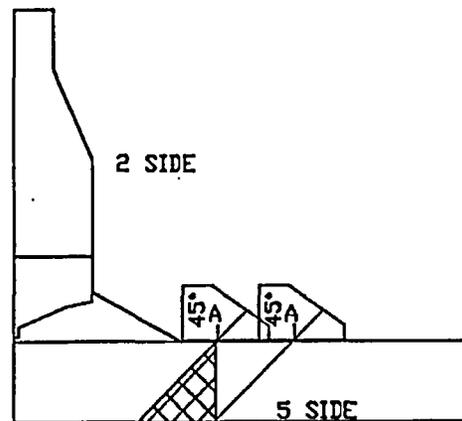
45° FOR 6" MS BC

The welds were examined to the maximum extent possible from four scan directions with 45° and 60° angles. Coverage was limited in all four directions due to the joint configuration resulting in a combined coverage for the 45° transducer of 48% with coverage of the weld root in only one direction. For the 60° scans, the combined total of 58.7% coverage was attained, and the root was examined from one direction. Please see attached sketches.

For scans searching for circumferentially oriented flaws with the 45° transducer, coverage of 5.3% was achieved in one direction and 84% coverage was achieved in the other direction. For scans searching for circumferentially oriented flaws with the 60° transducer, coverage of 41% was achieved in one direction and 91% coverage was achieved in the other direction. Coverage of the root and lower 1/3 of the weld was excellent for both the 45° and 60° transducers from one direction. For scans searching for axially oriented flaws, coverage was 51.3% with both the 45° and 60° transducers in both directions and was predominantly in the upper 1/2 of the weld.

No flaw type reflectors were identified during the examinations and all three nozzles were reported as acceptable.
