RE: Permit to Mine No. 603
In Situ Uranium Wellfield Release Report

Power Resources, Inc Smith Ranch-Highland Uranium Project URANIUM IN SITU WELLFIELD FLUID RELEASE REPORT

FAILURE OF BRASS NIPPLE HOSE CONNECTIONS ON INJECTION WELL HI-35

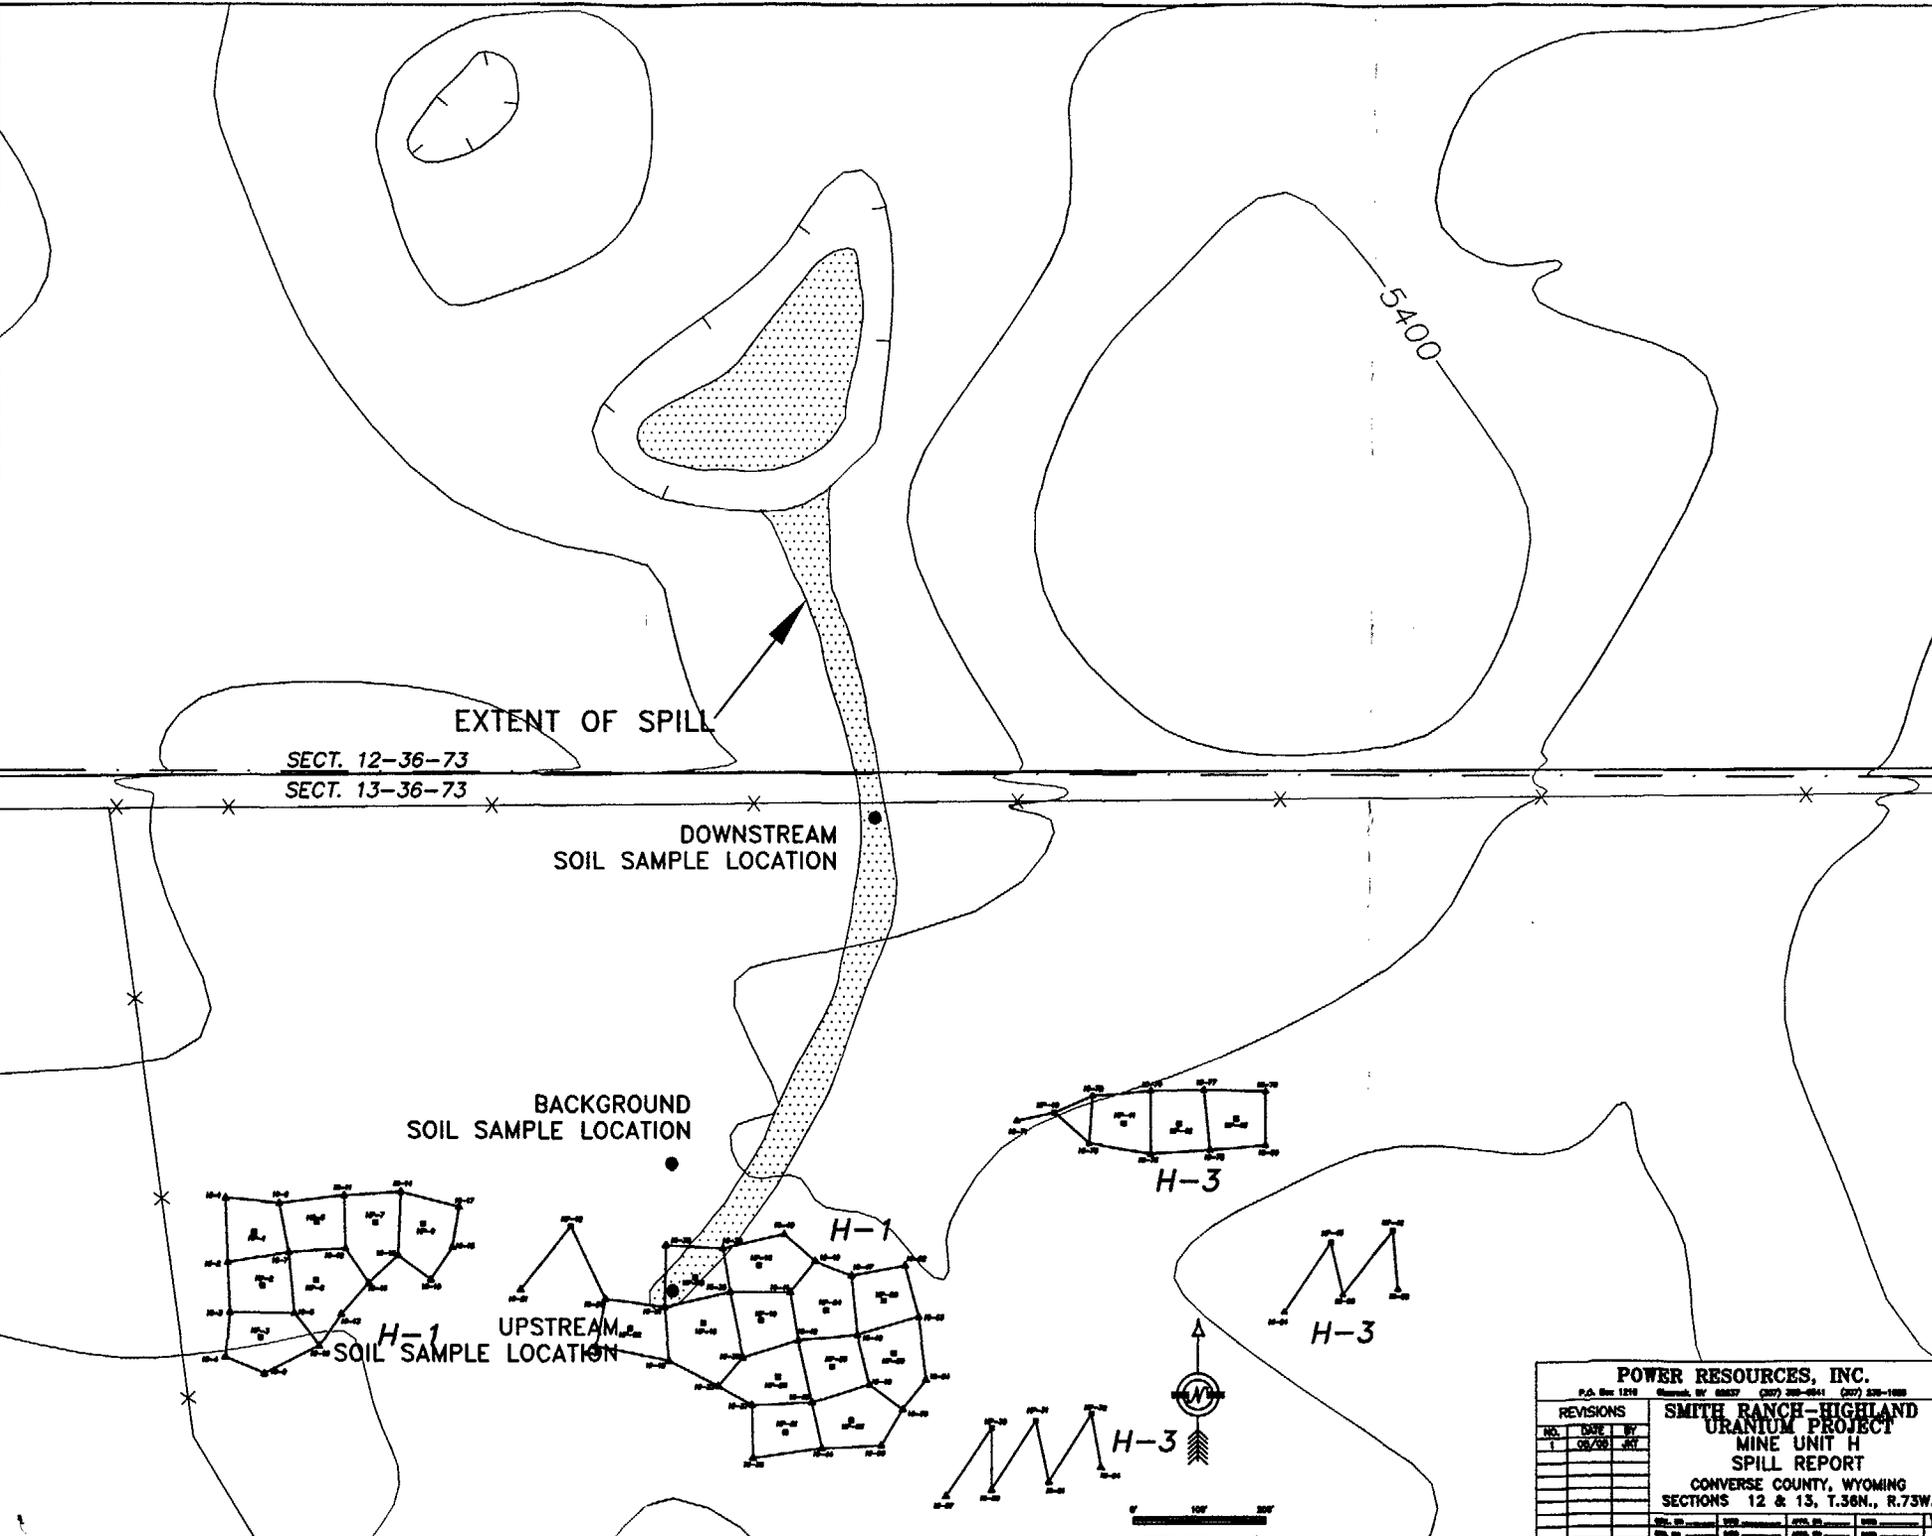
**SMITH RANCH-HIGHLAND
URANIUM PROJECT
MINE UNIT H
SPILL REPORT**
CONVERSE COUNTY, WYOMING
SECTIONS 12 & 13, T.36N., R.73W.

The release occurred in the SW $\frac{1}{4}$, SE $\frac{1}{4}$, Section 12, T36N, R72W and affected approximately 1.5 acres. The exact location and extent of the spill is shown on the attached map.
